TECHNICAL SERVICE BULLETIN
Click/Pop Noise While Turning The Steering Wheel From Straight Ahead To Full Lock During Low Speed Turning Events

Ford 2020-2025 Explorer	Built on or before 28-Jan-2025
-----------------------------------	--------------------------------

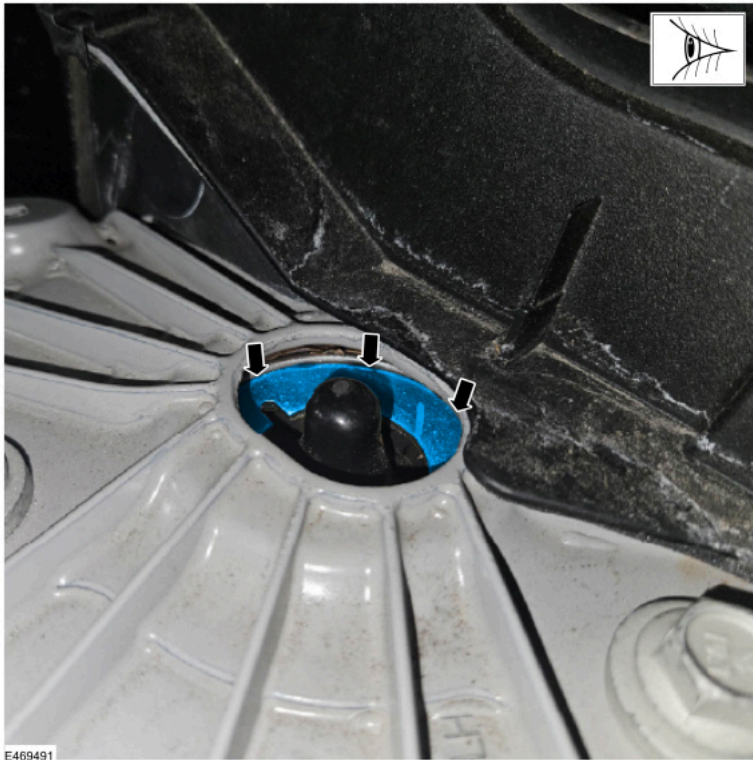
Issue: Some of the vehicles listed in the Model statement above may exhibit a click/pop noise while turning the steering wheel from straight ahead to full lock during low speed turning events. This may be due to the front upper strut mount washer movement under steering loads.

1. With the vehicle stationary on the ground and engine running, turn the steering wheel from straight ahead to full lock in both directions. Observe the strut mount washer and compare with Figure 1 and the video example below.

5. Replace the front upper strut mount(s).
