INSTRUCTION TO SERVICE

ITS61748		05/22/2026
SECTION:	470-Destination Signs	
SUBJECT:	Torque mounting hardware on front destination sign	
ISSUE:	Hardware is not torqued on front destination sign.	
SUMMARY:	Torque hardware to 60 IN/LBS.

ITS61748

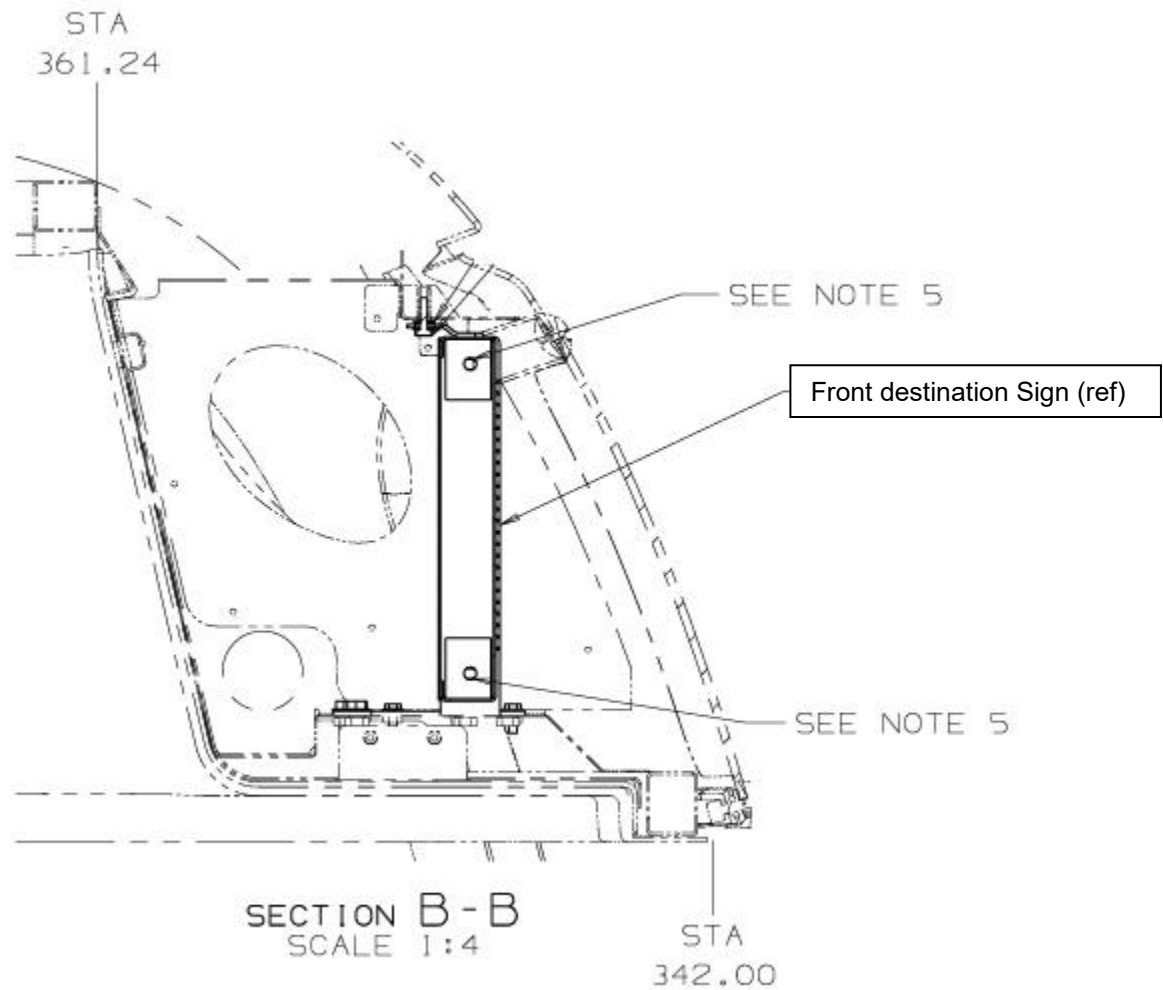
Figure 1a: Torque hardware as per note 5.

5) TORQUE VENDOR SUPPLIED HARDWARE TO 60 IN/LBS

1. Set Park brake.
2. Turn the main battery disconnect switch to the “OFF” position.
3. Locate the front destination sign in the upper front compartment in the bus. For steps 3 & 4, see Figure 1.
4. Loosen off side mounted bolts on the front destination sign. Re-tighten hardware and torque to 60 IN/LBS.
Repeat application on the 3 remaining bolts.
