GENERAL MOTORS
DCS7504
URGENT - DISTRIBUTE IMMEDIATELY

Subject: REVISION: N262547330-01 – Service Update
Telematic Control Module Reprogramming
Revised Warranty Table, Service Procedure & Additional Vehicles
Added

N262547330 Telematic Control Module Reprogramming

Revision: 02

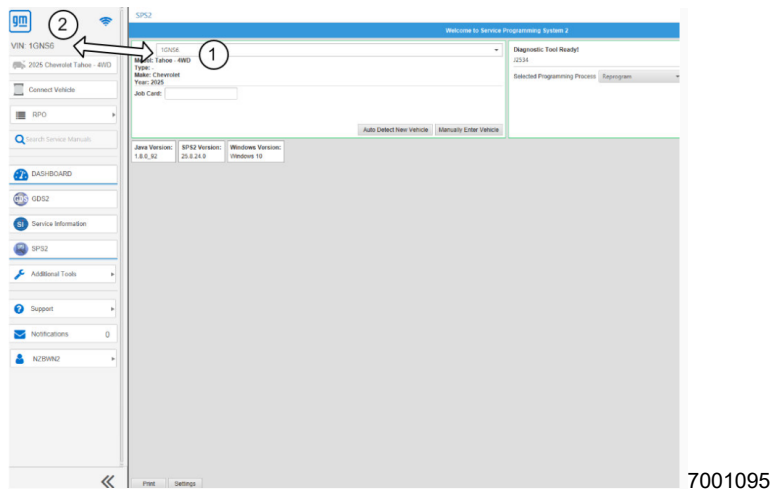
IMPORTANT: The service technician always needs to verify that the VIN displayed in the left side drop down menu (1) and the top center window (2) match the VIN plate of the vehicle to be programmed prior to using Service Programming System 2 (SPS2) for programming or reprogramming a module.

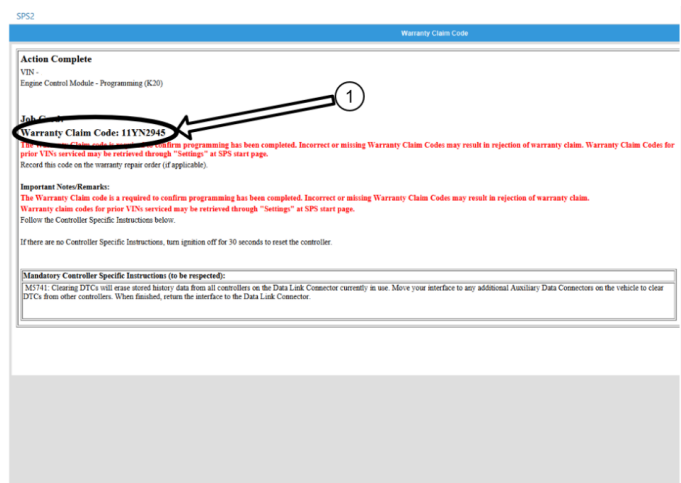
Important: To avoid warranty transaction rejections, you **MUST** record the warranty claim code provided on the Warranty Claim Code (WCC) screen shown above on the job card. Refer to callout 1 above for the location of the WCC on the screen.
