# Service Bulletin

Bulletin No.: PIP5927E

**Subject: Diagnostic Tips: Possible DTC P0237 P0101 P1101 P0234 or P0299 Reduced Engine Power**

Brand:	Model:	Model Year:		VIN:		Engine:	Transmission:
		from	to	from	to		
Chevrolet	Equinox	2023 - 2026		All	All	1.5 LSD	All
GMC	Terrain	2023 - 2026		All	All	1.5 LSD	All

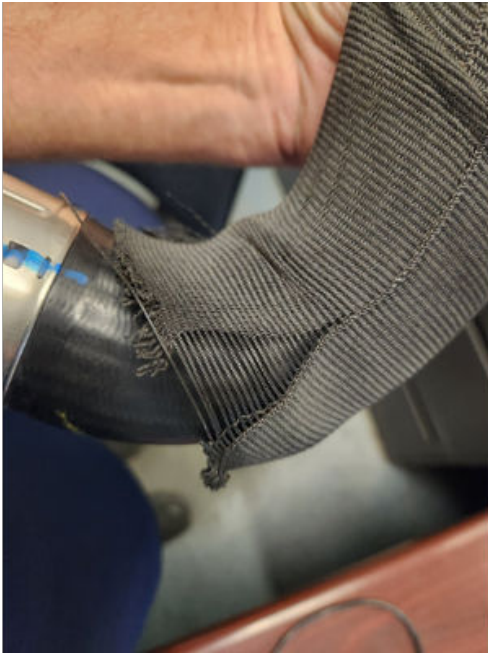
#1

Inspect the Charge Air Inlet Pipe at the Turbocharger to see if the anti-abrasion sleeve shows signs of being shredded or split.

Pictures below show damage to abrasion sleeve on Charge Air Inlet Hose.

Replace Charge Air Inlet Pipe assembly using latest parts listed in EPC.

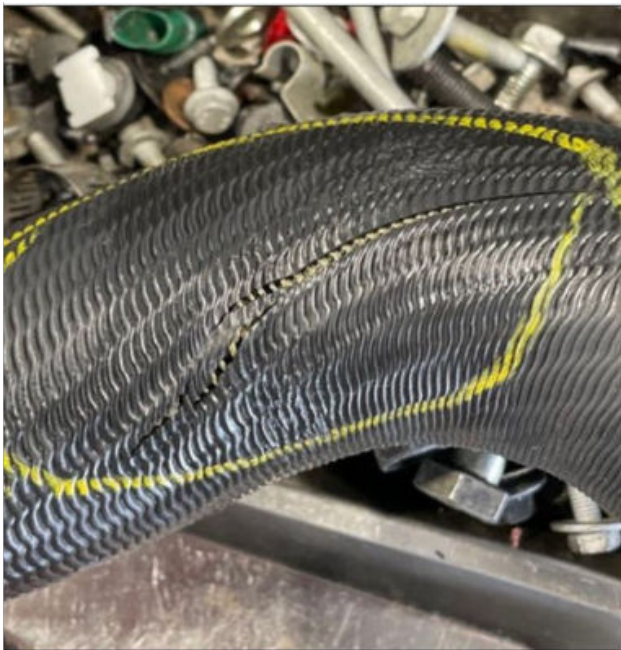
If this type of damage has been identified remove the Charge Air Inlet Hose assembly and inspect the Charge Air hose beneath the abrasion sleeve for signs of being split.

This type of damage would allow the hose to swell under pressure damaging the abrasion sleeve and altering the readings within the boost control system or create a potential air leak.

#3 Picture below inside the circled area shows damage to inner hose beneath abrasion sleeve
