# Service Bulletin

Bulletin No.: PIP6113

**Subject: Diagnostic Tip - Intermittent MIL / Engine Stalls At A Stop / DTC P0191 And Occasionally P0172**

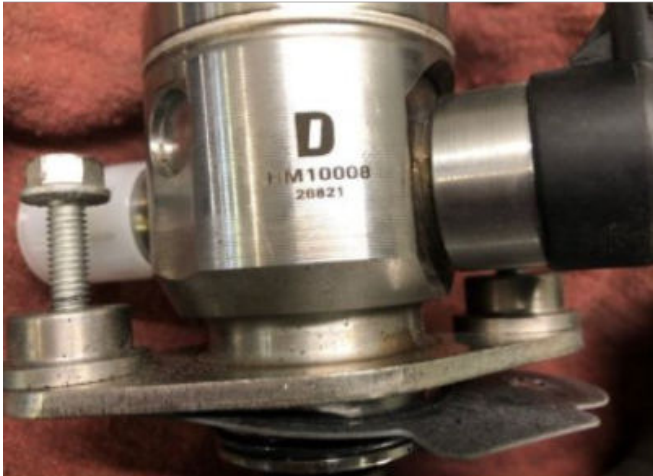
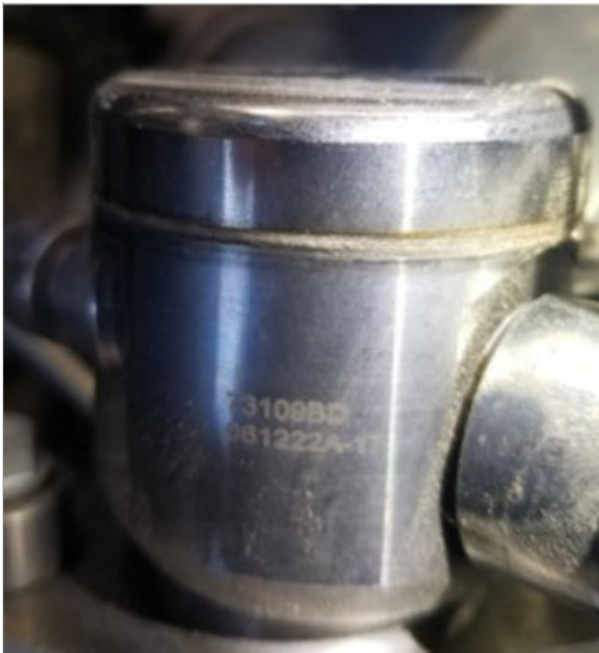
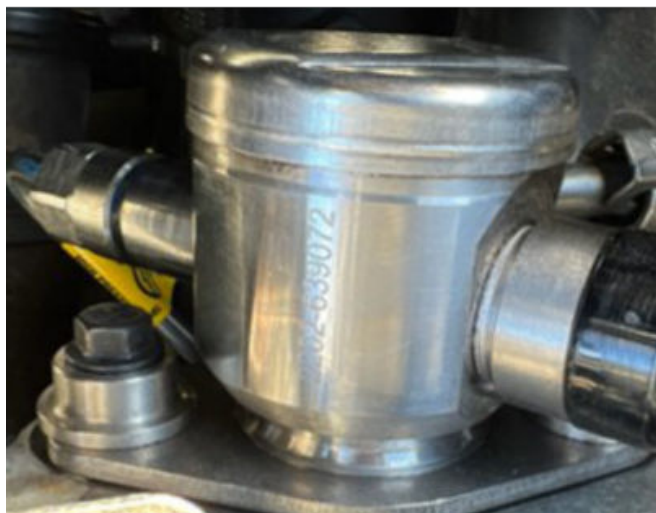
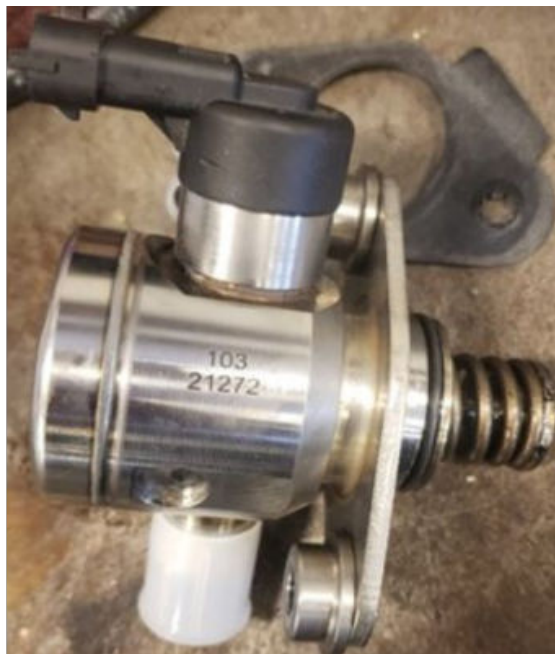
Below are some examples of non original manufacture / non GM high pressure fuel pump markings on the high pressure fuel pump body.

If the high pressure fuel pump is not an original manufacture / GM part, install one and evaluate the vehicle.
