# Service Bulletin

Bulletin No.: PIP5810D

**Subject: Transfer Case Input Seal Installation**

Brand:	Model:	Model Year:		VIN:		Engine:	Transmission:
		from	to	from	to		
Chevrolet	Silverado 2500 HD/ 3500 HD	2020 - 2026		All	All	All	MGM MGU MKM
GMC	Sierra 2500 HD/3500 HD	2020 - 2026		All	All	All	MGM MGU MKM

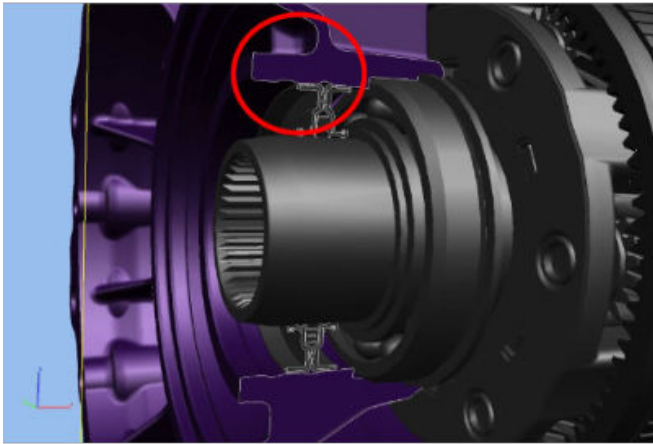
5845636

There is a gap around the outer portion of the seal that needs to be centered over a weep hole in the case.

Weep hole is drilled in the center of a groove machined into the case.

Seal installation depth is critical when replacing the transfer case input seal.

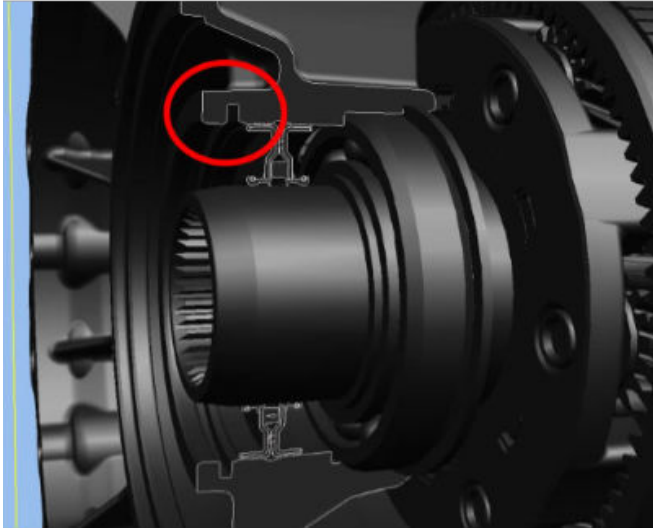
First Design

To identify design level look for a machined groove where the seal is installed (Red circles below).

If there is a defined machined groove in the case then it is a first design case.

For first design transfer case see Transfer Case Assemble (VIN LF263576 and Earlier (with MGM or MGU)) in 2020 model year Transfer case off vehicle repair instructions. Seal installer DT-53017 (GM-53017)

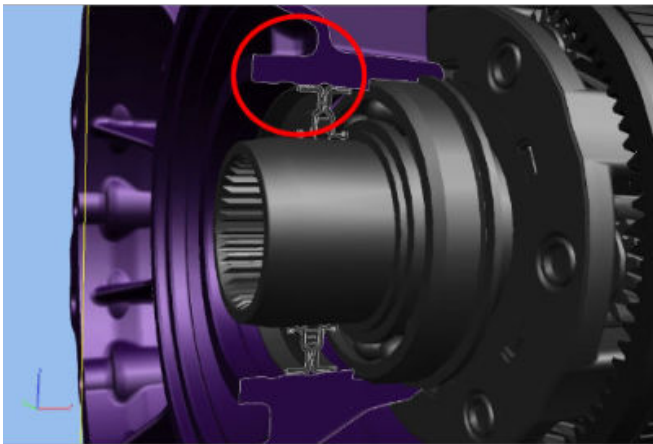
## Second Design

If there is not a defined groove machined into the case then it is second design.

For second design use either Transfer Case Assemble (VIN LF263577 and Later (with MGM or MGU)) in 2020 model year off vehicle repair instructions or the year of the vehicle you are working on. DT-53018 (GM-53018)

Use of incorrect tool will create a repeat leak as the seal may not be at the correct depth or may not be installed straight.
