Service Bulletin

Bulletin No.: PIC6652

Subject: Sunroof or Sunshade Does Not Move, Grinding or Clunk Noise Heard When Trying To Move or Calibrate The Sunroof or Sunshade After Motor Replacement

Brand:	Model:	Model Year:		VIN:		Engine:	Transmission:
		from	to	from	to		
Cadillac	LYRIQ	2023-2026		All	All	All	All

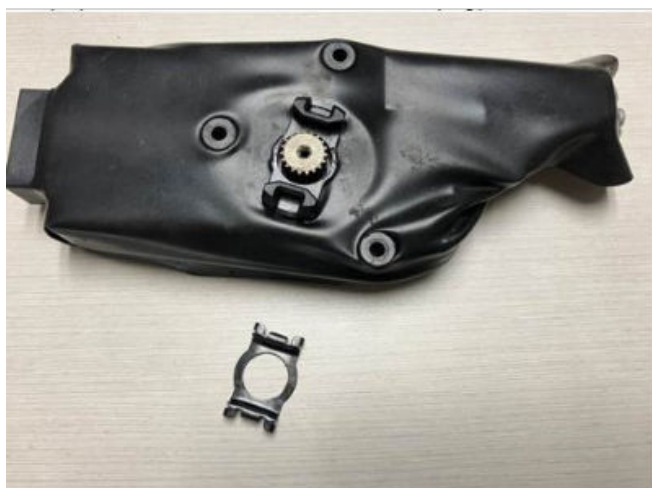
Involved Region or Country	North America
Additional Options (RPO)	CAJ - PANORAMIC DUAL PANE SUNROOF WITH POWER SHADE CFD - ROOF - SUN, SINGLE GLASS, FIXED, ELEC SUNSHADE
Condition	After replacement of a Sunroof or Sunshade Motor, it may be found that there is a clunk or grind noise heard and the roof/shade does not move.
Cause	The Spring Plate may not have been transferred from original motor to new motor.

The Spring Plate will remain attached to the original motor when removed.

Ensure the Spring Plate was transferred to the new motor.
