GENERAL MOTORS
DCS 7508
URGENT - DISTRIBUTE IMMEDIATELY

Subject: REVISION: N242468490-02 - Service Update
Missing Chassis Harness Plugs
Revised Population, Parts Information, & Service Procedure

Models: 2024 – 2025 Chevrolet Blazer EV

N242468490 Missing Chassis Harness Plugs

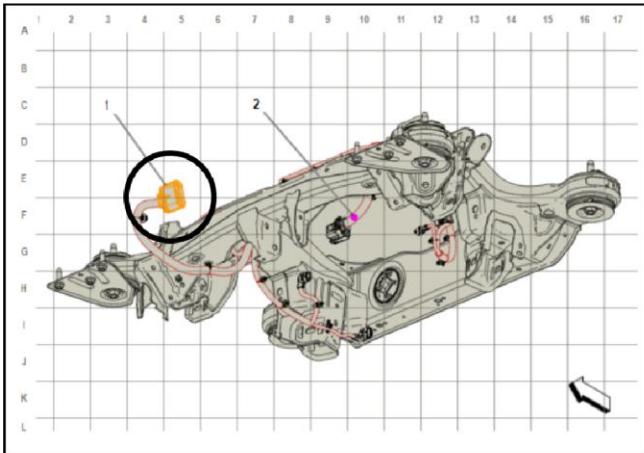
6780028

(1) X610 Body Wiring Harness to Chassis Rear Wiring Harness (X0D / X0E)
(2) J491 Chassis Rear Wiring Harness (X0D / X0E)

4. Locate and inspect X610 Body Wiring Harness to Chassis Rear Wiring Harness. Verify there is no corrosion within the connector.

4.1 If corrosion is found at either connector, replace the corroded terminals and thoroughly clean the connector. Refer to *X610 Body Wiring Harness to Chassis Wiring Harness* in SI for terminal location and proper tools. Refer to *Wire and Connector Repair* in SI for further instruction.

4.2 If no corrosion is found, clean and dry the connector and proceed to the next step.

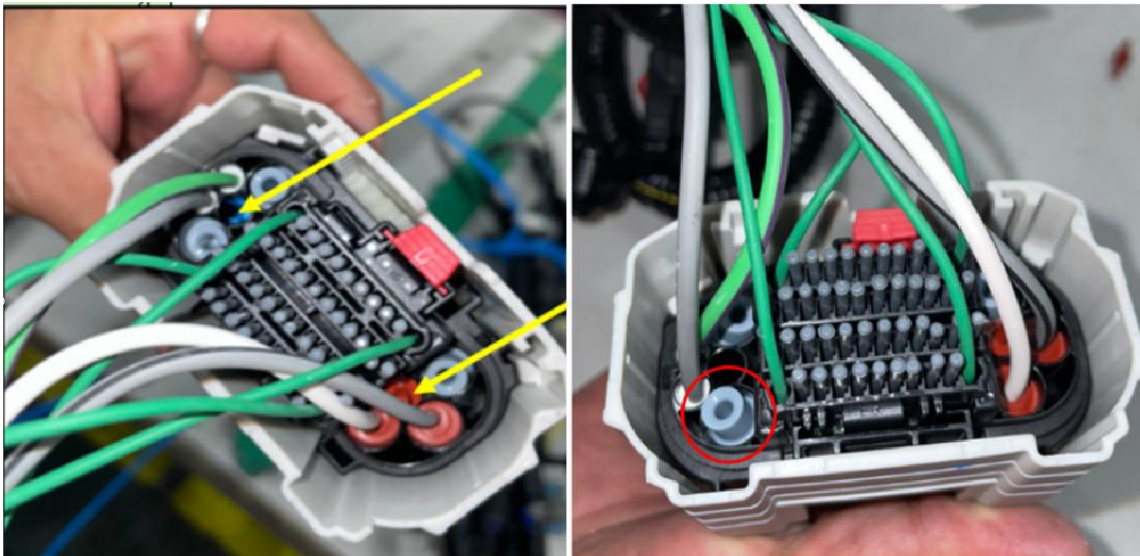
6781647

5. Inspect ALL blue and red cavity plugs to ensure they are seated flush and centered within the connector body.

5.1 If any of the cavity plugs **PROTRUDE** as indicated in the image above, use a small round or flat bladed tool to insert them correctly into the connector. Ensure the cavity plug seats flush and centered within the connector.
