REFERENCE:	TSB: 08-221-26 GROUP: 08 - Electrical	Date:	May 21, 2026	REVISION:	08-310-25
VEHICLES AFFECTED:	<p>2021 - **2025** (WL) Jeep Grand Cherokee / Grand Cherokee L 2022 - **2025** (WS) Grand Wagoneer/Wagoneer This bulletin applies to vehicles built equipped with one of the following radios:</p> <ul style="list-style-type: none"> ● Uconnect 5 w 8.4" Display (USA) (Sales Code UBF). ● Uconnect 5 w 8.4" Display (CAN) (Sales Code UEF). ● Uconnect 5 Nav w 8.4" Display (USA) (Sales Code UBL). ● Uconnect 5 Nav w 8.4" Display (CAN) (Sales Code UEL). ● Uconnect 5 Nav w 10.1" Display (USA) (Sales Code UBN). ● Uconnect 5 Nav w 10.1" Display (CAN) (Sales Code UEN). ● Uconnect 5 Nav w 12.0" Display (USA) (Sales Code UBQ). ● Uconnect 5 Nav W 12.0" Display (CAN) (Sales Code UEQ). ● Uconnect 5 w 8.4" Display (MEX) (Sales Code UFF). ● Uconnect 5 Nav w 8.4" Display (MEX) (Sales Code UFL). ● Uconnect 5 Nav w 10.1" Display (MEX) (Sales Code UFN). ● Uconnect 5 Nav w 12.0" Display (MEX) (Sales Code UFQ). 			<p>MARKET APPLICABILITY:</p> <p><input checked="" type="checkbox"/> NA <input type="checkbox"/> MEA <input type="checkbox"/> SA <input type="checkbox"/> IAP <input type="checkbox"/> EE <input ty

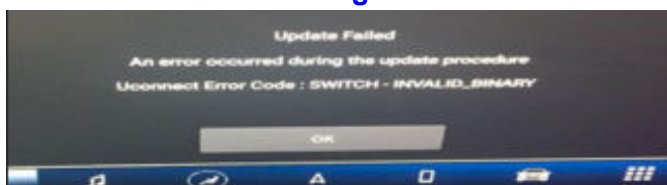
Fig. 5
Switch-Invalid_Binary Error

NOTE: Sometimes the radio throws an error pop up "Switch-Invalid_Binary" after successful radio update. Please ignore this error and click ok [Fig. 5](#).
