REFERENCE:	TSB: 02-001-26 REV. A GROUP: 02 - Front Suspension	Date:	May 22, 2026	REVISION:	02-001-26
VEHICLES AFFECTED:	2024 - **2025** (KM) Jeep Cherokee/Wagoneer S This bulletin applies to vehicles built on or before December 23, 2025 (MDH 1223XX).			MARKET APPLICABILITY: <input checked="" type="checkbox"/> NA <input type="checkbox"/> MEA <input type="checkbox"/> SA <input type="checkbox"/> IAP <input type="checkbox"/> EE <input type="checkbox"/> CH NOTE: This bulletin applies to the North American market.	
CUSTOMER SYMPTOM:	**Customers may comment on one or more of the following: <ul style="list-style-type: none"> Buzz, squeak or rattle can be heard from both sides of the front suspension. Rattling noise coming from the top strut mount.** 				
CAUSE:	**Strut integrity issue**

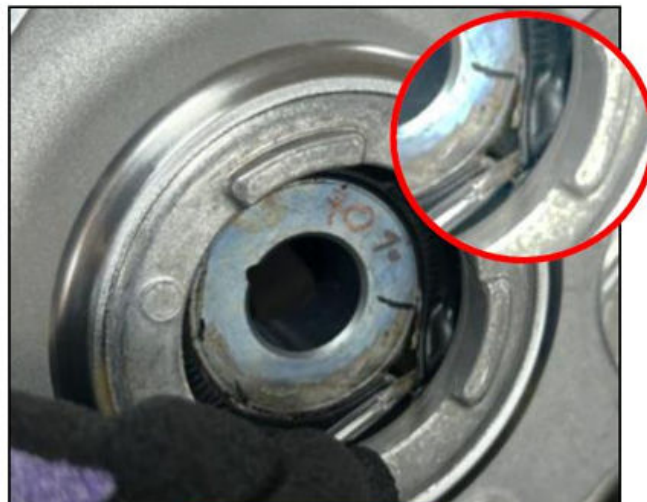
**Fig. 1**

- **Is the vehicle on the RSU VIN list?
 - YES>>> Proceed to [Step 5](#).
 - NO>>> Proceed to [Step 2](#).
- Remove the cowl cover. Refer to the detailed service procedures available in DealerCONNECT/Service Library under: Service Info>23 - Body / Exterior / Cover, Cowl Panel / Removal.
- Check to see if the bushing is de-bonded from the metallic part of the top mount [Fig. 1](#).

De-Bonded Top Mount

- If the strut mount is de-bonded, proceed to [Step 5](#).
- Replace the strut top mount(s). Refer to the detailed service procedures available in DealerCONNECT/Service Library under: Service Info>02 - Chassis / Suspension / Strut / Removal and Installation.
