<b>REFERENCE:</b>	<b>TSB:</b> 09-010-26 <b>GROUP:</b> 09 - Engine	<b>Date:</b>	May 22, 2026	<b>REVISION:</b>	—
<b>VEHICLES AFFECTED:</b>	<b>2025 - 2027 (B1) Jeep Renegade</b> <b>2025 - 2027 (H1) Jeep Commander</b> <b>2025 - 2027 (M1) Jeep Compass</b> This bulletin applies to vehicles built on or after July 07, 2025 (MDH 0707XX) and on or before February 20, 2026 (MDH 0220XX).			<b>MARKET APPLICABILITY:</b> <input checked="" type="checkbox"/> NA <input type="checkbox"/> MEA <input type="checkbox"/> EE <input type="checkbox"/> IAP <input checked="" type="checkbox"/> SA <input type="checkbox"/> CH <b>NOTE:</b> This bulletin applies to North and South America markets.	
<b>CUSTOMER SYMPTOM:</b>	<b>Customers may comment on the following:</b> <ul style="list-style-type: none"> <li>Oil Pressure warning light illuminates.</li> <li>Engine oil is leaking onto the floor beneath the vehicle.</li> </ul>

<b>CAUSE:</b>	Rear crankshaft oil seal (flywheel side)

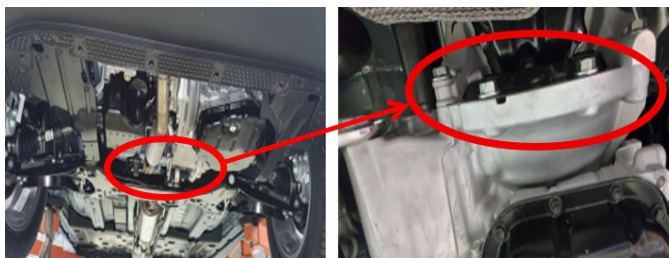
1. Start the vehicle and after 20 seconds at idle, accelerate to 3500 rpm for three minutes then turn off the vehicle.
2. Raise and support the vehicle. Refer to the detailed service procedures available in DealerConnect> Service Library under: Service Info> 04 - Vehicle Quick Reference/Hoisting/Standard Procedure.
3. Check for the presence of oil in the engine area coupling between the engine and transmission, and the flywheel seal area [Fig. 1](#).

**Fig. 1**  
Area For Oil Leaks

4. Is there presence of oil in the coupling area between the engine and transmission [Fig. 1](#)?
  - YES >>> Proceed to [Step 5](#).
  - NO >>> Lower the vehicle. This bulletin has been completed, use Inspect LOP (09-25-75-9A) to close the active RSU.
5. Replace the rear crankshaft oil seal (flywheel side). Refer to the detailed service procedures available in DealerCONNECT/Service Library under: 1020D39 - Retentor Traseiro - Lado Volante - Remoção/Recolocação e Substituição, para Veículos com Câmbio Automático. Incluso Procedimentos Necessários.
