REFERENCE:	TSB: 23-019-26 GROUP: 23 - Body	Date:	May 22, 2026	REVISION:	23-011-23 REV. A
VEHICLES AFFECTED:	2021 -**2027** (WL) Grand Cherokee This bulletin applies to vehicles equipped with ATC W/4 Zone Temp Control (Sales Code HAL) and/or ATC W/3 Zone Temp Control (Sales Code HAH).			MARKET APPLICABILITY: <input checked="" type="checkbox"/> NA <input checked="" type="checkbox"/> CH <input checked="" type="checkbox"/> EE <input checked="" type="checkbox"/> IAP <input checked="" type="checkbox"/> SA <input checked="" type="checkbox"/> MEA NOTE: **This bulletin applies to the North and South America, Enlarged Europe, India & Asia Pacific, Middle East & Africa and China markets.**	
CUSTOMER SYMPTOM:	Customers may comment on the following: <ul style="list-style-type: none"> When the rear heat temperature is set at or near max hot output, the front center console's surfaces, first row and second row cup holders and storage bins are getting warm to the touch.

CAUSE:	Center console insulator

REPAIR SUMMARY:

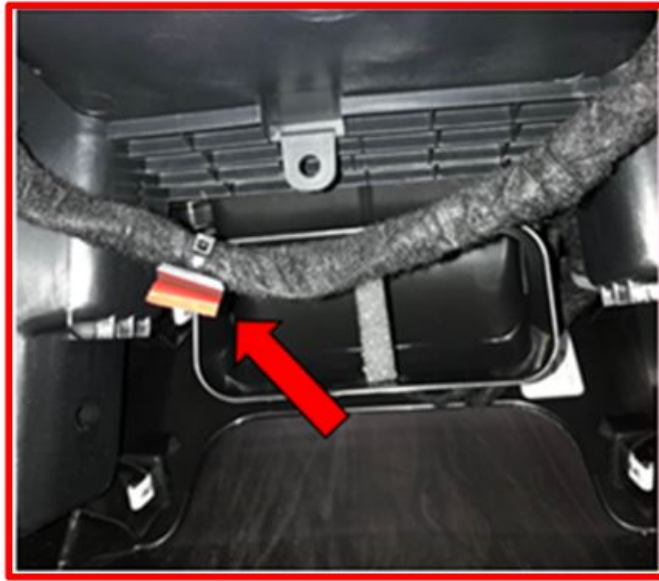
2. Check if there is a wire harness retainer is properly attached to the underside of the console [Fig. 4](#).

Fig. 4
Retainer Clip Not Attached

3. If retainer clip is not attached, peel off paper from adhesive and stick retainer clip to the underside of the console [Fig. 5](#).

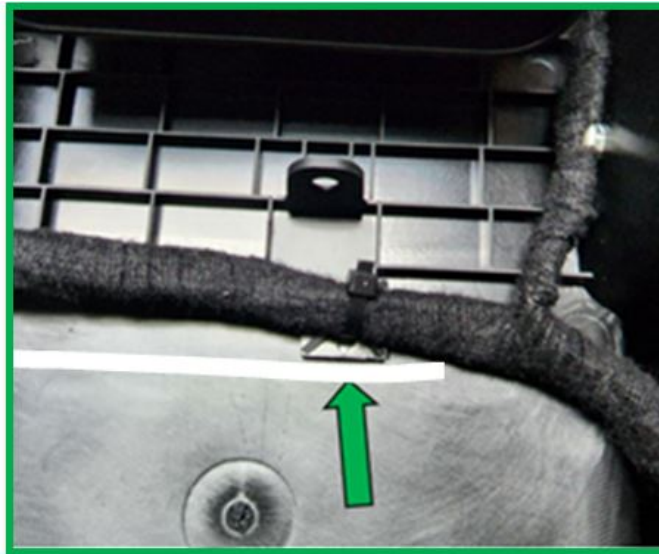
Fig. 5
Retainer Clip Properly Attached
