## Deactivation of the N112/9 HERMES communication module for vehicles without E-call requirement

Topic number	LI82.85-P-080559
Version	1
Function group	82.85 - Navigation and Communication systems
Date	5/26/26
Validity	Vehicles with HERMES communication module (codes 360, 362) without E-call requirement
Reason for change

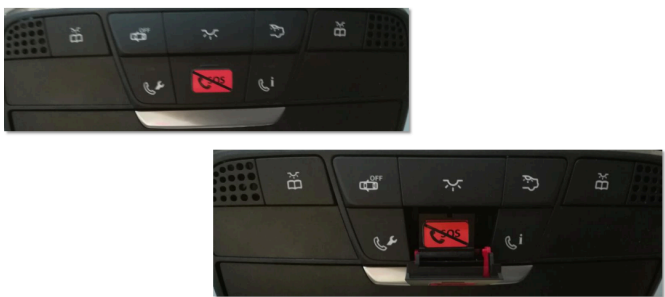
Attachments	
File	Description
<a href="#">How+to+request+adding+Code+09o+via+XSS+v2.pdf</a>	
<a href="#">Example - Deactivation communication module HERMES customer declaration English V3.0.pdf</a>	
<a href="#">HERMES-Deactivation_+pictures+of+sticker.png</a>  1.2.5 Sticker on overhead control panel and the button

7. Ordering of stickers (part number A9078172900), quantity: 2
8. Affixing of the sticker (part number A9078172900) to the cover of the emergency call button on the overhead control panel (see attachment HERMES-Deactivation\_+pictures+of+sticker.png)

9. Affixing of the sticker (part number A9078172900) to the emergency call button on the overhead control panel (see attachment HERMES-Deactivation\_+pictures+of+sticker.png)
