# TECHNICAL SERVICE BULLETIN

| EC26-013 | ITB26-006 | May 21, 2026 |

## ENGINE NO START WITH KEY SYSTEM ERROR AND DTC B2C20-24 STORED IN THE BCM

**APPLIED VEHICLES:** 2026 QX60 (L51)  
**APPLIED DATES:** AWD built on or before September 4, 2025  
 FWD built on or before September 8, 2025

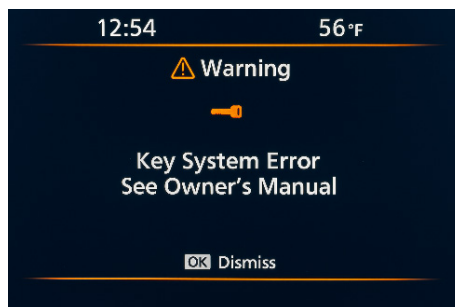
Figure 1

The customer states the engine will not start and "Key System Error" warning is displaying in the Information Display (Combination Meter) (Figure 1),

DTC B2C20-24 for "STARTER CONTROL RELAY" is stored in the BCM.

**HINT:** This DTC and warning message (Figure 1) may occur if the customer does not place the vehicle in Park Gear according to the Owner's Manual for shifter operation.

1. Confirm the current ECM part number.
2. Confirm the current TCM part number.
3. Reprogram the ECM, and then the TCM, if applicable.
4. Erase the DTCs.
