SIB 65 27 24

KNEE AIR BAG CCM G05 VARIANT WIRE HARNESS REPAIR

2026-05-19

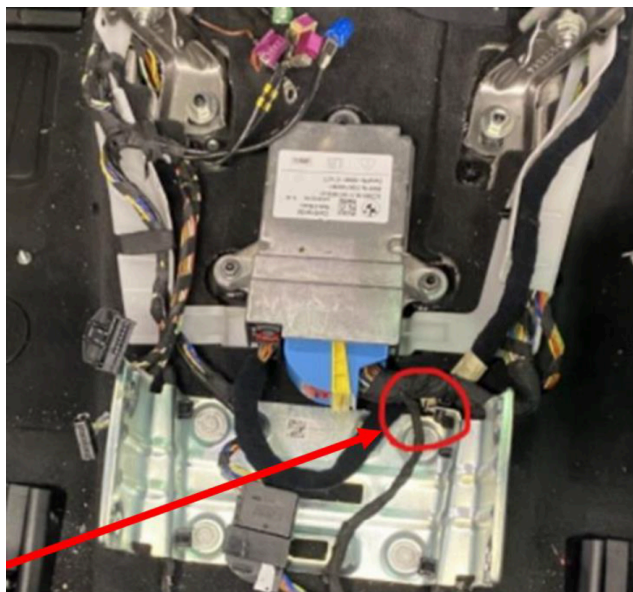
Over time, the wiring harness going to the knee air bag(s) can rub against the metal support tubes for the instrument panel, chafing and damaging the wiring.

6. Cover the edge of the center console support (the edge inside the circle) with felt tape (part number **54 34 7 248 700**).
