SERVICE BULLETIN

APPLICABILITY: 2012-23MY Impreza
 2013-19MY Crosstrek 2.0L
 2014-23MY Forester 2.5(excluding Wilderness)
 2013-19MY Legacy & Outback 2.5L

NUMBER: 16-156-25R
DATE: 09/15/25
REVISED: 05/13/26

SUBJECT: CVT Control Valve Body Design
 Change / P2757, P2762, P06EF, & Shudder

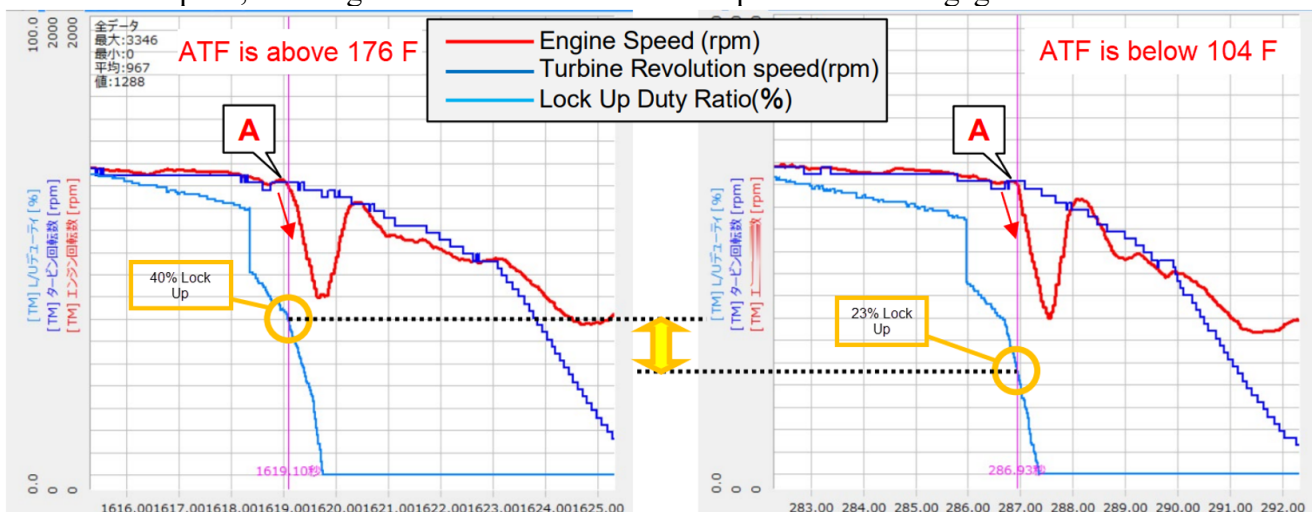
Perform a test drive while recording data using the Subaru Select Monitor, ensuring that all TCM data PIDs are captured. During the test, decelerate the vehicle from 25 mph to a complete stop twice when the CVT fluid temperature is below 104°F, and then twice more when the temperature is above 176°F. Graph the recorded data, set torque converter speed and engine speed range of 0 to 3000 rpm. Analyze the deceleration events where engine speed and torque converter speed no longer overlap on the graph (see example graphs below). At these points, determine whether there is a 10% or greater difference in the Lock-Up Duty Ratio (%) between the data recorded at 176°F and 104°F, specifically when the torque converter clutch is released.

NOTE: 'A' indicates a point where a difference occurs between the engine speed and the turbine revolution speed, marking the moment when the lock-up clutch is disengaged.

Example: 40%-23%=17%

Note: To determine the difference of Lock-Up duty Ratio Subtract the Lock-Up Duty Ratio when ATF temperature is below 104°F from the Lock-Up Duty Ratio when ATF temperature is above 176°F.

Yes – Replace the valve body and go to Step 5.

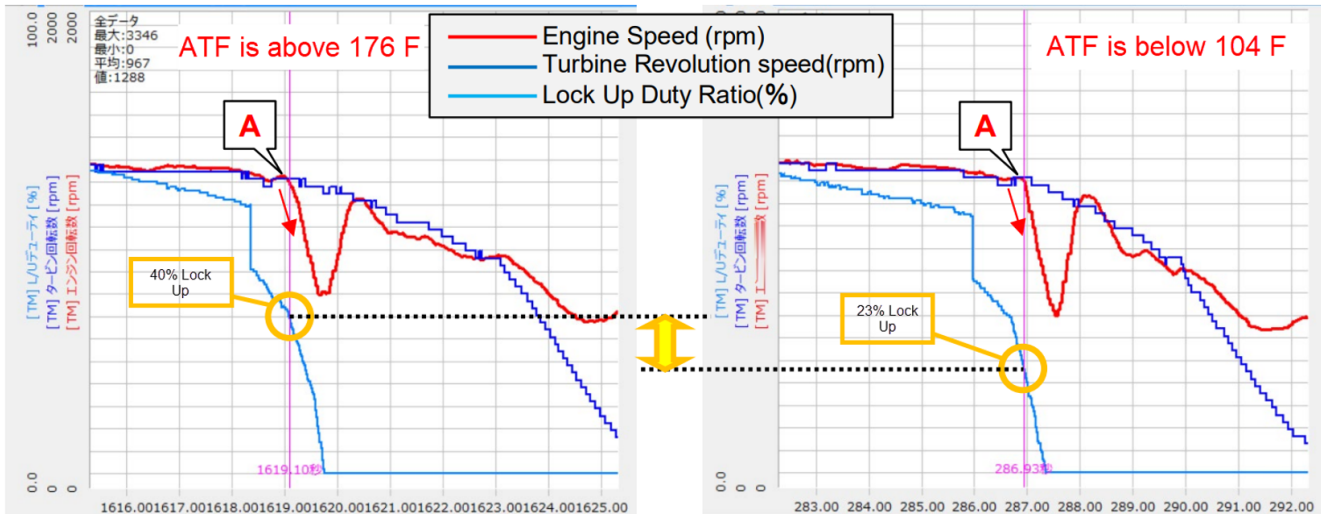
the graph (see example graphs below). At these points, determine whether there is a 10% or greater difference in the Lock-Up Duty Ratio (%) between the data recorded at 176°F and 104°F, specifically when the torque converter clutch is released.

NOTE: ‘A’ indicates a point where a difference occurs between the engine speed and the turbine revolution speed, marking the moment when the lock-up clutch is disengaged.

Example: 40%-23%=17%

Note: To determine the difference of Lock-Up duty Ratio Subtract the Lock-Up Duty Ratio when ATF temperature is below 104°F from the Lock-Up Duty Ratio when ATF temperature is above 176°F.

Yes – Replace the valve body and go to step 7.
