SERVICE BULLETIN

APPLICABILITY: 2020-22MY Legacy
 2020-22MY Outback(Including Wilderness)
NUMBER: 15-261-20R

SUBJECT: Reprogramming File Availability for Optimization of Gen 4 Denso CP1 Infotainment Systems
DATE: 03/10/20
REVISED: 05/15/26

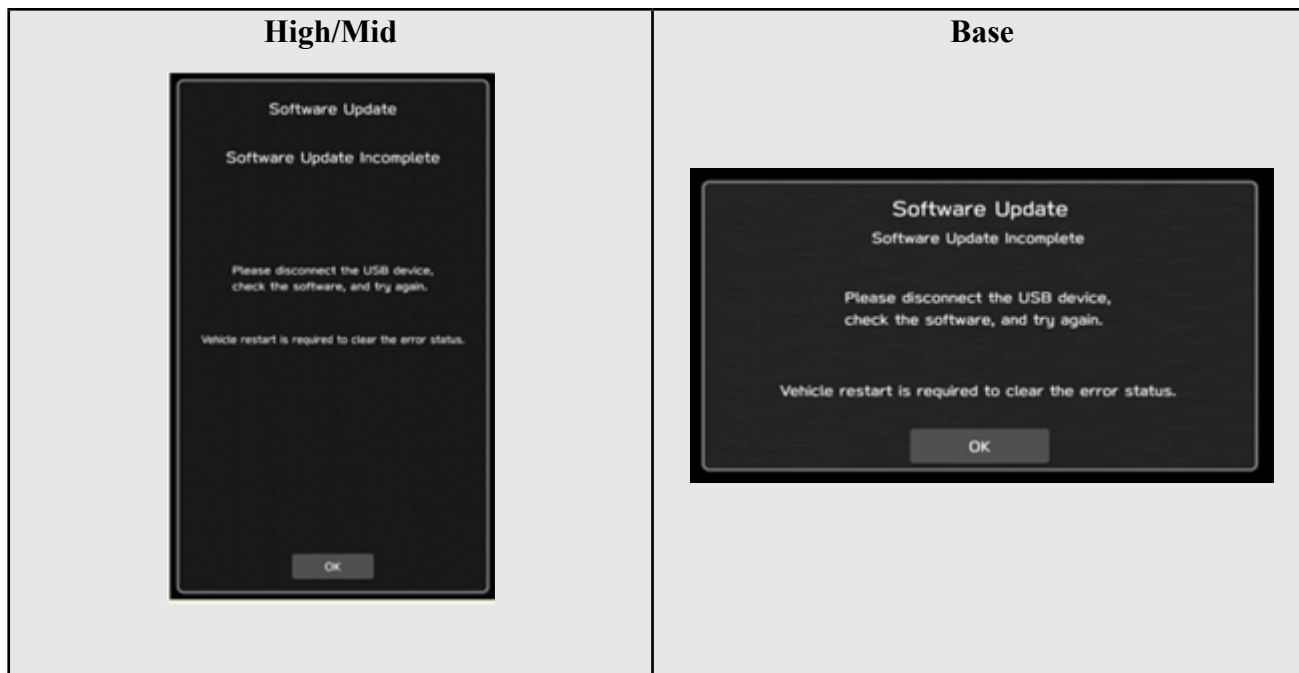
If you get the message Software Update Incomplete as shown below, please don't replace the hardware but retry updating the software according to the instructions in "Appendix B" on pg. 21.

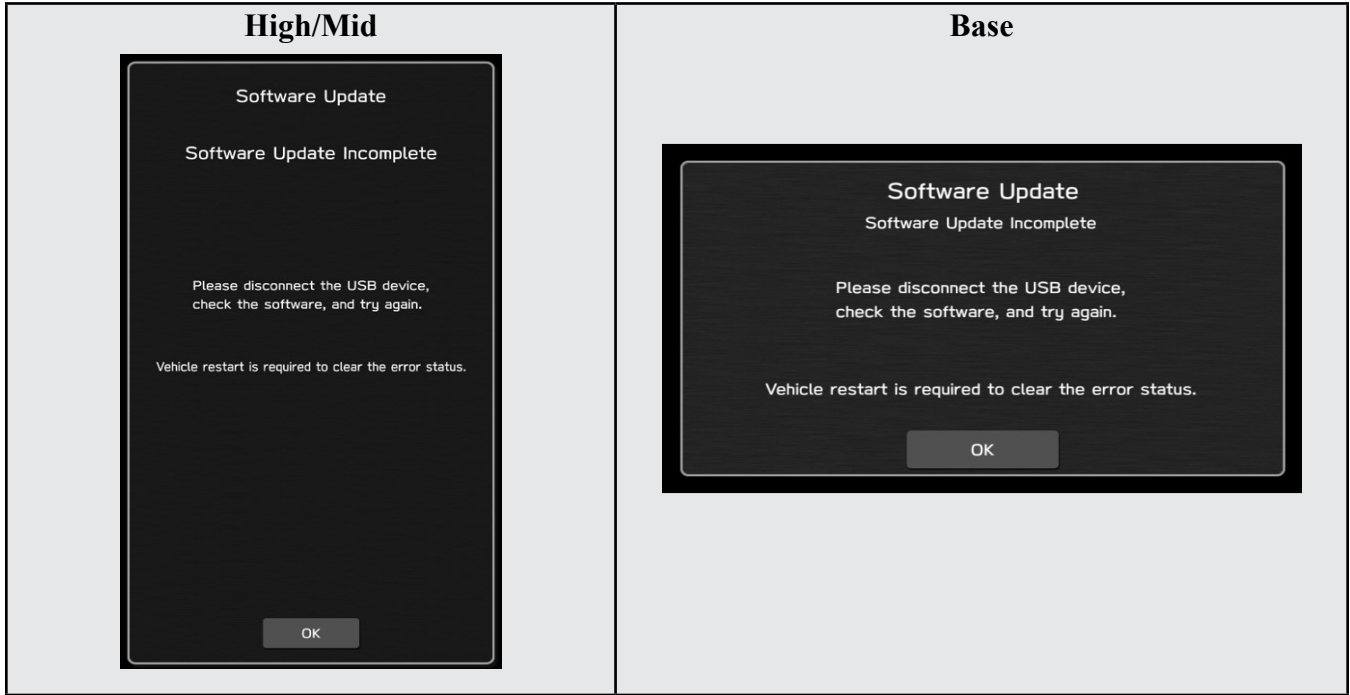
- If the first attempt of update fails with the message below, follow the steps described below 1-2 to 1-8 before retrying the software update.

1-1. Select OK in the screen below

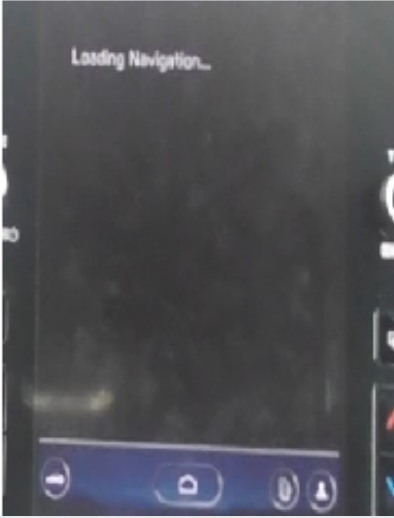
| 2 | <p>When turning ignition switch off and on while the Map screen is being displayed, the message "Loading Navigation..." remains on the screen, and the Map screen is not displayed</p> |

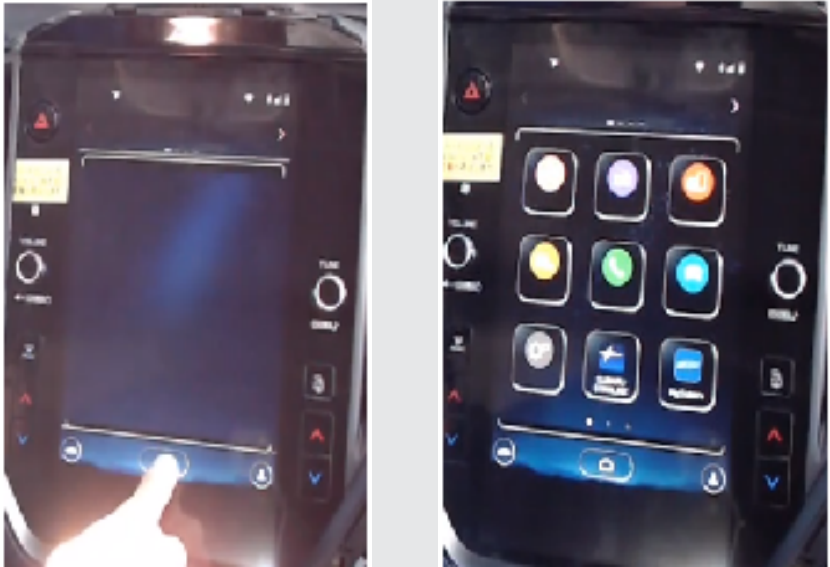
| 6 | <p>After switching the clock function to AUTO, the CID screen display becomes distorted</p> |

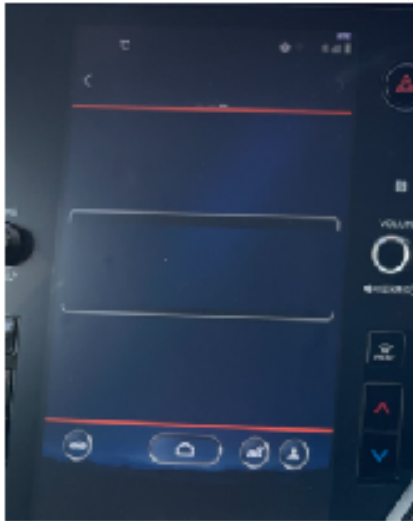
| 7 | <p>The CID screen display becomes distorted causing icons and text to be displayed incorrectly, when using USB audio in folder playback mode: the track list is scrolled at the moment when the playing folder switches.</p> |

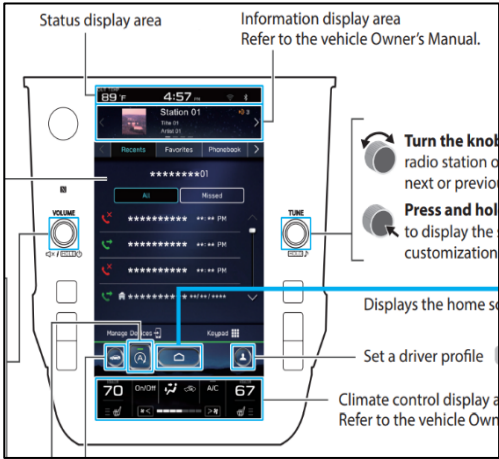
| Number | Symptoms to be Improved: |
|---|---|
| 5 | <p>The Information Display Area at the top of the CID screen displays a different information screen from the last time.</p> |

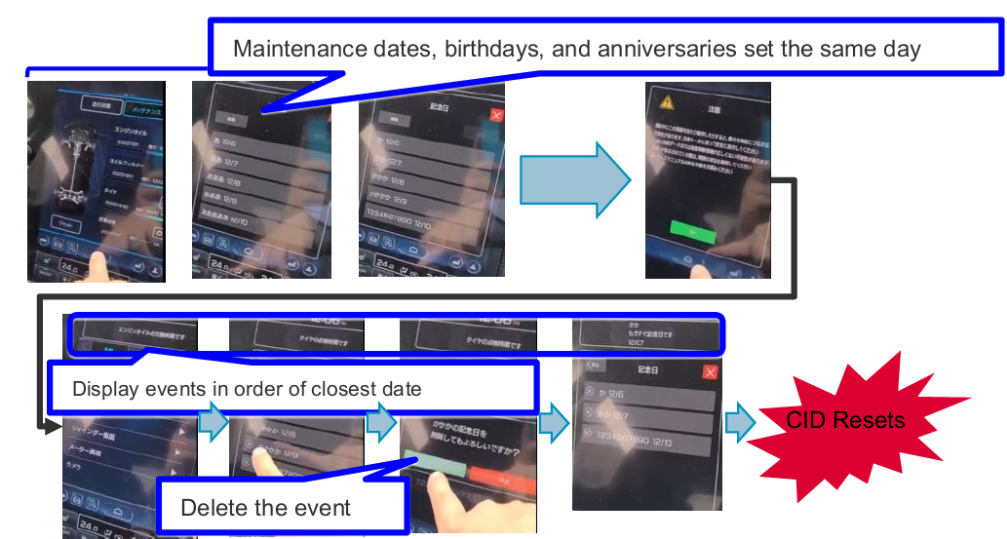
| Number | Symptoms to be Improved: |
|---|---|
| 10 | <p>If a same date is set to maintenance date, birthday, and anniversary date, pop-ups will appear in sequence on the top of the CID after engine is started when the day comes. Under this condition, if an operation is performed to delete the maintenance date, birthday or anniversary date registration within a few seconds immediately before the pop-up display, the CID screen will reset.</p> <p>The diagram illustrates the sequence of events leading to a CID reset. It shows three screenshots of the CID screen with dates set to the same day. A sequence of actions is shown: 'Display events in order of closest date', 'Delete the event', and 'CID Resets'.</p> |

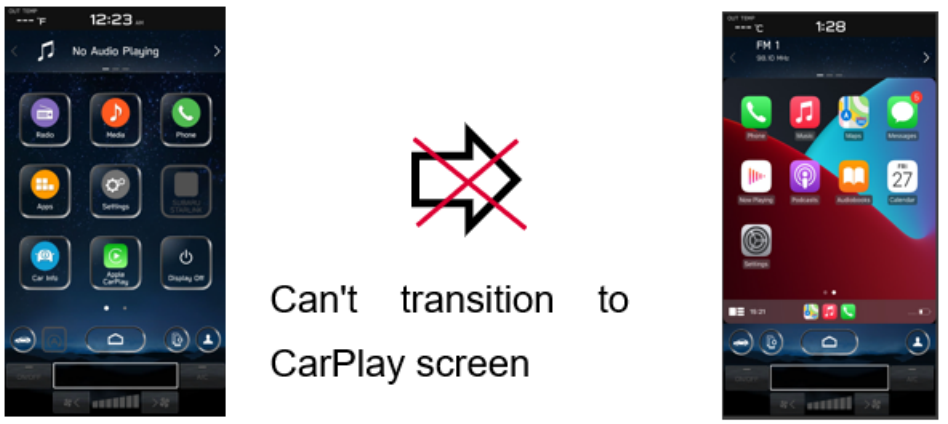
| Number | Symptoms to be Improved: |
|---|--|
| <p>14</p> | <p>When the engine is started with the iPhone connected via USB, CarPlay does not start even if the CarPlay icon on the home screen is pressed.</p> <p><Hint> This can be resolved by reinserting the USB cable.</p> <div style="text-align: center;"> <p>Can't transition to CarPlay screen</p> </div> |

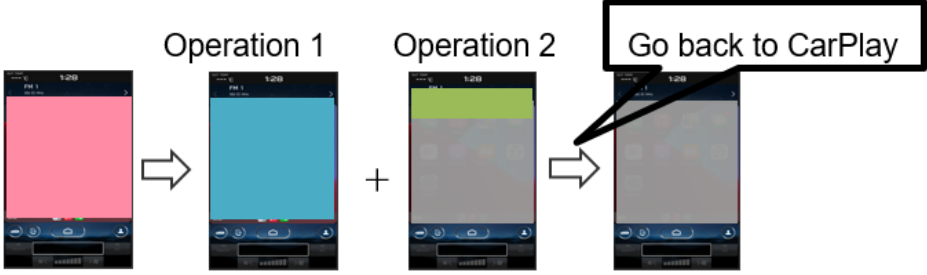
| Number | Symptoms to be Improved: |
|---|--|
| <p>15</p> | <p>After performing operations 1 and 2 below from the CarPlay screen, returning to the CarPlay screen causes the CarPlay screen to be black screen.</p> <p>Operation 1: Switching to a pop-up screen such as the air conditioner screen</p> <p>Operation 2: Interrupt pop-up screen display due to volume operation, etc.</p> <div style="text-align: center;"> <p>CarPlay Display Air Conditioner Display etc, Status Display Black Screen</p> </div> |

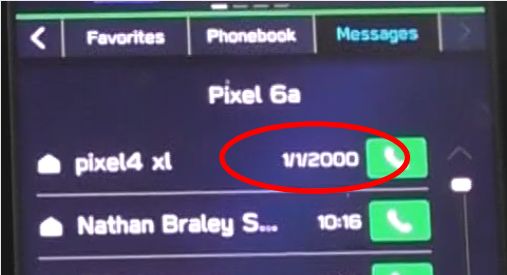
| Number | Symptoms to be Improved: |
|---|---|
| 28 | <p>The date of receipt of a received message is displayed as "2000/1/1."</p> <p>This occurs on some models of phones with Android OS 13 or later.</p> |

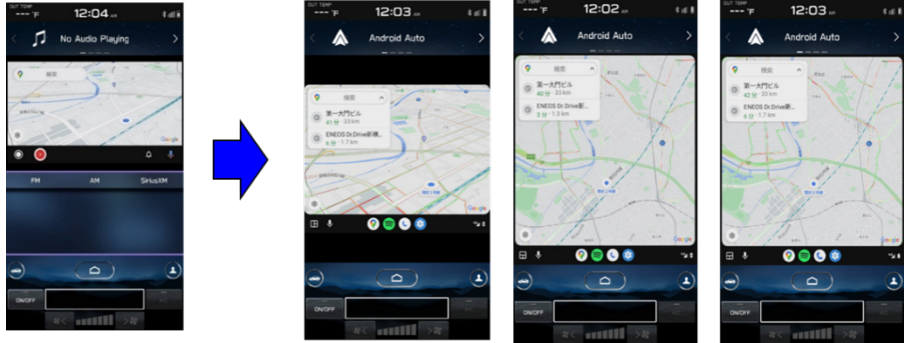
| Number | New Functions and Enhancements |
|---|---|
| 2 | <p>CCU Support vertical screen displays for Android Auto, but the actual display screen size differs depending on the Android device's OS version.</p> |

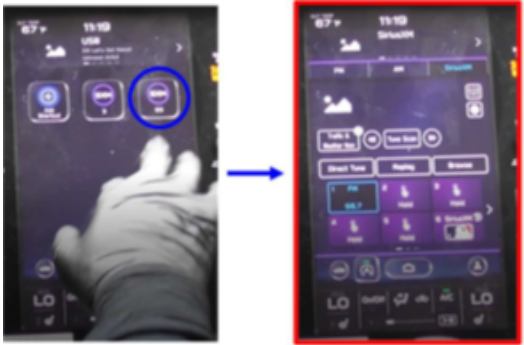
| Number | Symptoms to be Improved: |
|---|--|
| 23 | <p>When selecting shortcut for SXM channel on “Home” screen, the screen is changed to SXM but no sound is coming or no channel name is displayed.</p> |

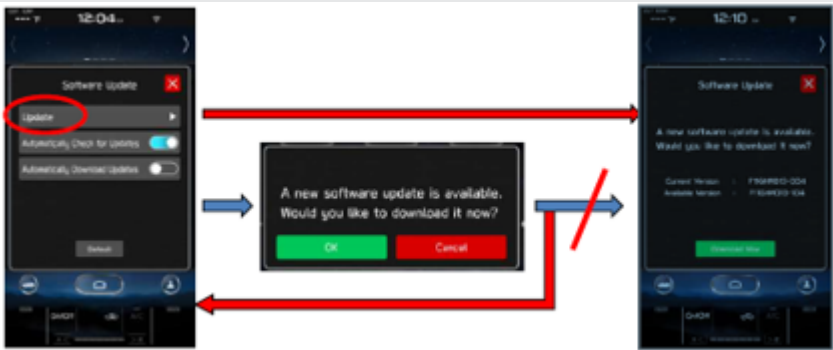
| Number | Symptoms to be Improved: |
|---|--|
| 24 | <p>When using FOTA service to update the software by selecting “Setting” > “Software Update,” a message of “A new software update is available. Would you like to download it now?” is displayed but the downloading does not start after pressing “OK.” When this symptom occurs, it comes back to the “Software Update” screen. The downloading can be started by pressing the “Update” on the “Software Update” screen. (Temporary solution.)</p> |

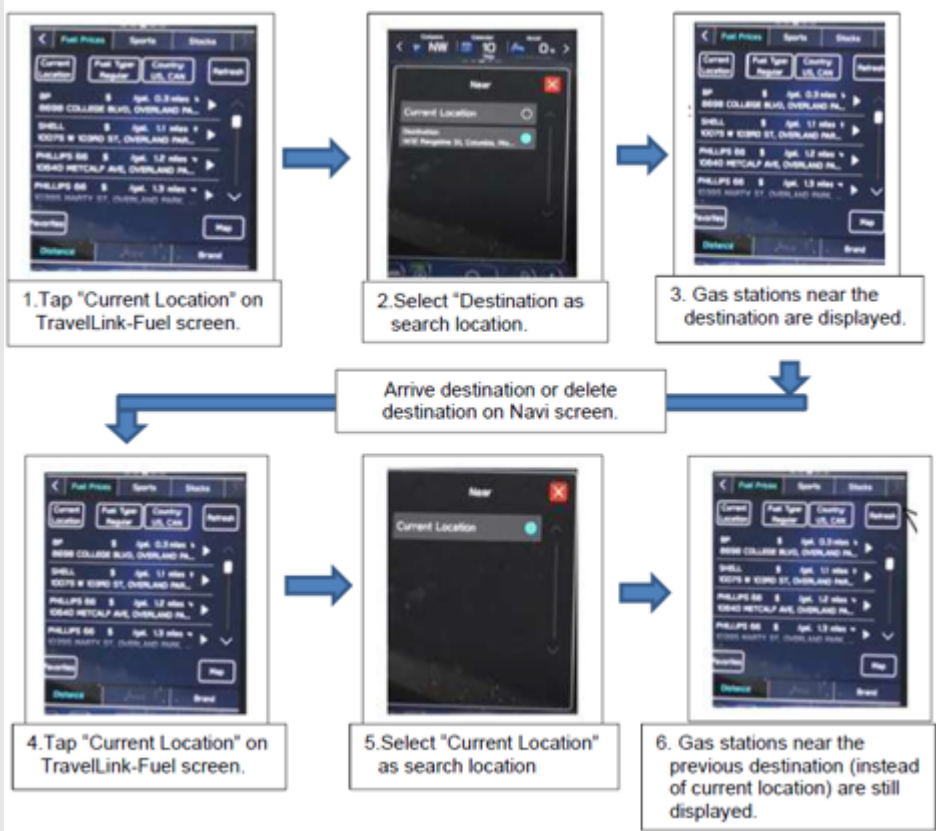
| Number | Symptoms to be Improved: |
|---|--|
| 30 | <p>A wrong search location is used on TravelLink function. Example of the symptom.</p> |

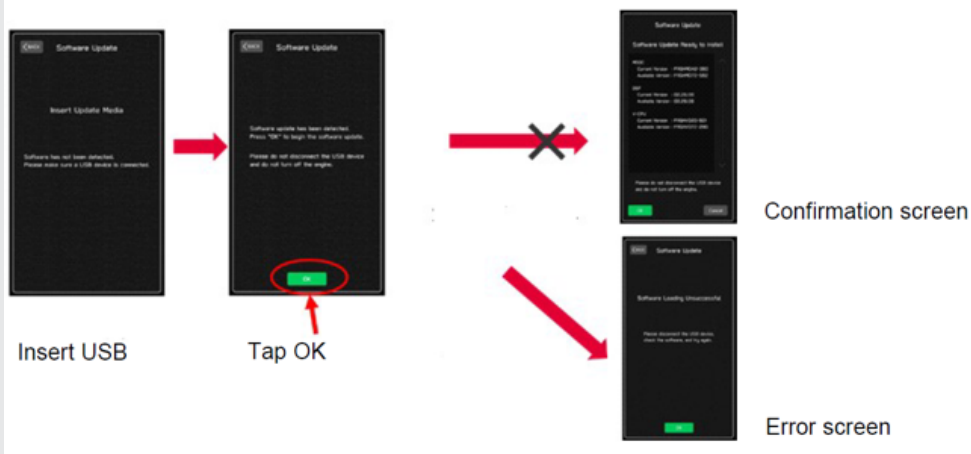
| Number | Symptoms to be Improved: |
|---|---|
| 12 | <p>When conducting USB reprogramming, the screen transition to error screen instead of confirmation screen.</p> <p>Insert USB</p> <p>Tap OK</p> <p>Confirmation screen</p> <p>Error screen</p> |

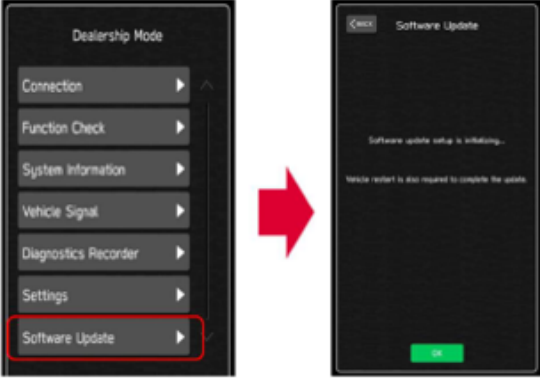
| Number | Symptoms to be Improved: |
|---|---|
| 13 | <p>When “Software Update” is selected in the Dealership Mode, the following initialization process does not end more than 20 minutes. *</p> <p>Dealership Mode</p> <p>Software Update</p> <p>Software Update</p> <p>Software update setup is initializing...</p> <p>Vehicle restart is also required to complete the update.</p> <p>Note* In case this USB update failure occurs, retry updating according to the instructions in “Appendix A”</p> |

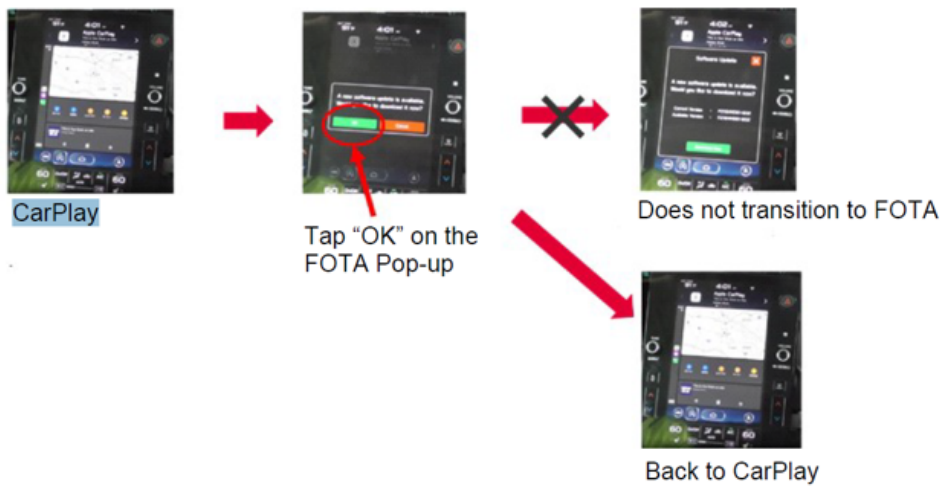
| Number | Symptoms to be Improved: |
|---|---|
| 14 | <p>When the FOTA pop-up (new software availability notification) is displayed while the CarPlay is being used, the display comes back to CarPlay screen even if the customer tries to get into the FOTA screen.</p> <p>CarPlay</p> <p>Tap “OK” on the FOTA Pop-up</p> <p>Does not transition to FOTA</p> <p>Back to CarPlay</p> |

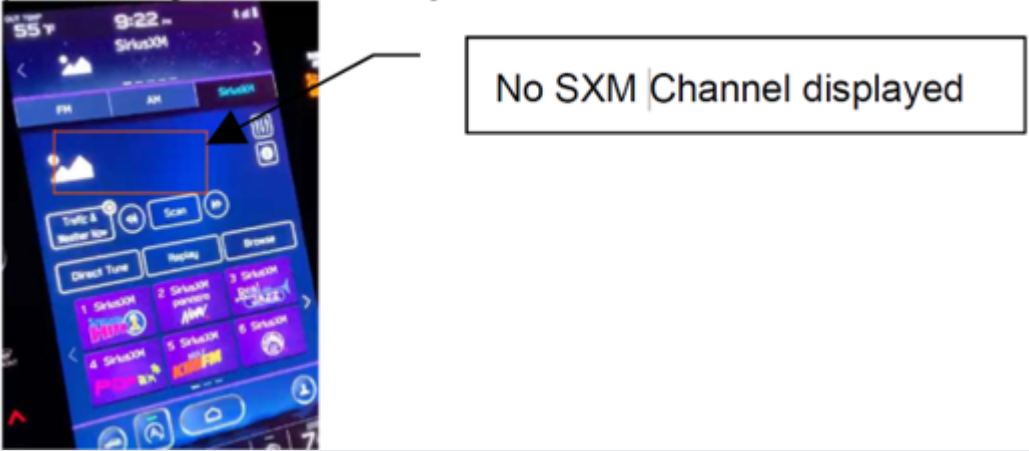
| Number | Symptoms to be Improved: |
|---|---|
| 26 | <p>SXM has blank screen and no sound when the SXM screen had been selected as audio source at the previous ignition off timing.</p> |

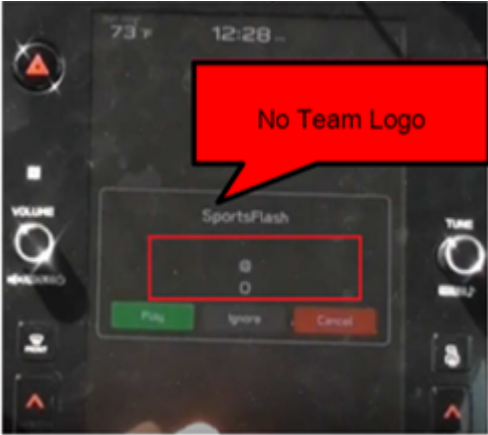
| Number | Symptoms to be Improved: |
|---|--|
| 31 | <p>The team logo is not displayed on Sports Flash screen when the SXM screen had been selected as audio source at the previous ignition off timing.</p> |

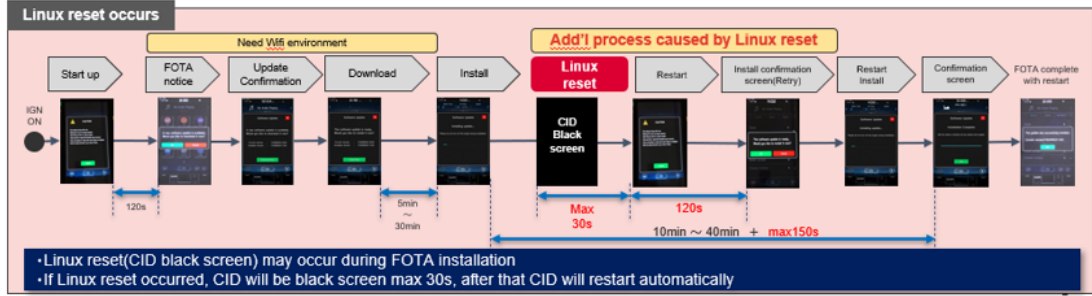
However, in rare case, the CCU restarts itself* during installation.

Note* Even if this symptom occurs, after approximately 2 minutes, the system resumes, and the CID comes back to the below screen. Customer can then push the “Install Now” to proceed with the installation.

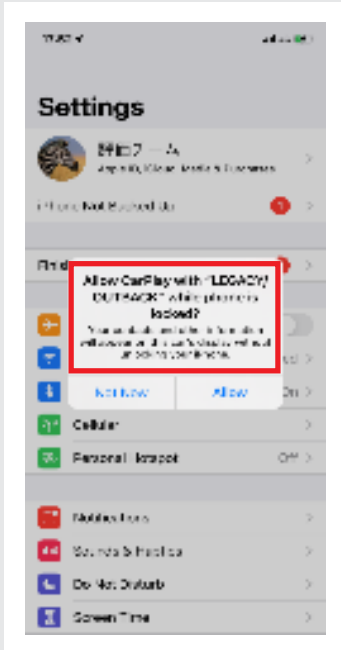
| Number | Symptoms to be Improved: |
|---|--|
| 3 | <p>While using Apple CarPlay, “SUBARU” is displayed on the iPhone Setting menu instead of vehicle name <LEGACY/OUTBACK>.</p> <p>The image is a screenshot of an iPhone's Settings app. The 'Settings' title is at the top. Below it, there are several menu items: 'Profile', 'iCloud', 'Phone Not Reachable', 'Find My', 'AirDrop', 'Cellular', 'Personal Hotspot', 'Notifications', 'Sounds & Haptics', 'Do Not Disturb', and 'Screen Time'. A red box highlights a pop-up dialog box that says 'Allow CarPlay with "LEGACY/OUTBACK" while phone is locked?'. Below the dialog, there are 'Allow' and 'Deny' buttons.</p> |

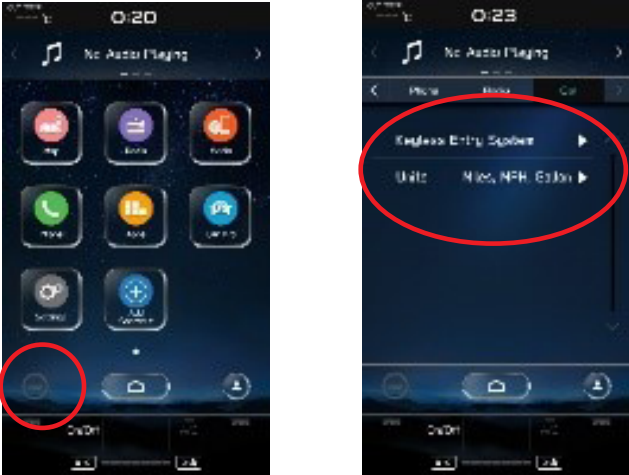
| Number | Symptoms to be Improved: |
|---|---|
| 4 | <p>Vehicle Setting Icon in <Home> menu is grayed out. Menu list in the “Car” tab in the Setting Menu is not displayed.</p> |

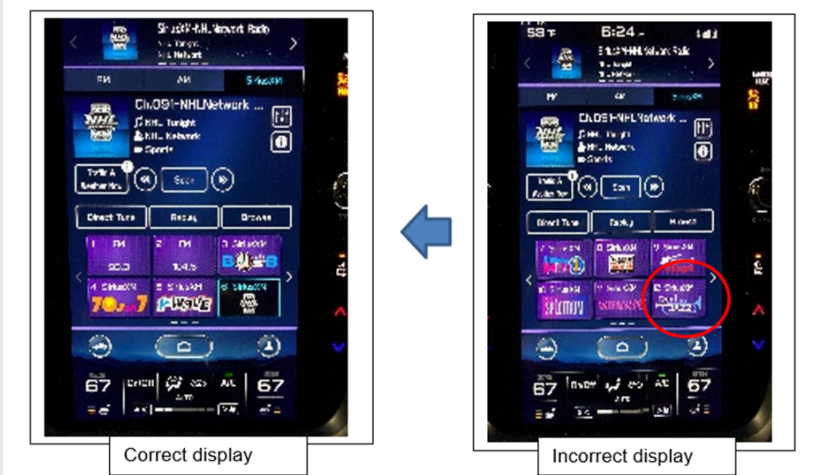
| Number | Symptoms to be Improved: |
|---|--|
| 29 | Preset outline is not shown following station selection using steering switch <div style="text-align: center;"> </div> |

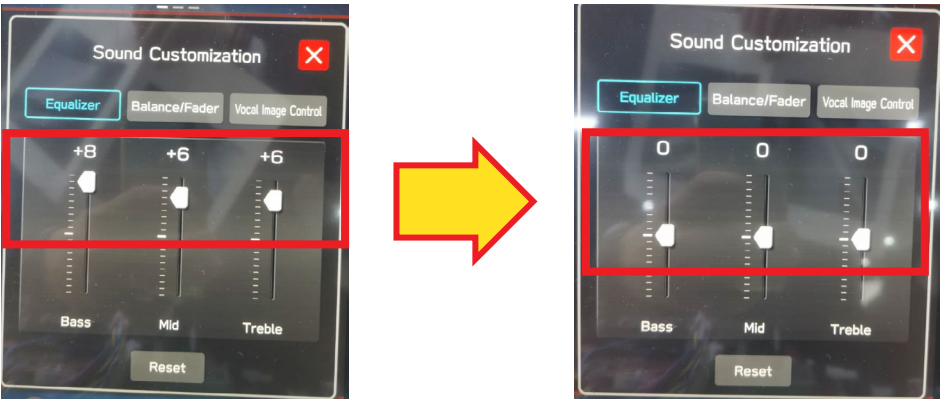
| Symptom # | Description of Symptom: |
|---|---|
| 7 | Customer-selected Equalizer settings are lost. Equalizer returns to the default settings after ignition switch is turned OFF and back ON. |

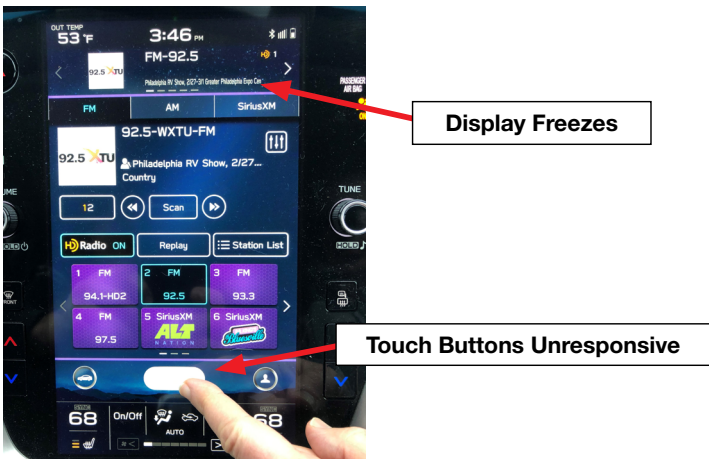
| Symptom # | Description of Symptom: |
|---|--|
| 1 | <p>The CP1 display and/or center Combination Meter display freezes. No response from touch screen or voice guidance. After switching the ignition off and opening the driver’s door, the system does not recover**.</p> <p>**NOTE: After switching the ignition off and leaving the driver’s door open more than 70 seconds, the system <i>may</i> recover after switching the ignition back on.</p> |

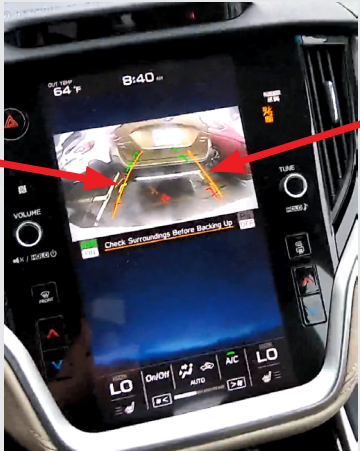
| Symptom # | Description of Symptom: |
|---|---|
| 2 | <p>Delayed response of rear view camera guide lines. When the rear view camera is activated and the steering wheel is turned, there is a delay before the steering-responsive guide lines respond to the steering wheel input.</p> <p>The image shows a car's infotainment screen displaying a rear view camera feed. The screen shows a top-down view of the car with yellow and red guide lines. Two red arrows point to the guide lines, indicating a delay in their response to steering input. The screen also displays '8:40 AM', '64°F', and a 'Check Surroundings Before Backing Up' warning.</p> |

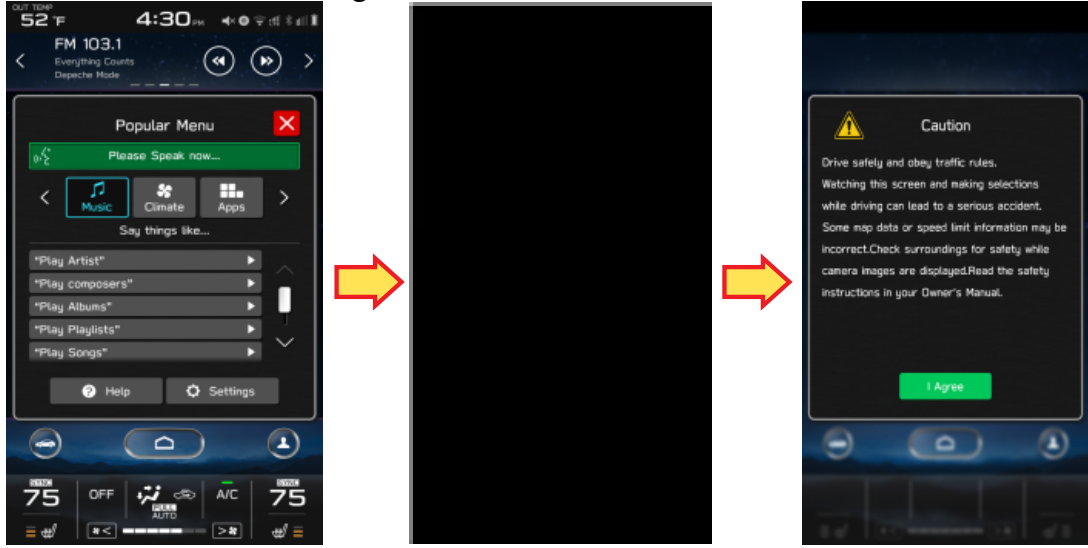
| Symptom # | Description of Symptom: |
|---|--|
| 5 | <p>When using Voice Recognition to search for a 'Nearby POI' (Point of Interest) in Canada with FRENCH language selected, the CP1 display turns black and displays a Caution / disclaimer message.</p> <p>The image shows a sequence of three screenshots illustrating the symptom. The first screenshot, labeled 'Voice Recognition', shows a car infotainment system interface with a 'Popular Menu' overlay. The second screenshot, labeled 'Black Screen', is a solid black rectangle. The third screenshot, labeled 'Caution / Disclaimer Message', shows a warning screen with a yellow triangle icon and the text: 'Caution. Drive safely and obey traffic rules. Watching this screen and making selections while driving can lead to a serious accident. Some map data or speed limit information may be incorrect. Check surroundings for safety while camera images are displayed. Read the safety instructions in your Owner's Manual.' Below the text is a green 'I Agree' button.</p> |
