SERVICE BULLETIN

APPLICABILITY: 22-23MY WRX Models **NUMBER:** 15-301-22R
SUBJECT: Reprogramming File Availability for Optimization of Gen 4 Denso CP1 Infotainment Systems **DATE:** 09/09/22
REVISED: 05/15/26

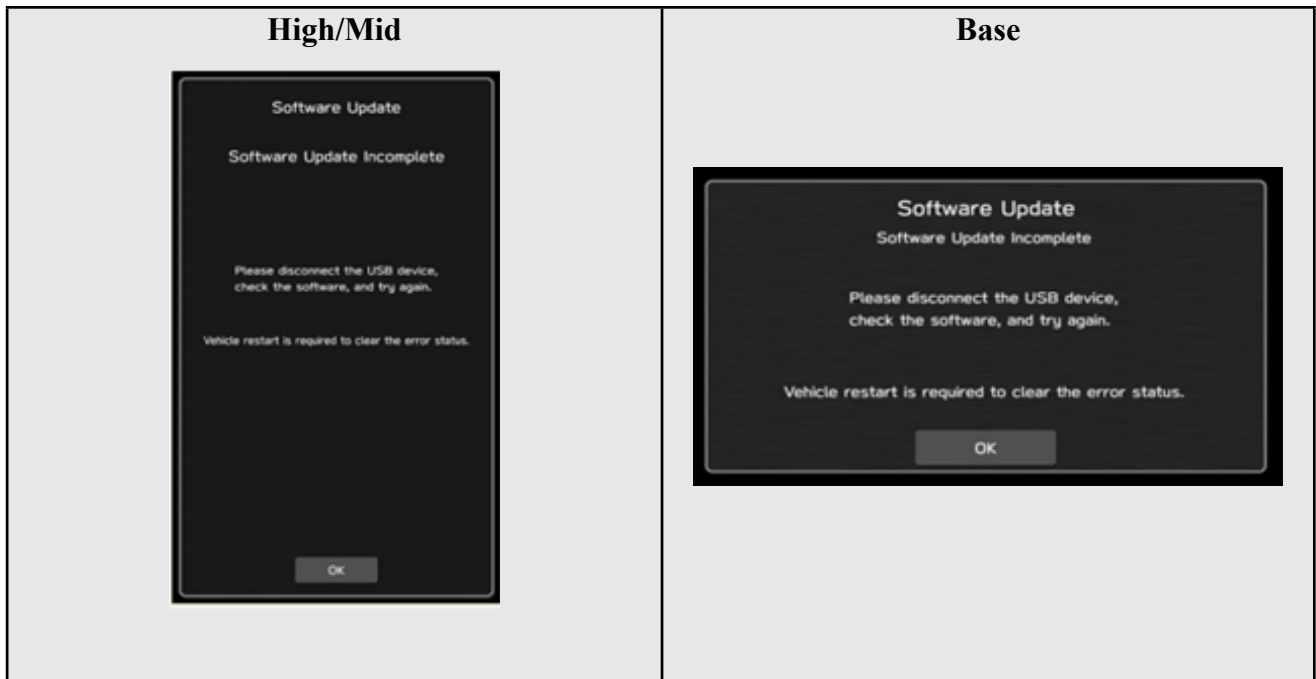
If you get the message **Software Update Incomplete** as shown below, please don't replace the hardware but retry updating the software according to the instructions in "**Appendix B**" on pg. 17.

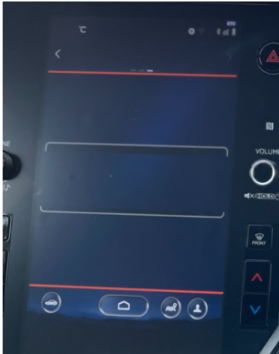
7	<p>The CID screen display becomes distorted causing icons and text to be displayed incorrectly, when using USB audio in folder playback mode: the track list is scrolled at the moment when the playing folder switches</p>

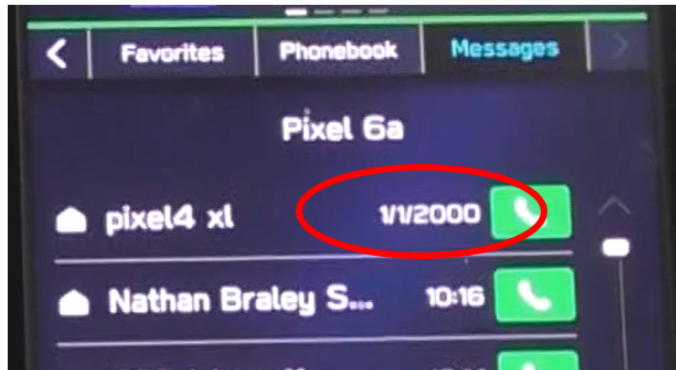
28	<p>The date of receipt of a received message is displayed as "2000/1/1."</p> <p>This occurs on some models of phones with Android OS 13 or later.</p>

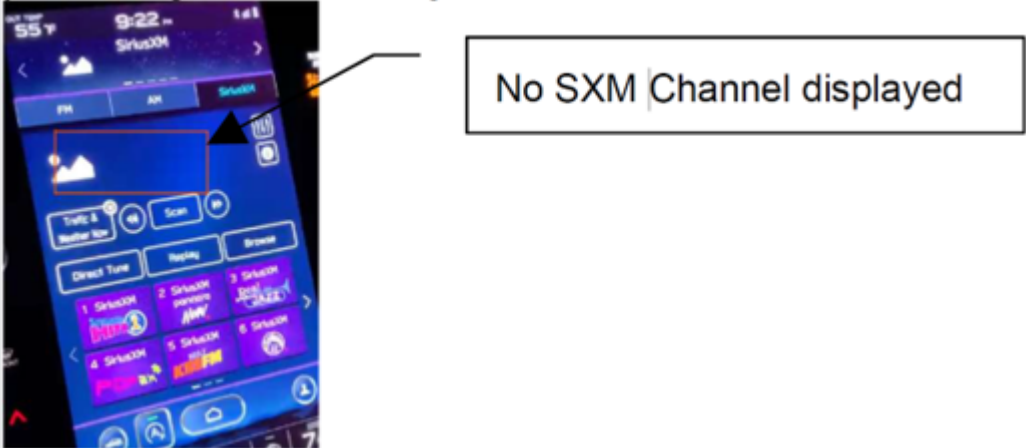
26	<p>SXM has blank screen and no sound when the SXM screen had been selected as audio source at the previous ignition off timing.</p>

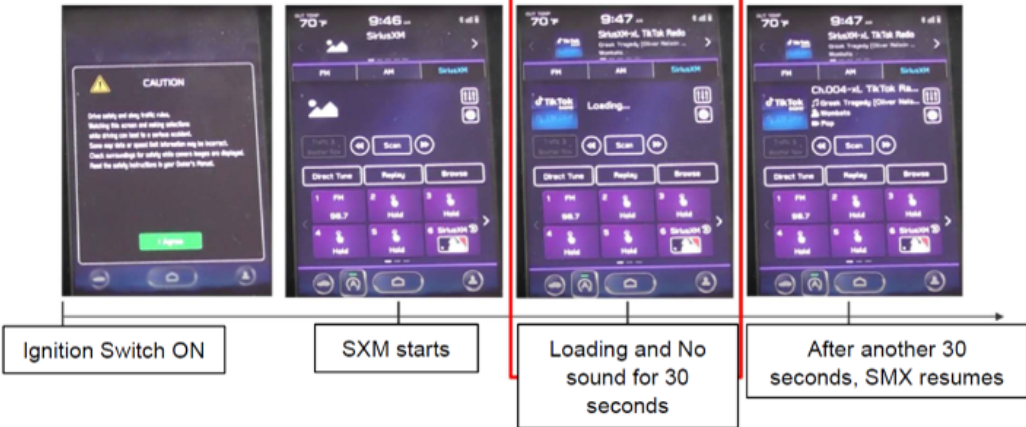
27	<p>About 30 seconds after starting the SXM the operation is paused with loading screen and resume after another 30 seconds. This symptom occurs when the SXM screen had been selected as audio source at the previous ignition off timing.</p>

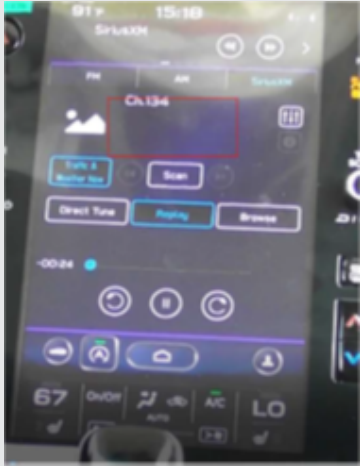
30	<p>The channel information becomes blank when the seek button (<</>>) of the steering satellite switches is pressed continuously to control the Traffic & Weather Now (TWN) in SXM.</p>

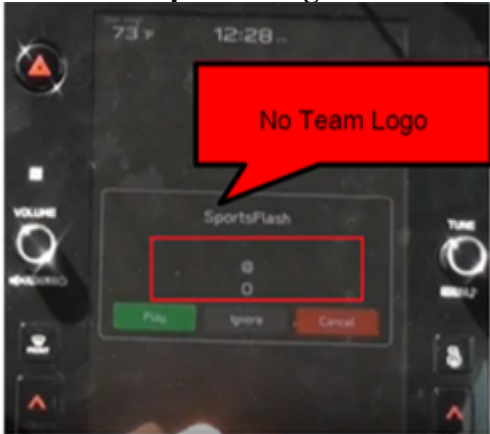
31	<p>The team logo is not displayed on Sports Flash screen when the SXM screen had been selected as audio source at the previous ignition off timing.</p>
