Subject: BSM WARNING LIGHT ON EVEN WHEN NO VEHICLE IS BEHIND	Bulletin No.: 15-001/26
	Last Issued : 05/20/2026

2025-2026 CX-70 with VINS lower than JM3KJ*****200974 (produced before October 11, 2025)

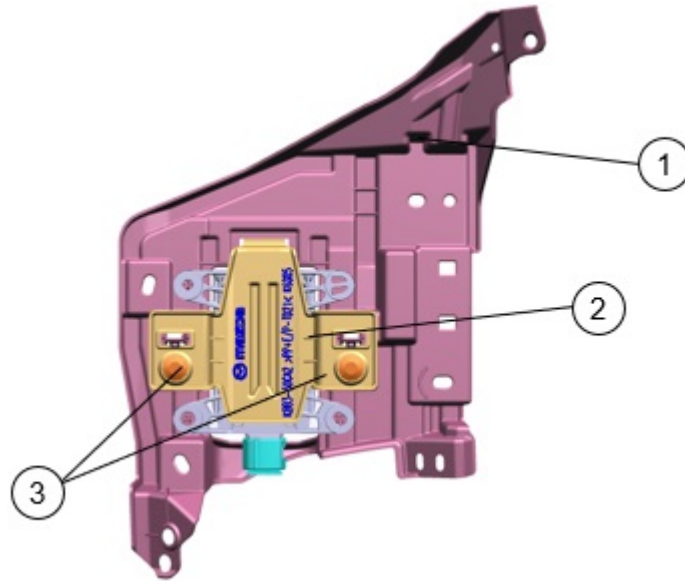
- If the fastening condition matches the level shown in the video, the repair is complete.
- If the fastening exceeds that shown in the video (1 mm or more), the fastening is not acceptable; proceed to the next step.

- (1) Bracket
- (2) Retainer
- (3) Rivet

6. Replace the bracket, retainer, and rivet as necessary, then perform aiming adjustment in according to the instructions in MGSS (REAR SIDE RADAR SENSOR AIMING) after installing the rear bumper.
