Service Bulletin

Bulletin No.: PIP6117

Subject: Diagnostic Tip - SES MIL /No Start / BECM DTCs due to Corroded Splice Pack

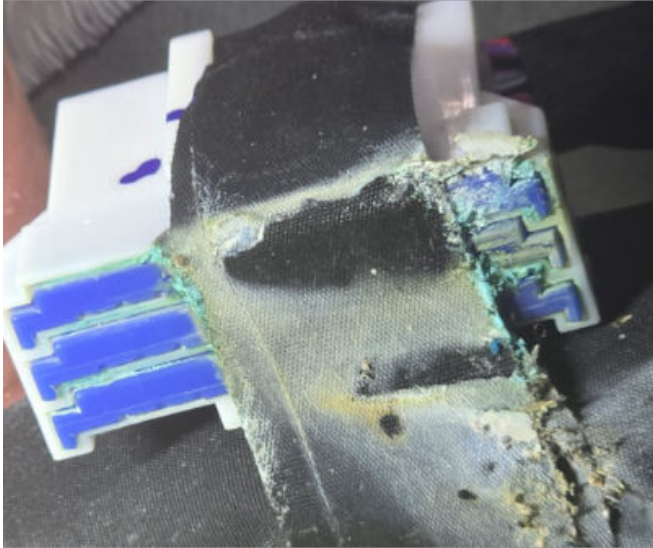
7143850

Cause	<p>Corrosion at JX310 can lead to circuit malfunctions including the potential for high resistance, an open circuit or excessive voltage drop specifically to the K16 BECM (Battery Energy Control Module) or to the A28 Hybrid/Electric Vehicle Battery Disconnect Relay internal to the A4 Hybrid/ Electric Vehicle Battery Pack.</p>

If signs of moisture are apparent, inspect JX310 for signs of corrosion or terminal damage and repair JX310 as necessary while also correcting the source of the moisture intrusion.
