ID # CBR-2585

C106718 and/or C106818 DTC - VN (4) - AN (4) - PR

The purpose of this CBR is to provide support for fault codes C106718 and/or C106818.

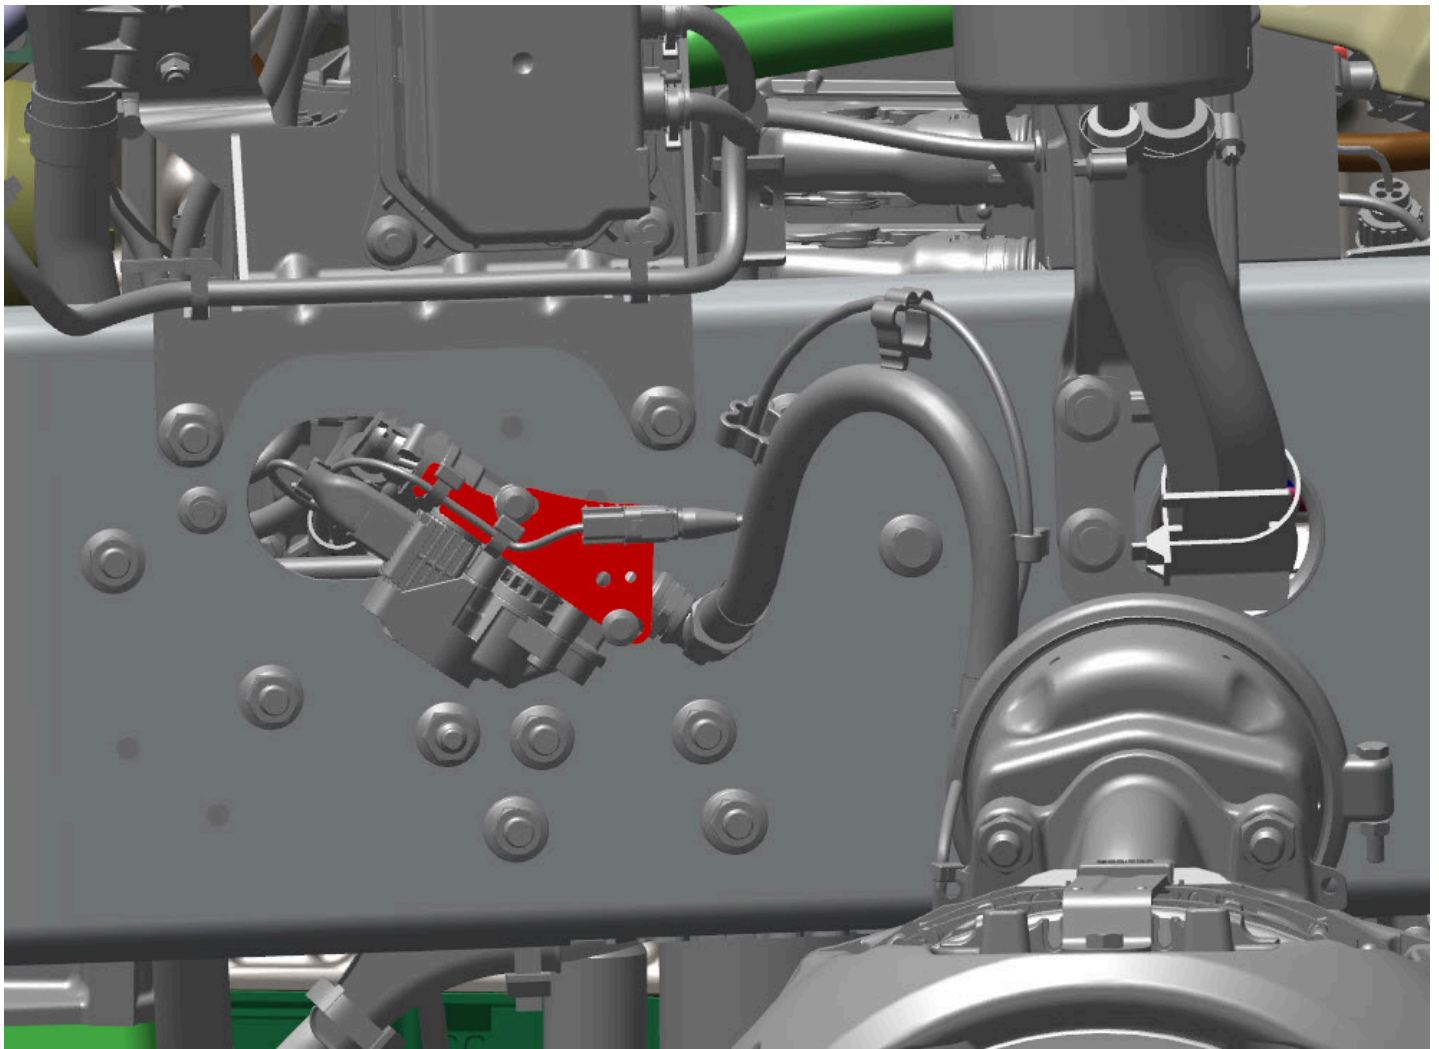
When fault codes C106718 and/or C106818 are present, and/or it has been identified that the wheel speed sensor harness is contacting the shock, please follow the instructions below before releasing the unit.

1. Cut the zip ties and removed the harness from the wheel speed mounting bracket. Then remove bracket from the truck.
