Check engine light with fault code P3005CA in MRD1 (CDI)

Topic number	LI49.20-N-078466
Version	4
Function group	49.20 - Exhaust gas aftertreatment
Date	5/8/26
Validity	Sprinter 907 OM654
Reason for change	Remedy update

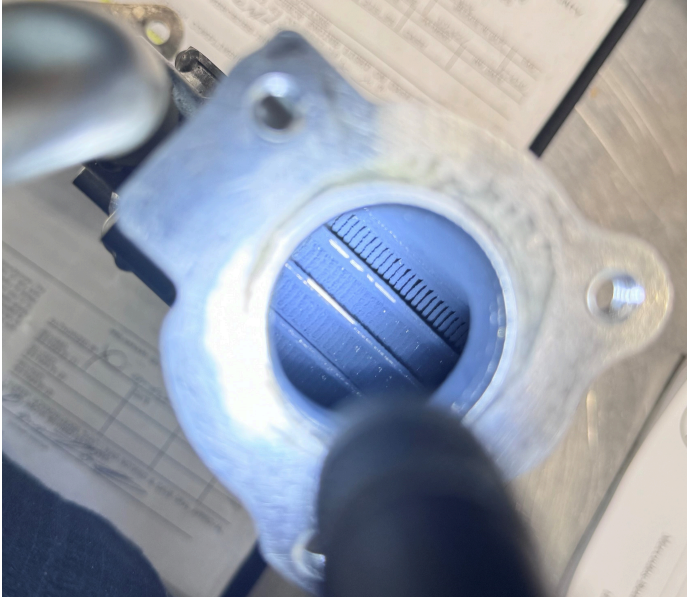
Attachments	
File	Description
LP EGR Cooler.jpg

Low-Pressure EGR Cooler
LP EGR.jpg
