Tesla, Inc.
Service Bulletin

Replace Suspension Components

SB-25-31-005
May 8, 2026

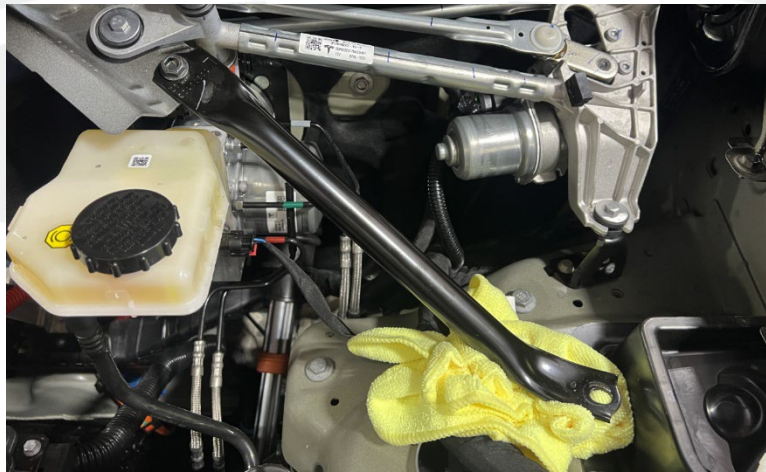
Figure 1

- If the rattling or knocking noise is present, continue to the next step.
 - If the rattling or knocking noise is not present or a different noise is heard, discontinue this procedure and use correction code S022531005.
2. Remove the bolts (x2, 13 mm) from the LH and RH wiper bracket pencil brace lower attachment points and swing the arms away from the bolted flanges, then wedge a shop towel between each of the braces and mounts to isolate the lower attachment points (Figure 1).
