Tesla, Inc.
Service Bulletin

Inspect and Lubricate Front Seat Recliner Tube Ends

SB-26-13-006
May 29, 2026

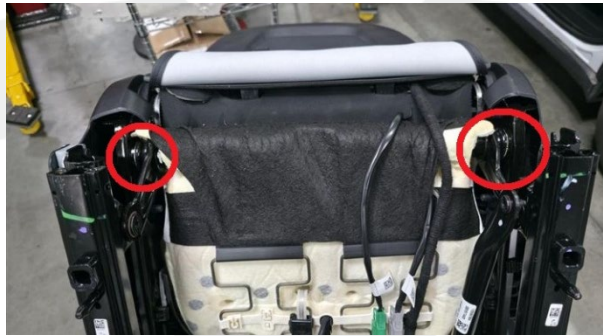
Figure 1

On some vehicles, insufficient lubricant at the front seat recliner tube ends may cause creaking noises during weight shifting when the seat is occupied.

- If no creaking noise is present, or the noise is not from the recliner tube area, discontinue this procedure and use Correction Code S012613006.
 - If a creaking noise is heard, coming from the recliner tube area, continue to the next step to lubricate the recliner tube ends.
2. Remove the reported seat(s) (refer to Service Manual procedure; [2024+ Model 3](#), [2025+ Model Y](#)).
 3. Place shop towels at the recliner tube ends area to prevent over spray and to protect the trims and covers (Figures 1–3).
