Service Bulletin

Bulletin No.: PIT6209K

PRELIMINARY INFORMATION

Subject: Update Failed See Dealer to Restore System Screen Recovery

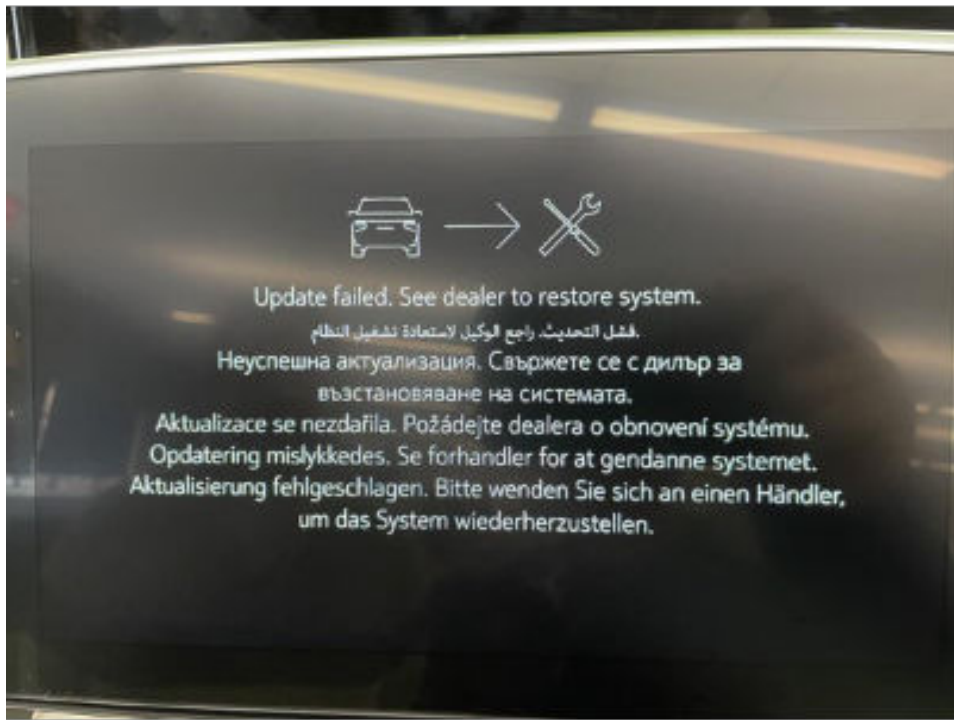
<p>Condition</p>	<p>A customer might bring the vehicle in with radio showing a vehicle and an arrow pointing to a wrench. The recover method in Radio Malfunction may not work.</p>

<p style="text-align: right;">6873187</p>
<p>Cause</p>	<p>The cause of the condition may be software anomalies.</p>
