| | | MODEL Z FRONT CAP REPOSITIONING INSTRUCTIONS | | | 4 | 4 | Difficulty Level |
| WI: | WI-092-2026 Model Z Front Cap Repositioning Instructions | | | | | | |
| PRODUCT: | Model Z (See Below) | VIN Range: | 000001 - Current | REVISION: | REV-A | | |

Certain Model Z units may have the front cap installed in a manner that contacts the structure behind it. As a result, there is the possibility a “bulge” may occur in the cap. Should this occur, the following procedure for repositioning the front cap will eliminate this anomaly.

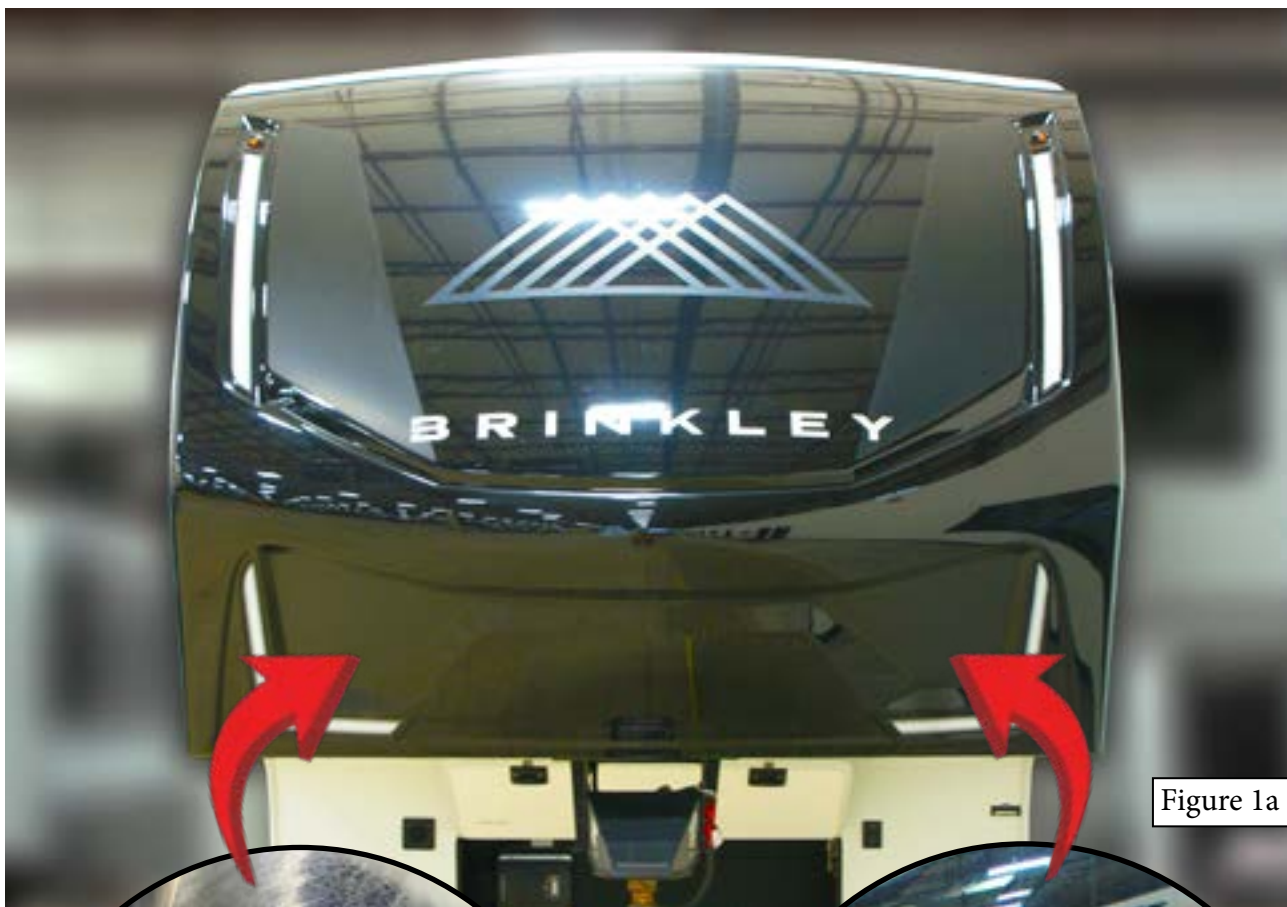
Figure 1a

- 1. READ AND UNDERSTAND ALL INSTRUCTIONS PRIOR TO BEGINNING WORK.**
- Inspect the front cap for a bulge in the flat portion of the lower front section (Figure 1a, 1b and 1c). Bulges can occur on either side or both sides.

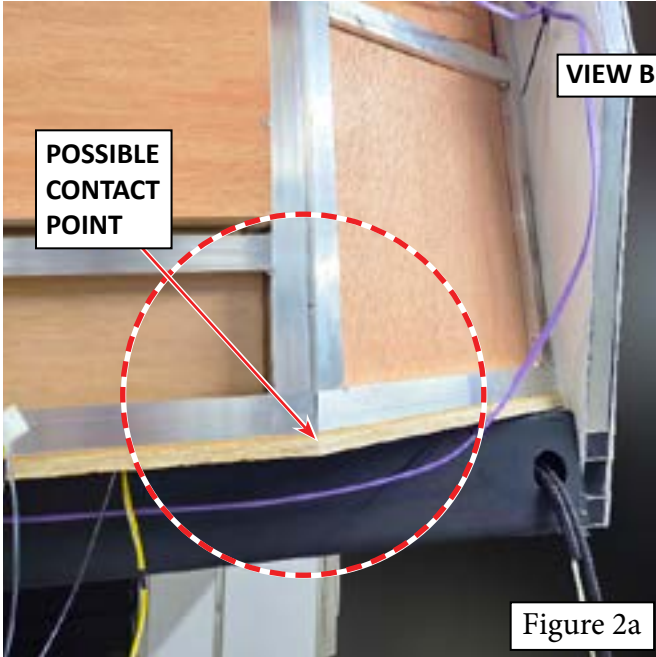
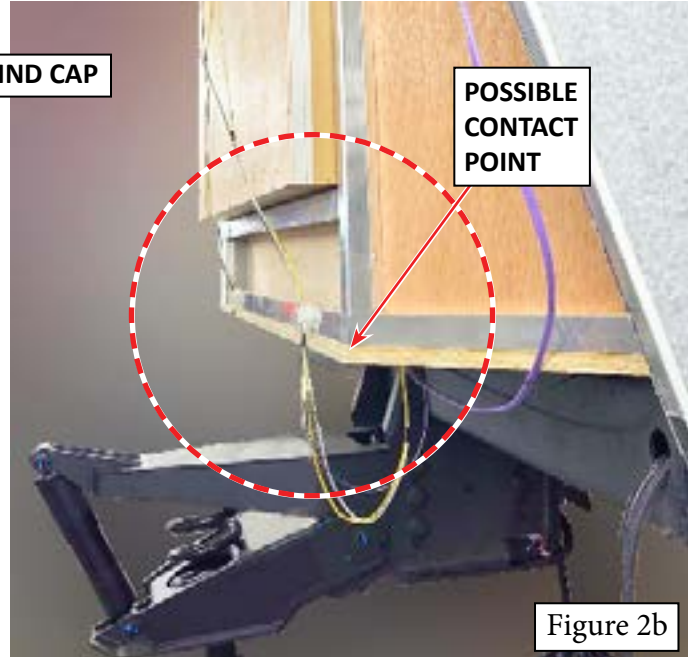
3. If a bulge is present, it is likely caused by the cap being too far back, which causes physical contact with the lower corner portion of the “cage” support structure behind it (Figure 2a and 2b).

4. To remove the anomaly, the lower portion of the cap must be moved forward approximately 3/16” on the side where the bulge is. Use a razor knife to cut the sealant around the lower trim cover (Figure 3a).
5. Use a screw gun and a #2 square drive bit to remove the two (2) fasteners holding the lower front corner trim cover in place (Figure 3b). Remove the lower corner cover (Figure 3c).

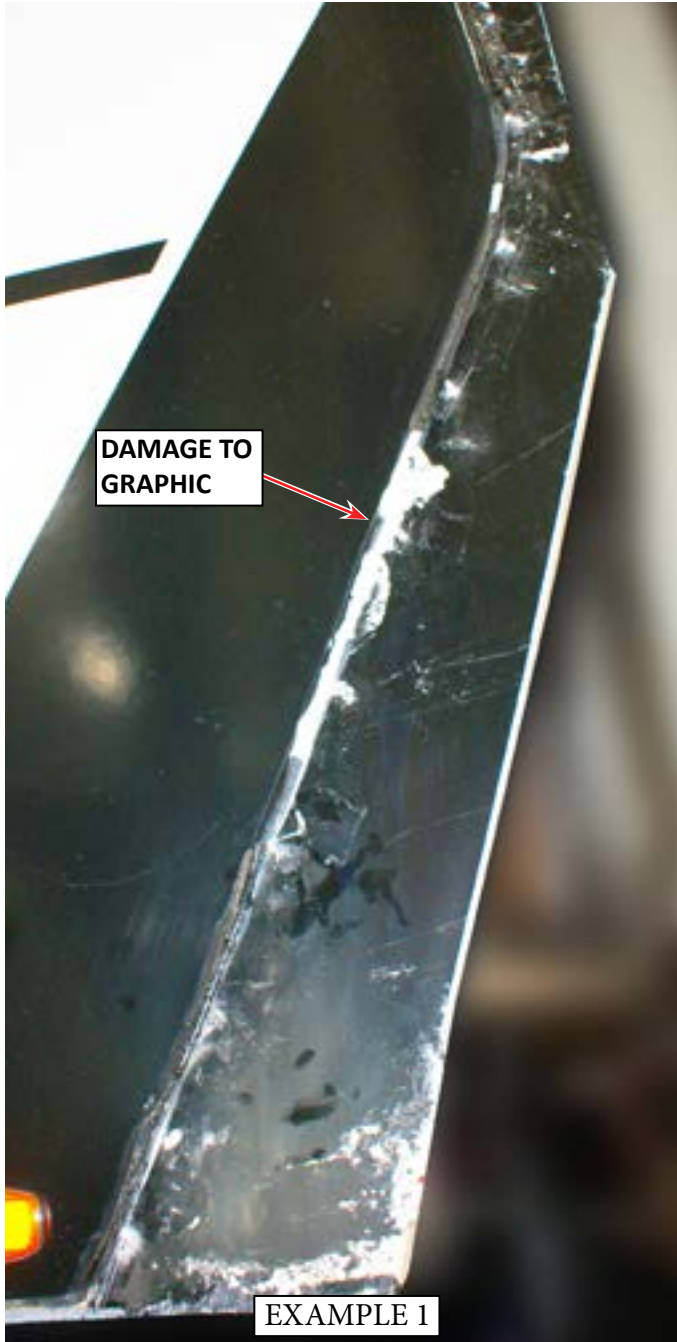
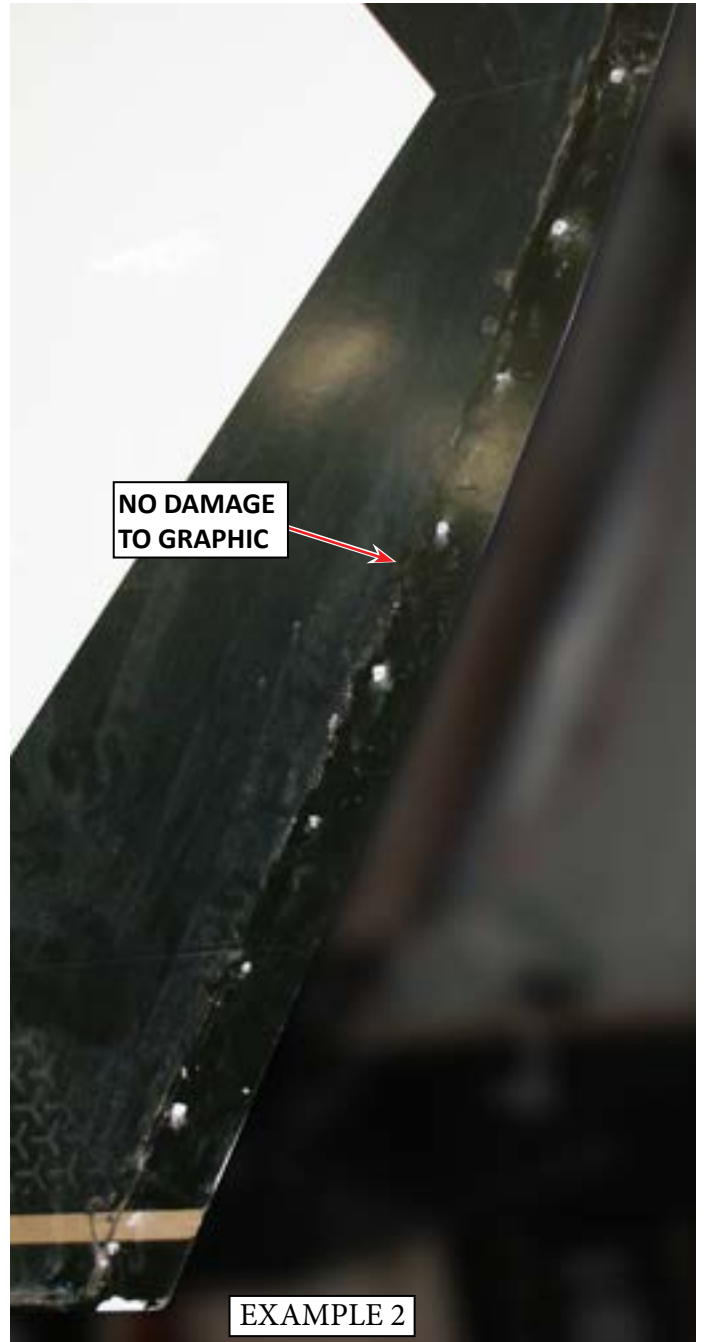
USE CAUTION when cutting and removing the seals between the cap and the sidewall. If the sidewall graphic is damaged, it will have to be replaced. Examples below show the difference between careless (Example-1) and careful (Example-2) cutting of the decals that are installed between the cap and the sidewalls. For a detailed list of sealants used to seal the cap to the sidewall, see Figure 12, Page 10. Unnecessary damage may occur to the sidewall graphics if not performed safely and within the parameters set forth in this document.
