EMISSIONS RELATED RECALL

Global Recall Action
Number: D103

Subject: Plug-in Hybrid Electric Vehicle (PHEV) High Voltage (HV) Battery Capacity - Replace 1 - 26S Module	Publication No.: D103
	Model: Range Rover (LK)
	Model Year: 2023 - 2025
	Model: Range Rover Sport (L1)
	Model Year: 2024
	Date of Issue: 21 May 2026

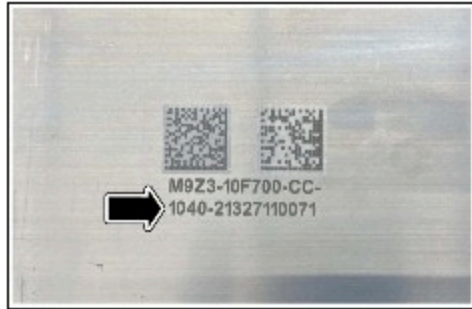
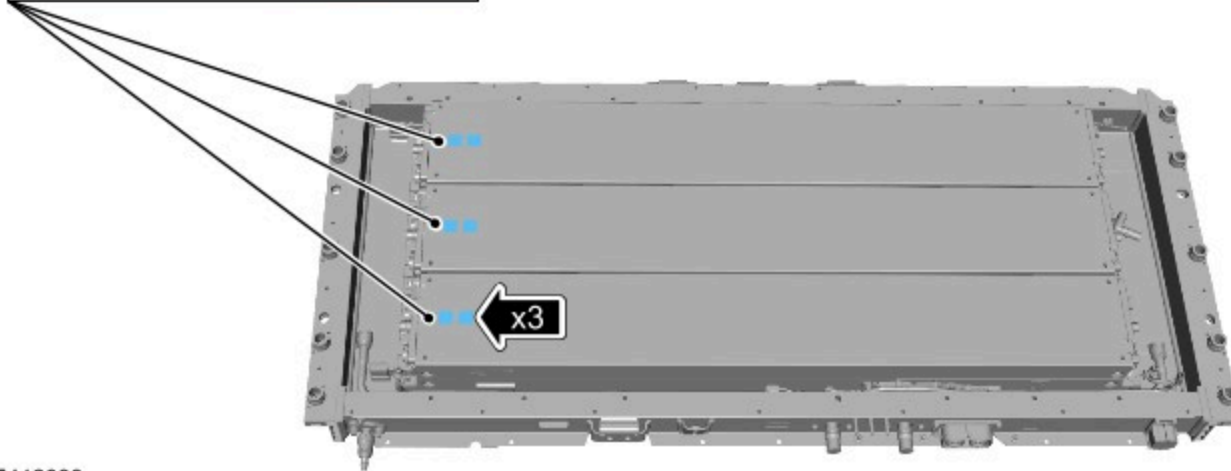
E412033

6. Inspect the 3 modules to locate the serial number for the [PHEV](#) battery module which requires replacement.

- Use the vehicle information table at the beginning of this Service Instruction to identify the serial number of the [PHEV](#) battery module requiring replacement.

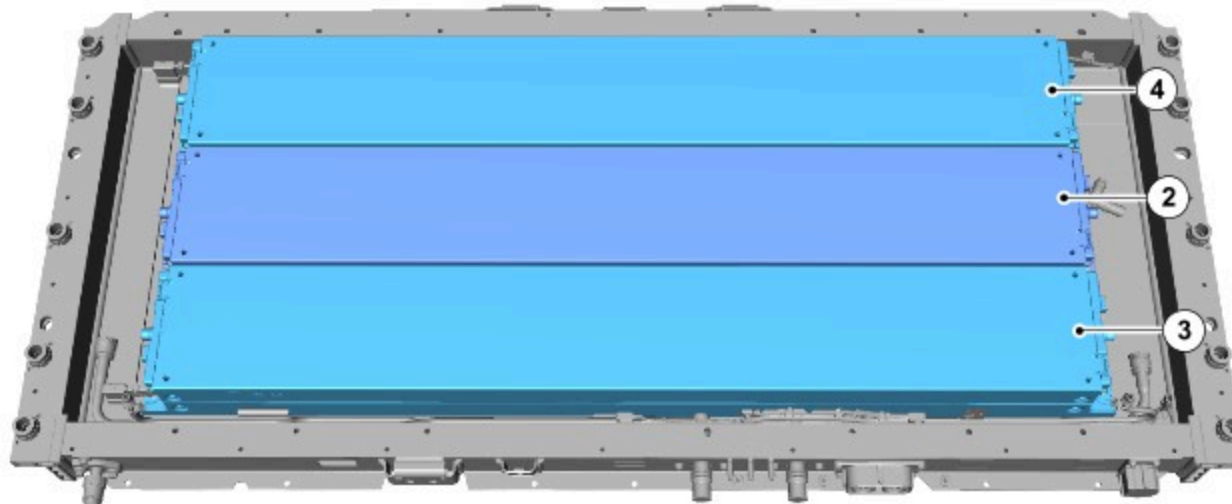
E412034

7. Identify the position / module number of the [PHEV](#) battery module to be replaced.

- If [PHEV](#) battery module 2 requires replacement, **continue to step 1 of the SERVICE INSTRUCTION.**
- If [PHEV](#) battery module 3 requires replacement, **continue to step 2 of the SERVICE INSTRUCTION.**
- If [PHEV](#) battery module 4 requires replacement, **continue to step 3 of the SERVICE INSTRUCTION.**
