SERVICE ACTION

Global Service Action
Number: D117

Subject: Left Outer Tail Lamp Aperture - Sealant Concern	Publication No.: D117
	Model: New Range Rover Evoque (LZ)
	Model Year: 2026
	Date of Issue: 14 May 2026
	Expiry Date: 31 May 2028

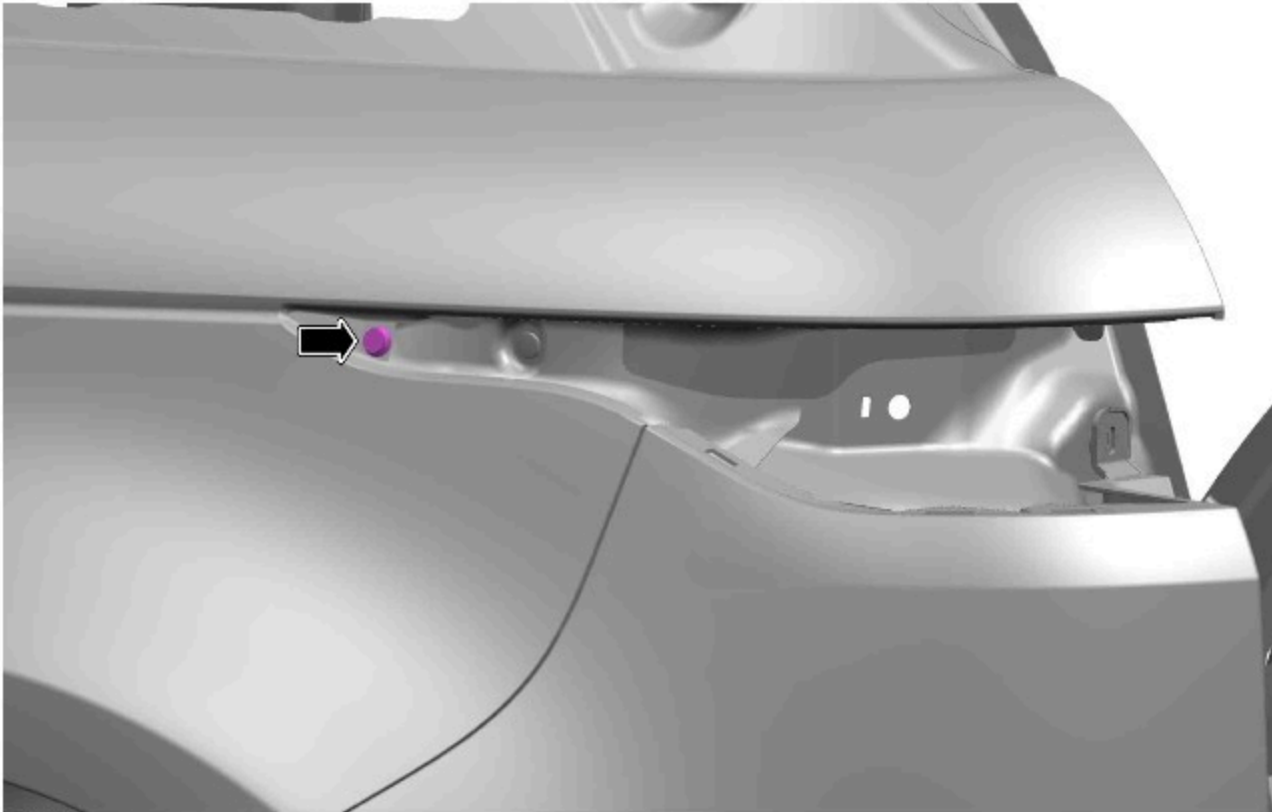
E416409

2. Remove the clip.

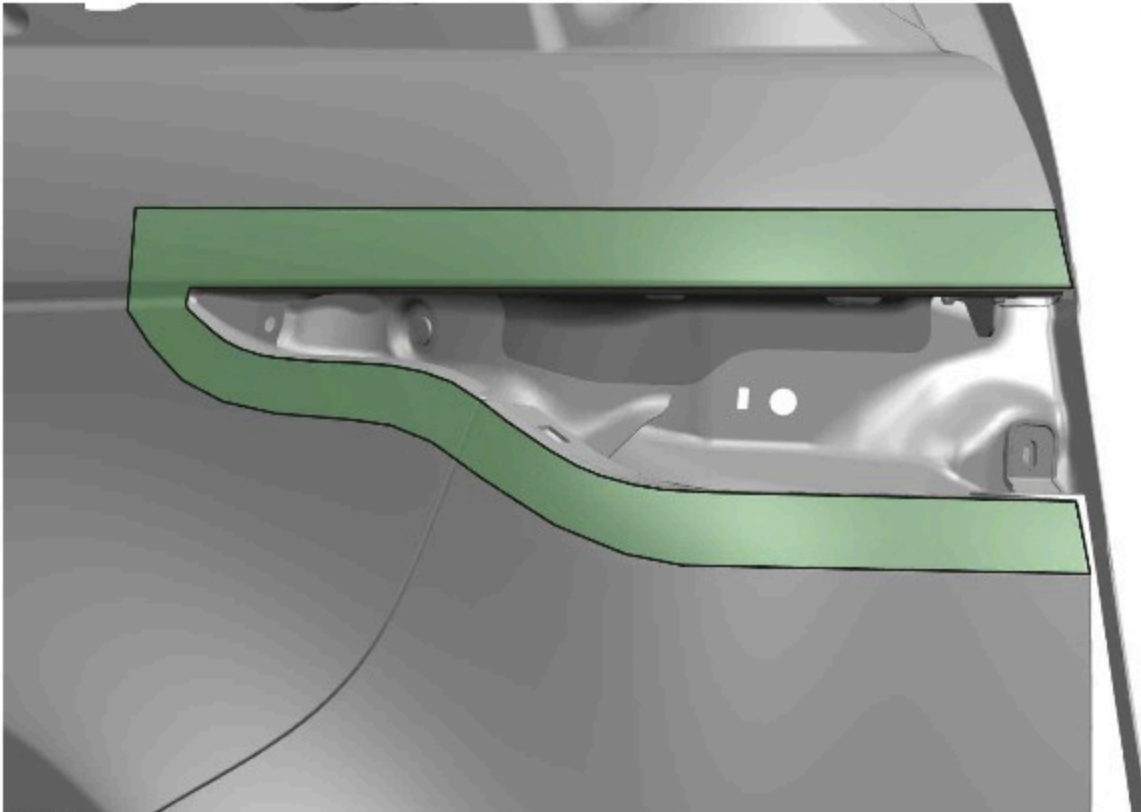
E416106

3. Protect vehicle exterior paint work in the area of the outer tail lamp aperture.

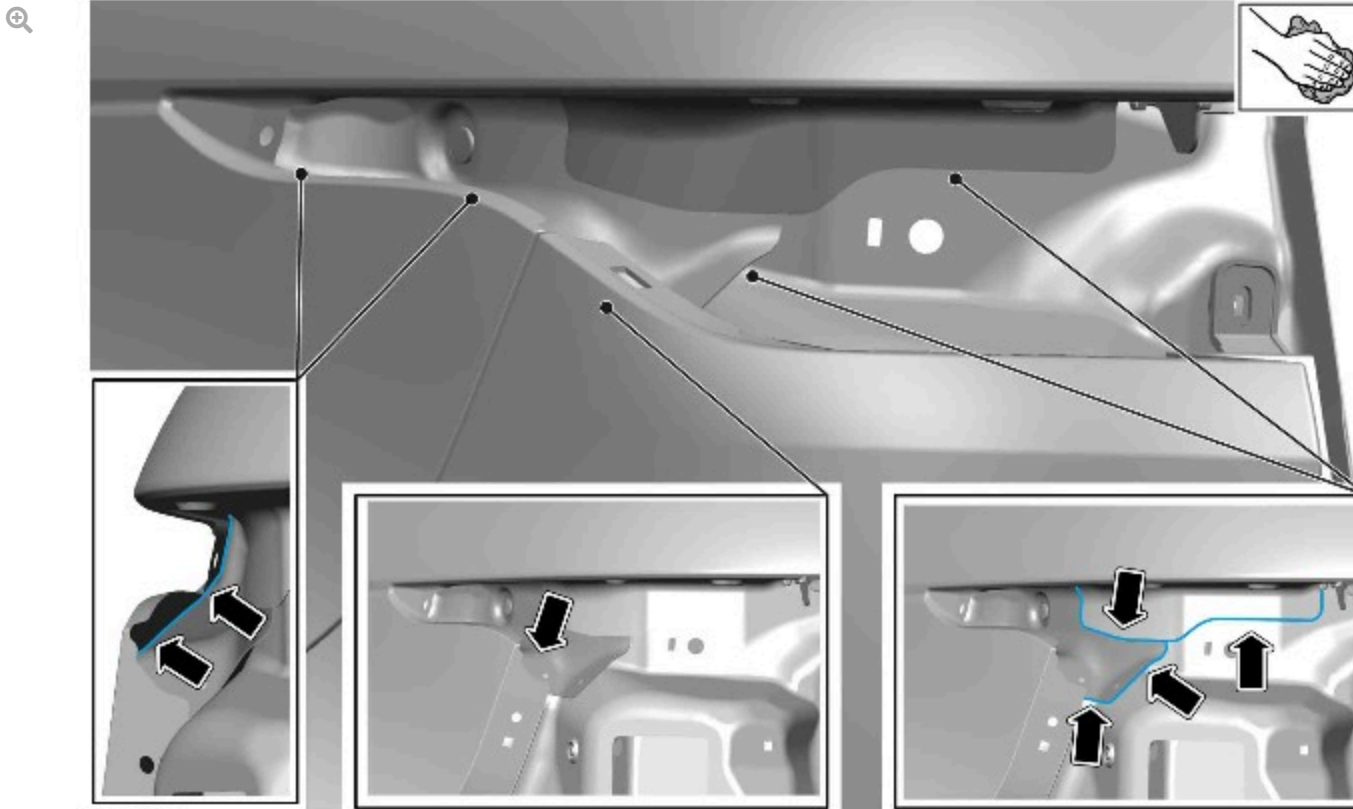
E416107

4. Clean the areas shown in the illustration with a suitable solvent cleaner.

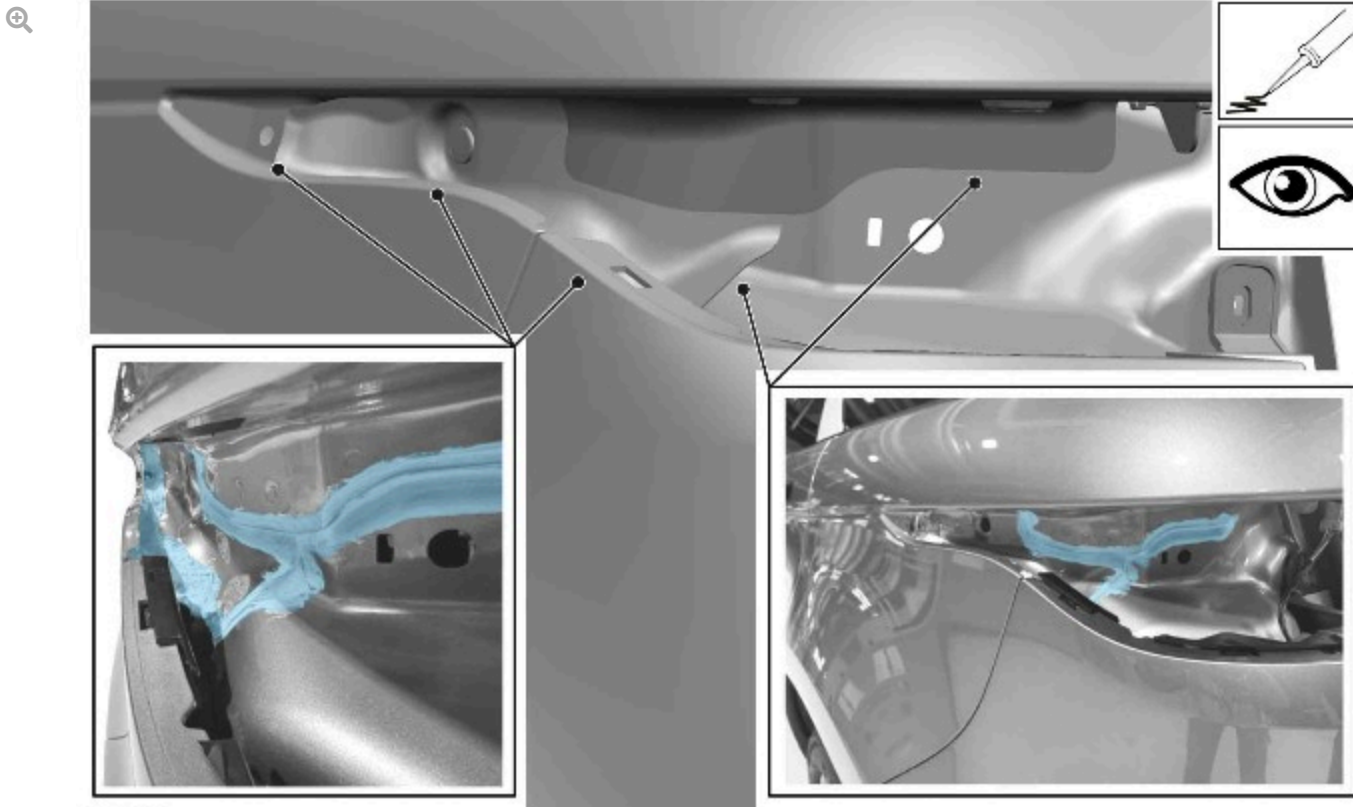
E416108

Sealant **MUST NOT** be applied to the panel 'A' surface.

Sealant must be applied to the joint hidden behind the rear quarter panel to rear bumper joint.

Apply the sealant in the area shown in the illustration.

- Using a gloved finger make sure the sealer is pushed into the full length of the panel joint.

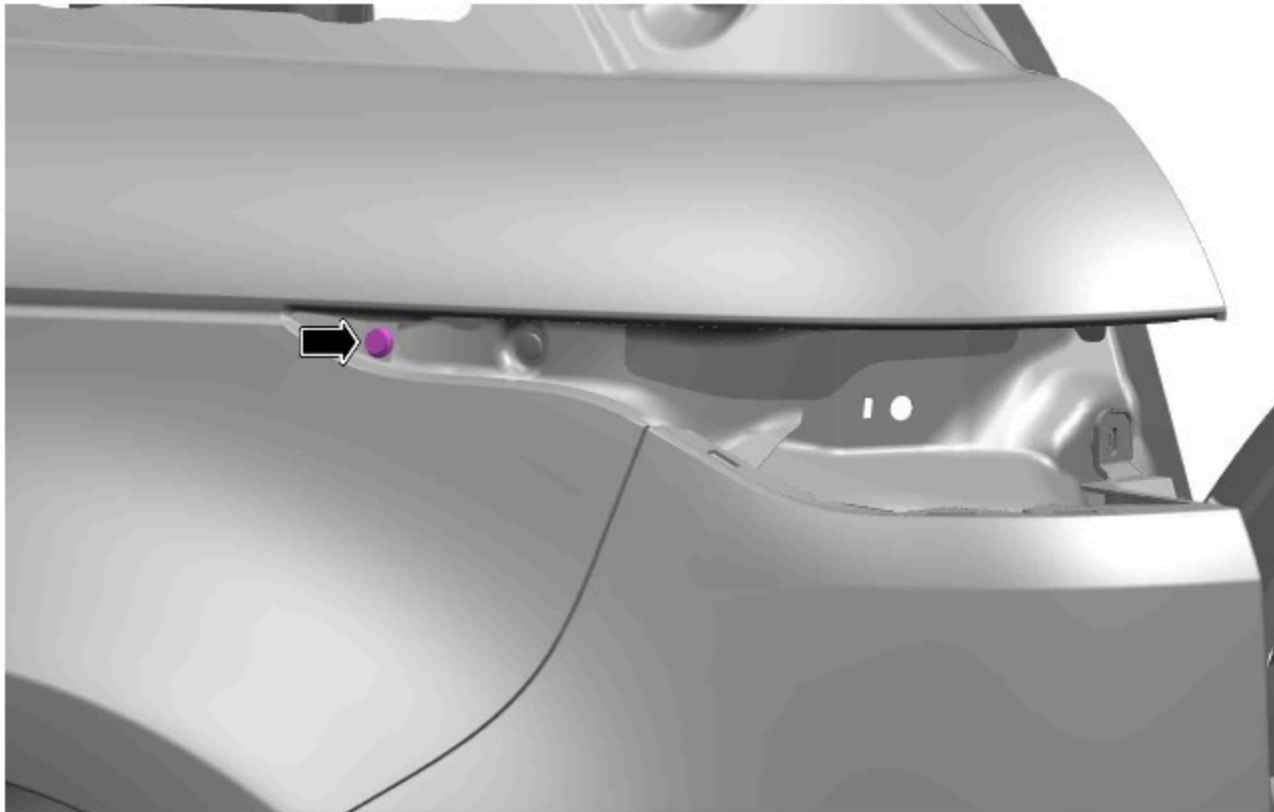
E416409

The sealant must not be displaced when installing the clip.

Install the clip.
