Reference	SSM76449
Models	New Range Rover / L460 New Range Rover Sport / L461
Title	Deployable Side Step Diagnostic Aid Video Clips
Category	Accessories
Last modified	06-May-2026 16:54:00
Symptom	General Accessories
Attachments	SSM76449 Attachment.pdf (SSM76449 Attachment.pdf)

Range Rover / 22MY onwards / All fitted with Deployable Side Steps (DSS)
Range Rover Sport / 22MY onwards / All fitted with Deployable Side Steps (DSS)

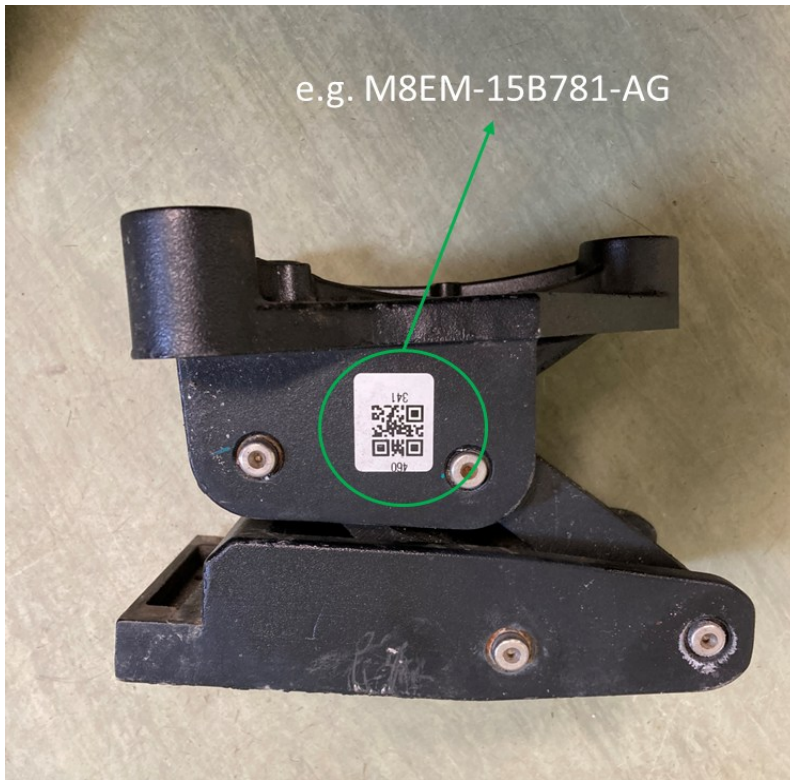
1.

Note: Record the part number of the old idler gear and motor that can be displayed by scanning the QR code with reference to image 1 and 2 in the attachment.
