<b>Topic</b>	Warnings in the DIP: DTCP0F0000 stored in HV battery management controller 008C   Bentayga PHEV   23MY
<b>Market area</b>	Bentley: worldwide (2WBE),China 796 VW Import Comp. Ltd (Vico), Beijing (6796)
<b>Brand</b>	Bentley
<b>Transaction No.</b>	2080411/2
<b>Level</b>	EH
<b>Status</b>	Released for publishing
<b>Release date</b>	May 1 2026

Warnings in the DIP: DTCP0F0000 stored in HV battery management controller 008C

| Bentayga PHEV | 23MY

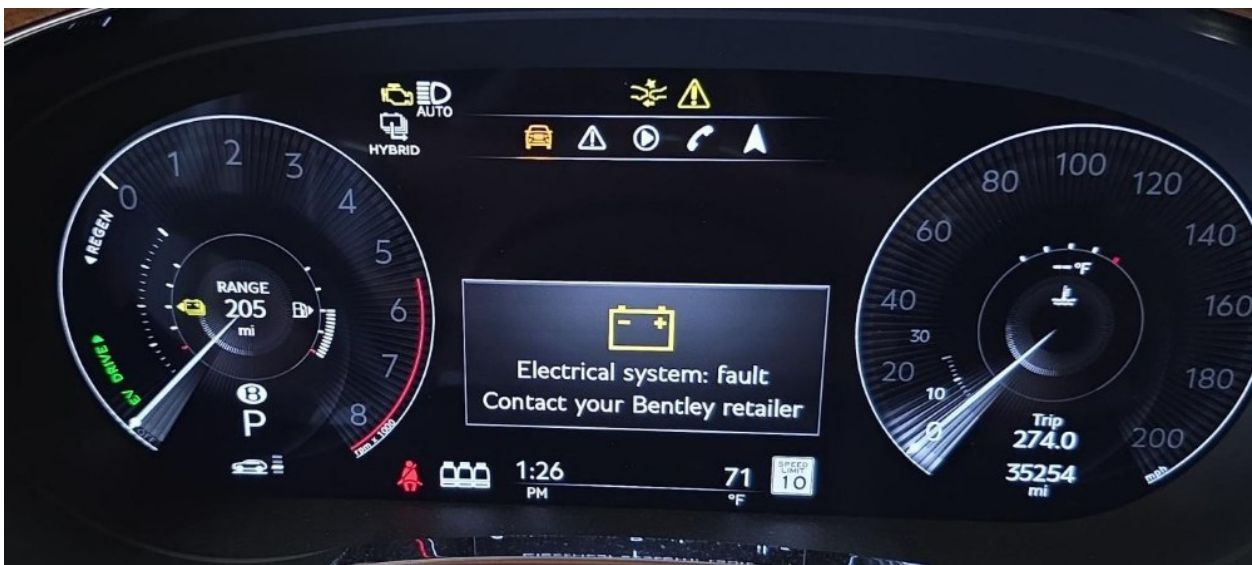
Malfunction Identification lamp (MIL) occurs in the driver's instrument panel (DIP).

Figure 1. Malfunction Identification Lamp (MIL) warning

Customer findings verified in the workshop with the following DTC stored in the HV battery management controller (diagnostic address 008C):

- P0F0000: Hybrid/EV Battery Module "A" Performance

- B1D9EF4: Hybrid/high-voltage battery Cell module ANY, self-discharge detected.

NOTICE
<b>Raise a full technical DISS query and include the uploaded GFF log that shows the error encountered. Do not carry out any work on the vehicle until a response is received via DISS.</b>
