FIRE CHASSIS

## Spartan Fire, LLC

Campaign Service Bulletin  
CSB26-200-001

- DATE:** 5/14/2026
- APPLIES TO:** This service bulletin applies to certain model year 2025-2026 Gladiator and Metro Star, 2025 FC-94, 2025 KME Panther, and 2024-2025 Smeal Aerial Fire Apparatus model emergency response chassis cabs built between December 2024 and November 2025.

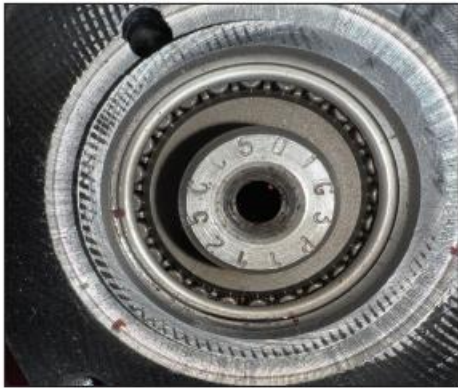
Figure 1

CAGE DESIGN

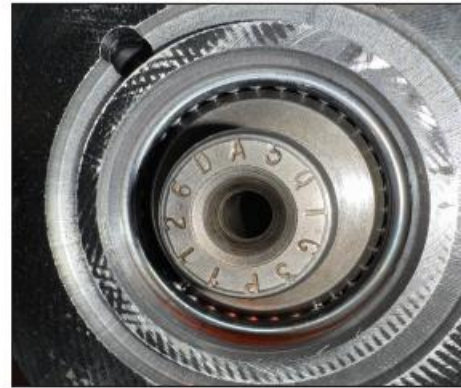
Figure 2

Due to higher viscosity transmission fluid during the recent falling temperatures, Parker Chelsea has received feedback from customers that our 281 and 890 series PTOs have been experiencing unrequested PTO output shaft rotation. The clutch drag is due to lubrication restrictions within the bearing structure, which is also restricting the exhaust flow from the clutch causing partial engagement.

The bearing flow restriction is isolated to the full complement bearing design on the 281 and 890 series PTOs. Since January 2025 Parker Chelsea has two approved bearing designs: the cage and the full complement, both of these bearings are shown below.

FULL COMPLEMENT DESIGN

The field repair solution is to replace the integral solenoid valve cap with a remote cap and use a remote valve to exhaust clutch flow through the PTO's EOC port. The Chelsea kit part number is 330176-12X and these will be supplied to the dealers.
