STAR ONLINE PUBLICATION

Case Number: S2623000038

Symptom/Vehicle Issue: Central ADAS Decision Module (CADM), Long Range Camera Front(LRCF), Advanced Driver Assist System (ADAS), Lane Assist Inoperative, Service Active Lane Management Message, Inside Rearview Mirror Cover and LRCF Windshield Bracket.

2024-2026 Jeep Grand Cherokee (WL)

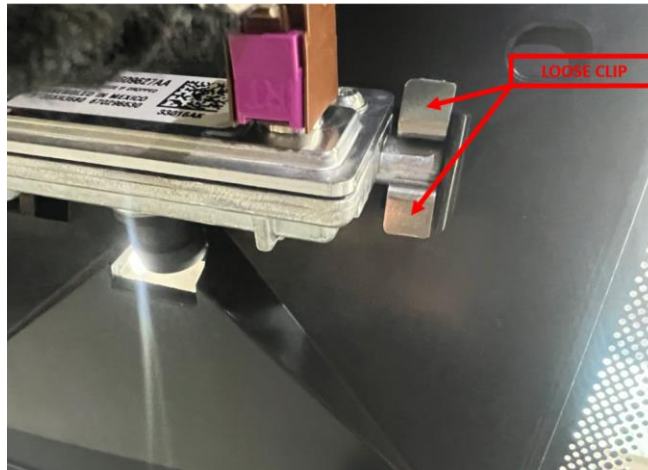
Some recently replaced and returned LRCF were analyzed and have been found to have no internal failures. **C2318-76 - Front Camera-Wrong Mounting Position** is correctly set by the CADM and may be related to insufficient tension of the LRCF windshield bracket mounting retention clip and/or other LRCF mounting related issues, which include installation of an aftermarket windshield (non-MOPAR).

Fig 1 Insufficient Tension of the LRCF Windshield Bracket Mounting Retention Clip

1. Start your diagnosis with inspection LRCF windshield bracket mounting looking for areas of excessive tolerance. **Figure 1 and 2 Below**
2. Check for an aftermarket windshield or accessories that could affect the ride height of the vehicle and inhibit the Forward Facing Camera dynamic service

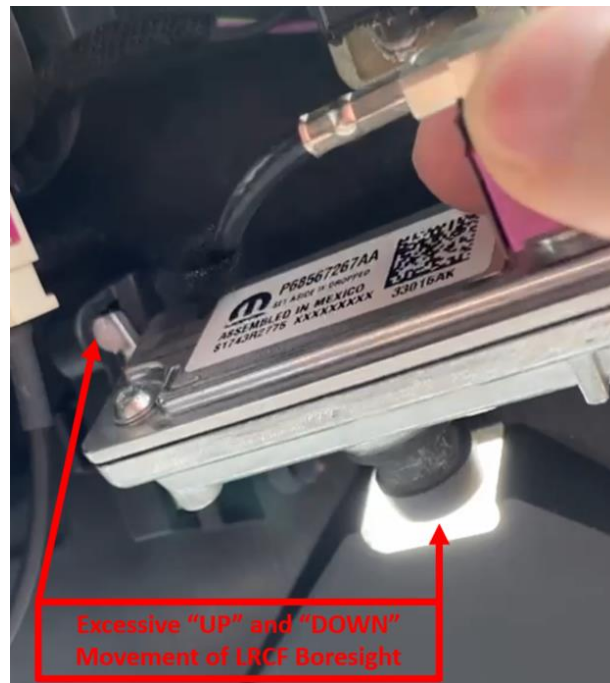
Fig 2 Excessive Displacement of LRCF Boresight **OR** Insufficient Spring Retention compared to other vehicles **OR** Excessive Coax Cable Tension
