Technical Service Bulletin (TSB)
Damaged Hood Bumpers

REFERENCE:	TSB: 23-020-26 GROUP: 23 - Body	Date:	May 28, 2026	REVISION:	—
VEHICLES AFFECTED:	2026 (WS) Grand Wagoneer/Wagoneer This bulletin applies to vehicles built on or after November 25, 2025 (MDH 1125XX) and on or before January 23, 2026 (MDH 0123XX).			MARKET APPLICABILITY: <input checked="" type="checkbox"/> NA <input type="checkbox"/> CH <input type="checkbox"/> EE <input type="checkbox"/> IAP <input type="checkbox"/> SA <input type="checkbox"/> MEA NOTE: This bulletin applies to the North America market.	
CUSTOMER SYMPTOM:	Customers may comment on one or more of the following: <ul style="list-style-type: none"> Excessive hood under flush to fenders. One or both adjustable hood bumpers are broken. 				
CAUSE:	Material defect

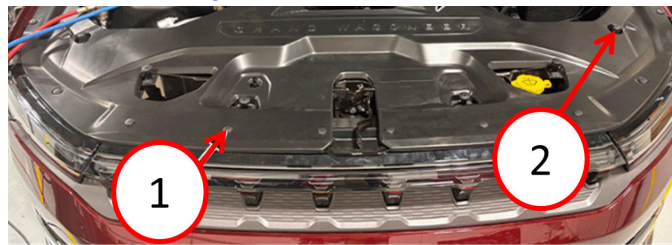
Fig. 1
Bumpers And Closeout Fasteners

1 - Closeout Panel Fasteners
2 - Plastic Bumper

1. Open the hood.
2. Remove the 10 closeout panel fasteners [Fig. 1](#).

3. Remove the close out panel.
4. Using a trim stick or equivalent, pry the plastic bumpers assemblies [Fig. 1](#) upward to release the locking tabs [Fig. 2](#) from the body.

5. Compare the old bumper height to the new bumper and adjust the new bumpers to the same heights [Fig. 2](#).
6. Install two new hood bumpers to the body by pressing the bumpers into body mounting holes.
7. Install the closeout panel [Fig. 1](#) using the 10 fasteners.
8. Close the hood.
9. Verify flushness and gaps if needed. Adjust both bumpers if required to achieve flush hood to fender gaps. Refer to the detailed service procedures listed in DealerCONNECT> Service Library under: 31 - Collision Information / Technical Specifications (**Gap and Flush Dimensions**).
