Technical product information

Topic	Fluid leak from front air spring
Market area	Bentley: worldwide (2WBE)
Brand	Bentley
Transaction No.	2054635/8
Level	EH
Status	Released for publishing
Release date	May 8 2026

Technical product information
Fluid leak from front air spring

Transaction No.: 2054635/8

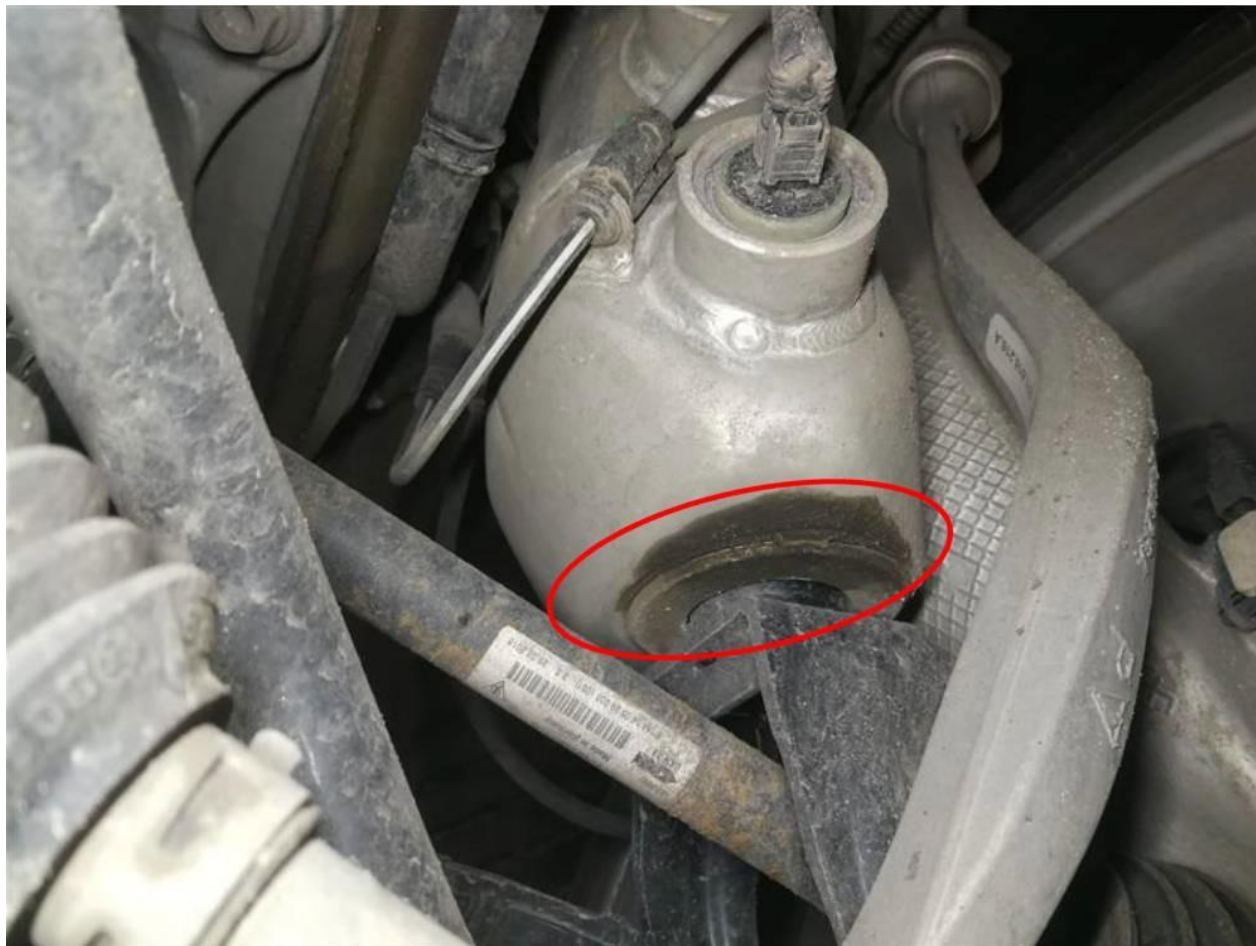
Figure 1

- Fluid leak from the base (Figure 1) and/or the top (Figure 2) of the front air spring/s

The fluid shown in Figures 1 and 2 is assembly fluid residue. The fluid is applied to various internal components of the air spring during manufacture.

- 1) Take a photograph of the applicable air spring in which the residue is evident
 - Clean the residue from the air spring
- 2) Conduct a road test
- 3) On return from road test - Conduct a further inspection to check/confirm the residue is no longer evident
 - Should the residue no longer be evident – No further action is required, parts must not be replaced for this concern
 - Should the residue be evident on return from the road test – Raise a DISS query and await feedback before carrying out any further work NOTE: Please ensure photographs of the residue are attached within the DISS query clearly showing the residue prior to cleaning/road test and post road test
