Topic	Window Drop Glass Anti-Trap Activating / Window Bounce-Back   Bentayga EWB
Market area	Bentley: worldwide (2WBE),China 796 VW Import Comp. Ltd (Vico), Beijing (6796)
Brand	Bentley
Transaction No.	2081449/3
Level	EH
Status	Released for publishing
Release date	May 8 2026

Transaction No.: 2081449

Window Drop Glass Anti-Trap Activating / Window Bounce-Back | Bentayga  
EWB

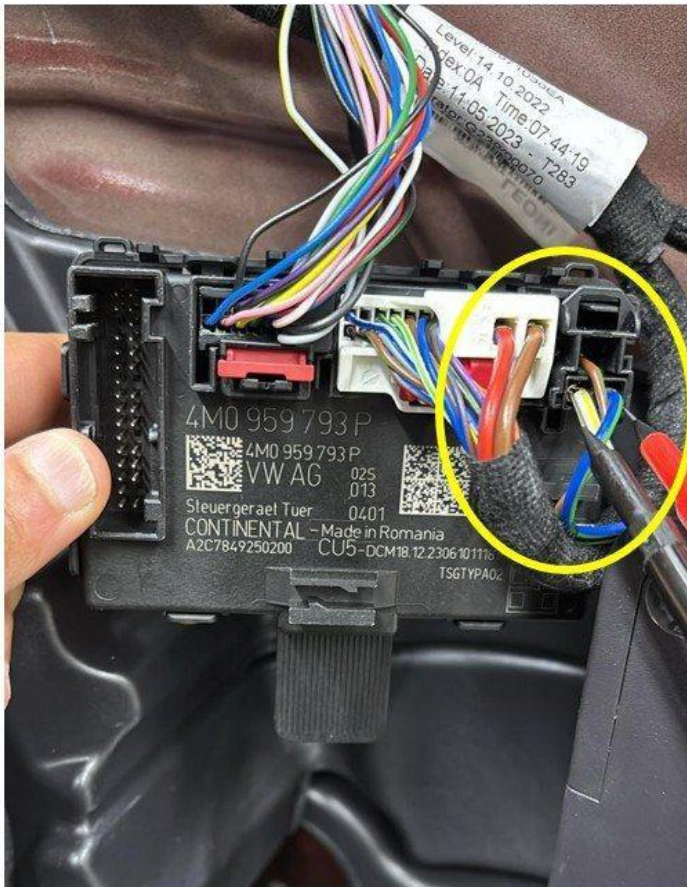
Figure 1

- As highlighted in figure 1, connect the positive and negative terminals to the door ECU connector.

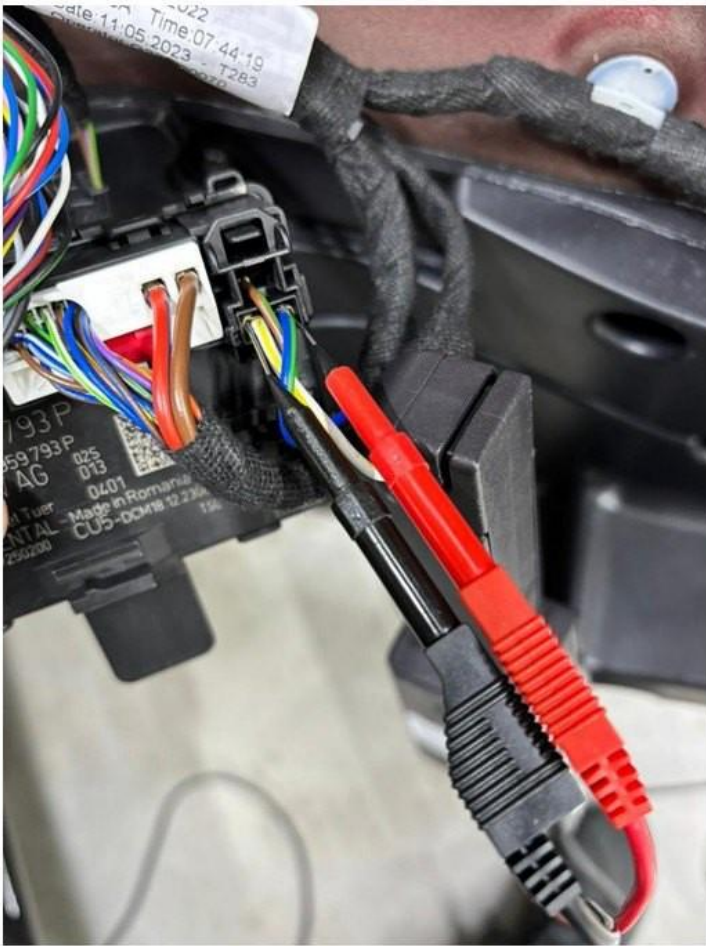
Figure 2

- Connect the Positive probe to the blue and green wire and the negative probe to the yellow wire.

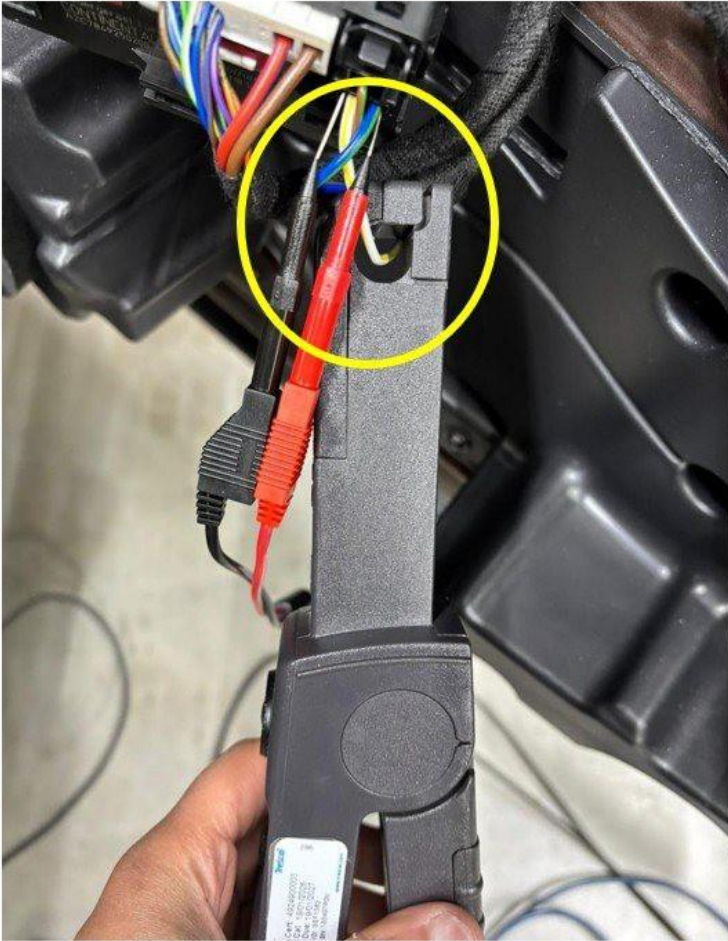
Figure 3

- As highlighted in figure 3, connect the current clamp to the white wire.
