## Technical product information

<b>Topic</b>	Continental Series and Flying Spur - Camshaft Timing Over Advanced - V8T
<b>Market area</b>	Bentley: worldwide (2WBE),China 796 VW Import Comp. Ltd (Vico), Beijing (6796)
<b>Brand</b>	Bentley
<b>Transaction No.</b>	2047762/5
<b>Level</b>	EH
<b>Status</b>	Released for publishing
<b>Release date</b>	May 18 2026

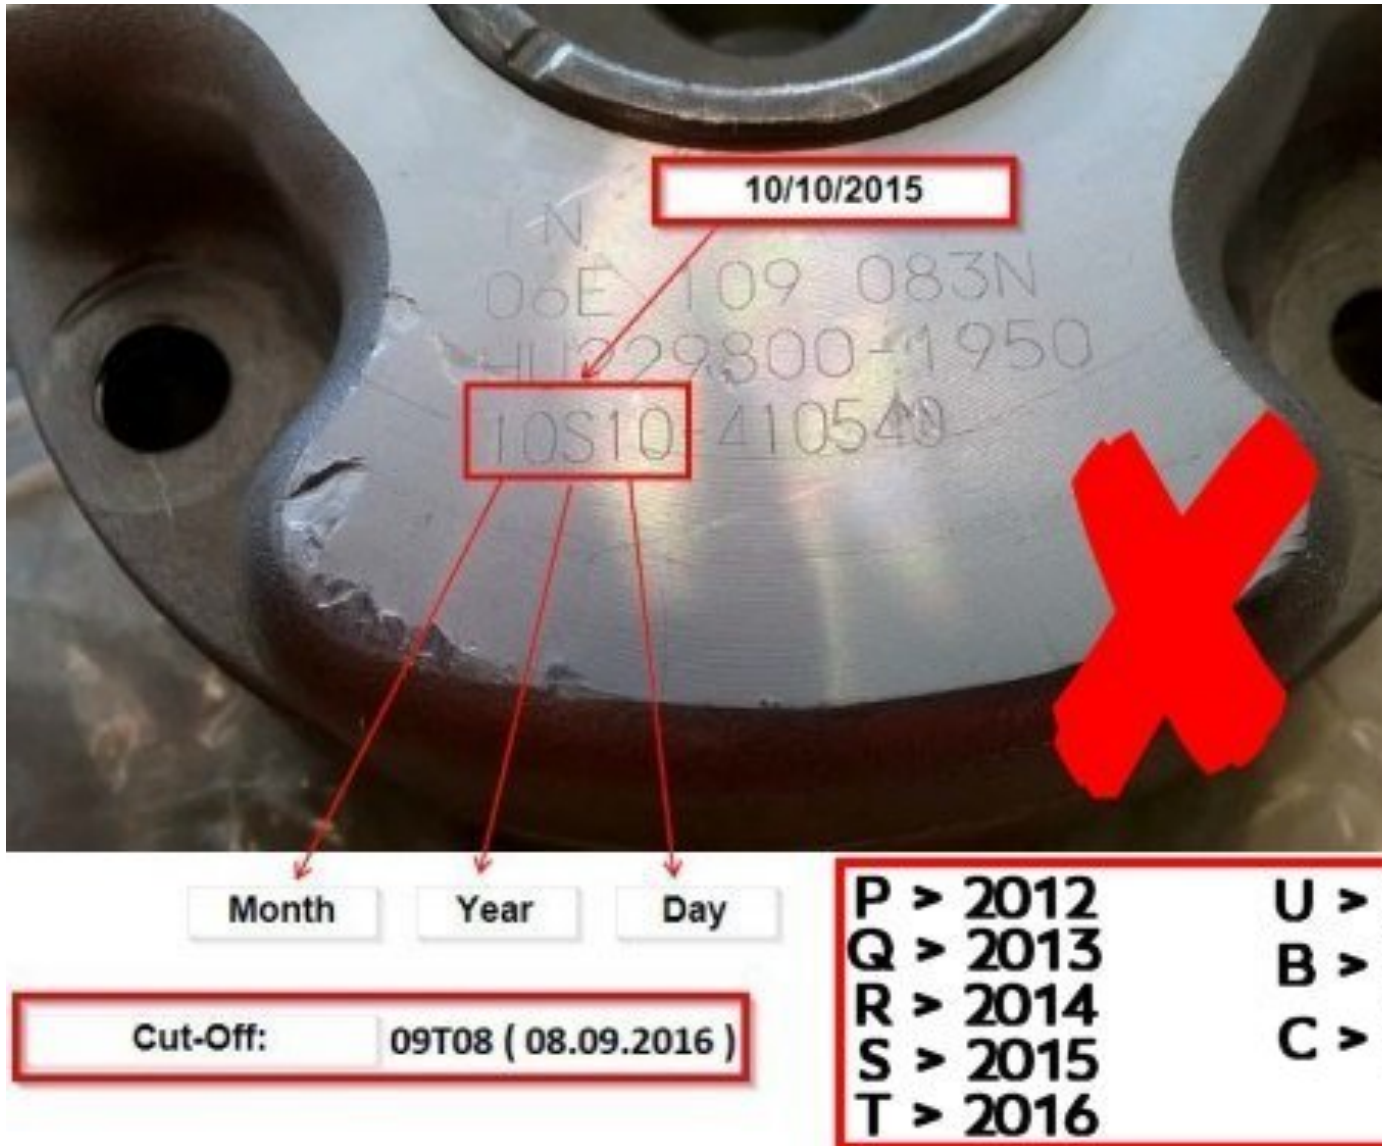
- Check the date code marked on each of the four Camshaft Adjusters, any found to be prior to 8/9/2016 (Date code 09T08) - Figure 1 - should be replaced. When changing a Camshaft Adjuster the relevant Camshaft Control Valve should also be replaced.
- Camshaft adjusters later than date code 8/9/2016 (09T08) do not need to be changed – Figure 2 - unless the fault code stored is specifically for that particular Camshaft Adjuster.

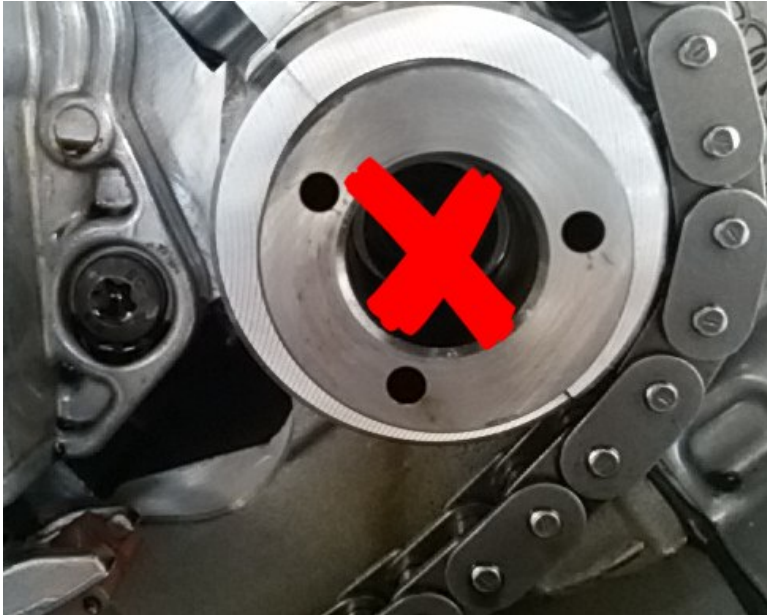
- When replacing the camshaft adjusters check and confirm the specification of ALL four camshaft mating faces IMPORTANT: Should the camshaft faces be smooth as shown in Figure 3 all four camshafts should be replaced

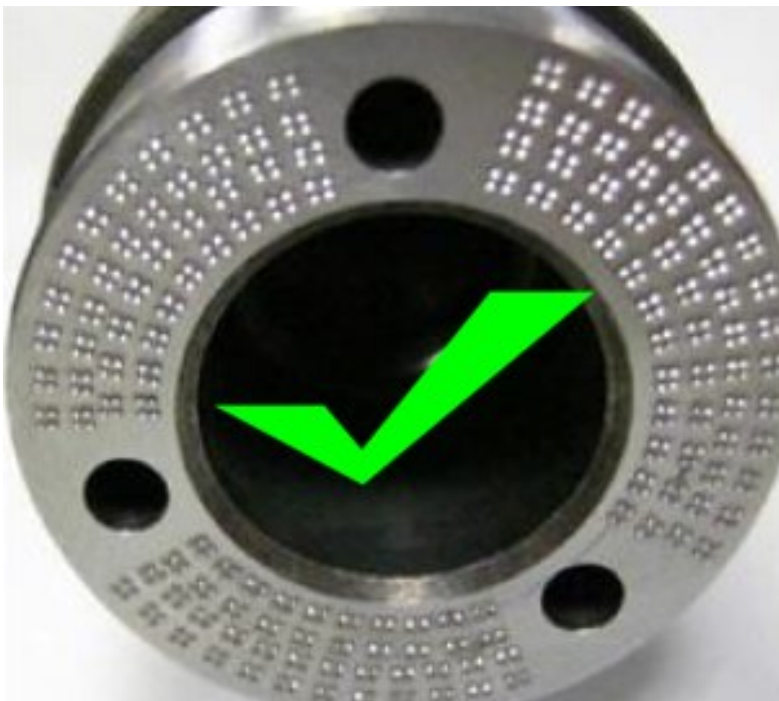
Figure 4

- Should the camshaft mating faces be machined patterned as Figure 4, there is no requirement to replace the camshafts
