Technical product information

Topic	EPB Warning light in DIP - Front door/s power latch system intermittent - DTC U112300 within Address 03 and Address 46
Market area	Bentley: worldwide (2WBE),China 796 VW Import Comp. Ltd (Vico), Beijing (6796)
Brand	Bentley
Transaction No.	2075034/4
Level	EH
Status	Released for publishing
Release date	May 18 2026

Transaction No.:
2075034/4

EPB Warning light in DIP - Front door/s power latch system intermittent - DTC
U112300 within Address 03 and Address 46

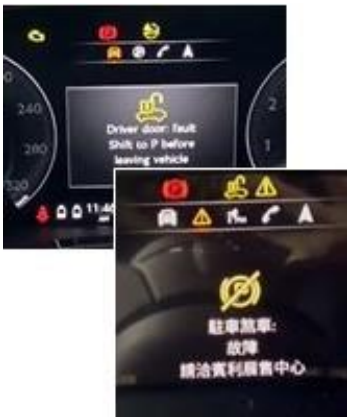
Figure 1

One or a combination of the following is evident within the DIP (Figure 1)

- Electronic parking brake warning

- Drivers door power latch intermittent operation warning

- The front door/s power latching system sporadically does not work. The door remains in the first latch of the door lock but is not closed by the power latching system
- DTC U112300: Databus error value received Symptom 450560 evident within the ESP control unit (electronic stabilisation program) (J104)

The micro switch signal of the door lock is not recognised or is recognised briefly, a counter press of the door by the operative is required to clearly recognise the signal

Insufficient back pressure of door (door closing loads / seal load) results in the pawl microswitch signal becoming too short. This short signal is then calculated as an error state by address 0003 -Brake electronics
