Vibration at Idle in Drive

Service Category Engine/Hybrid System

YEAR(S)	MODEL(S)	ADDITIONAL INFORMATION
2024 - 2026	GX550

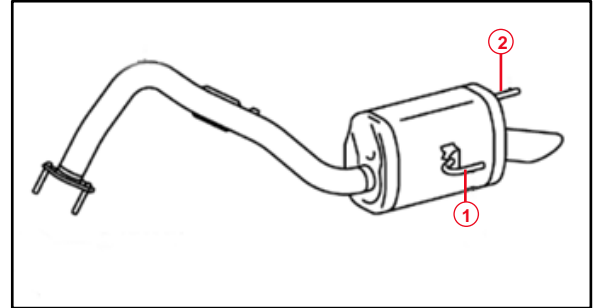
1	Hanger 3
2	Hanger 4

- Replace the exhaust supports on exhaust hangers three and four found in Figure 1.

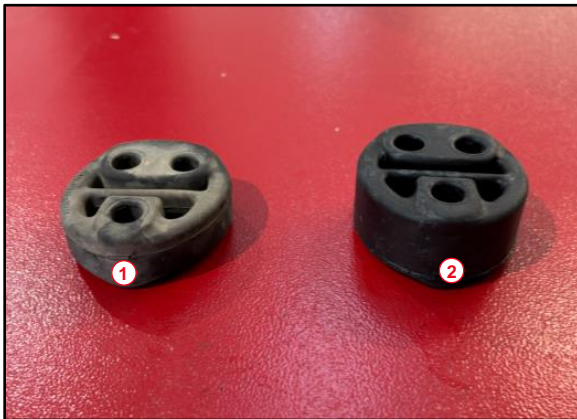
Figure 2. Exhaust Support Hanger 3

1	Original Exhaust Pipe Support (17565-74320)
2	Countermeasure Exhaust Pipe Support (17565-64180)

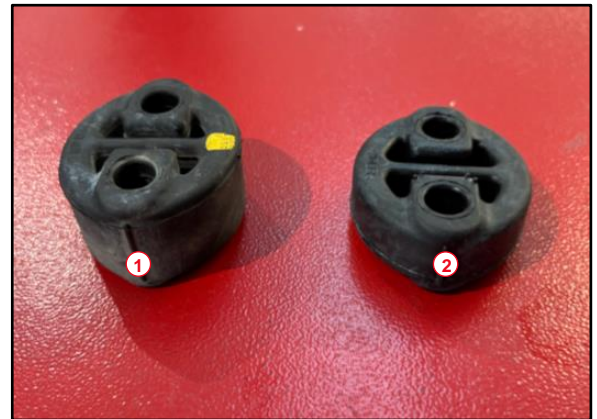
Figure 3. Exhaust Support Hanger 4

1	Original Exhaust Pipe Support (17565-22040)
2	Countermeasure Exhaust Pipe Support (17565-22030)

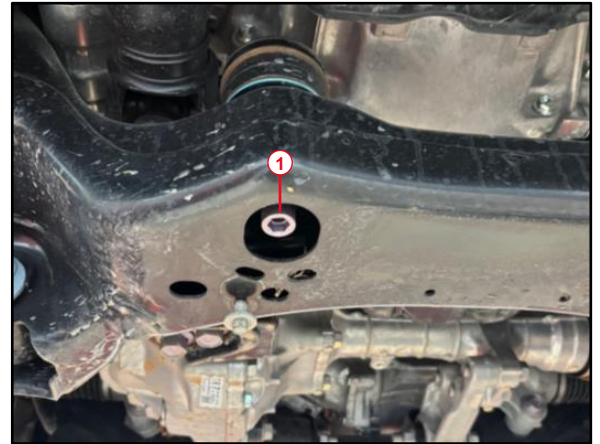
Figure 4. Rear Mount

1	Support Bolt
---	--------------

5. Loosen the front differential support points, as shown in Figure 4, Figure 5, and Figure 6.

7. Re-torque differential support bolts using proper torque specifications found in Repair Manual.
 - [2024 – 2026](#) GX 550:
Drivetrain – Axle and Differential – Front Differential Carrier Assembly – Installation

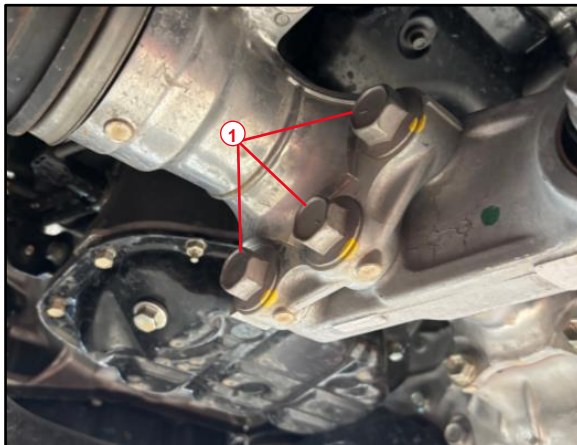
Figure 5. Front Right-hand Mount

1	Support Bolts
---	---------------

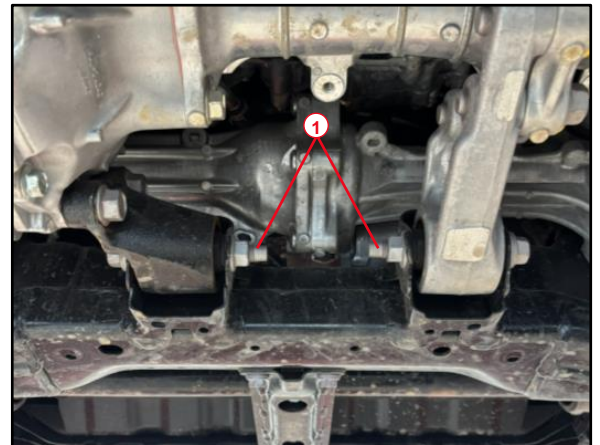
Figure 6. Front Mount

1	Support Bolts
---	---------------
