Service Alert

Mazda North American Operations
Irvine, CA 92618-2922

Subject: TELEMATICS COMMUNICATION UNIT (TCU) REPLACEMENT / ACTIVATION PROCEDURE	Service Alert No.: SA-034/26
	Last Issued : 05/18/2026

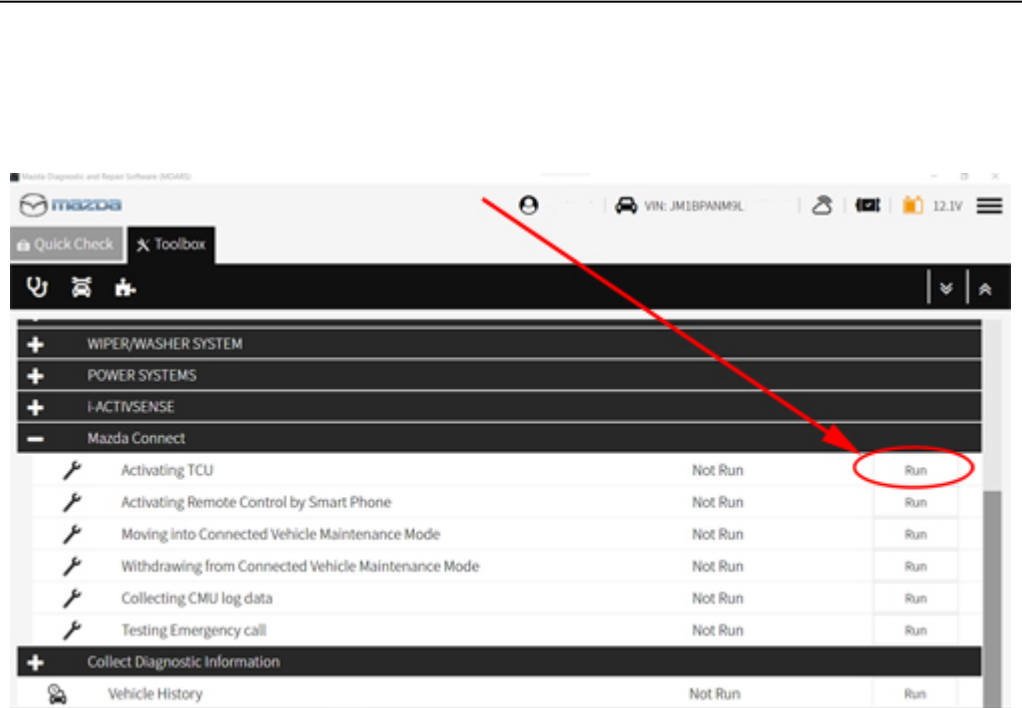
NOTE: MDARS may show "Incomplete". This may be caused by:

- Advanced key is not in the vehicle.
- Connected vehicle maintenance mode is enabled.
- Pacemaker radio wave interference prevention is enabled. See [SECURITY AND LOCKS-RELATED PARTS PROGRAMMING \[SECURITY AND LOCKS\]](#)
- key transmitter power saving function is enabled. See [SA-020/21](#).

9. Select Activating TCU (links TCU to server) -> "Run".
Wait for "initialization complete" message.
