Technical Service Bulletin

Transaction No.: **2074806/5**

37 Noises after selecting a gear while idling and the vehicle is stationary, or while driving

Release date: May 28, 2026

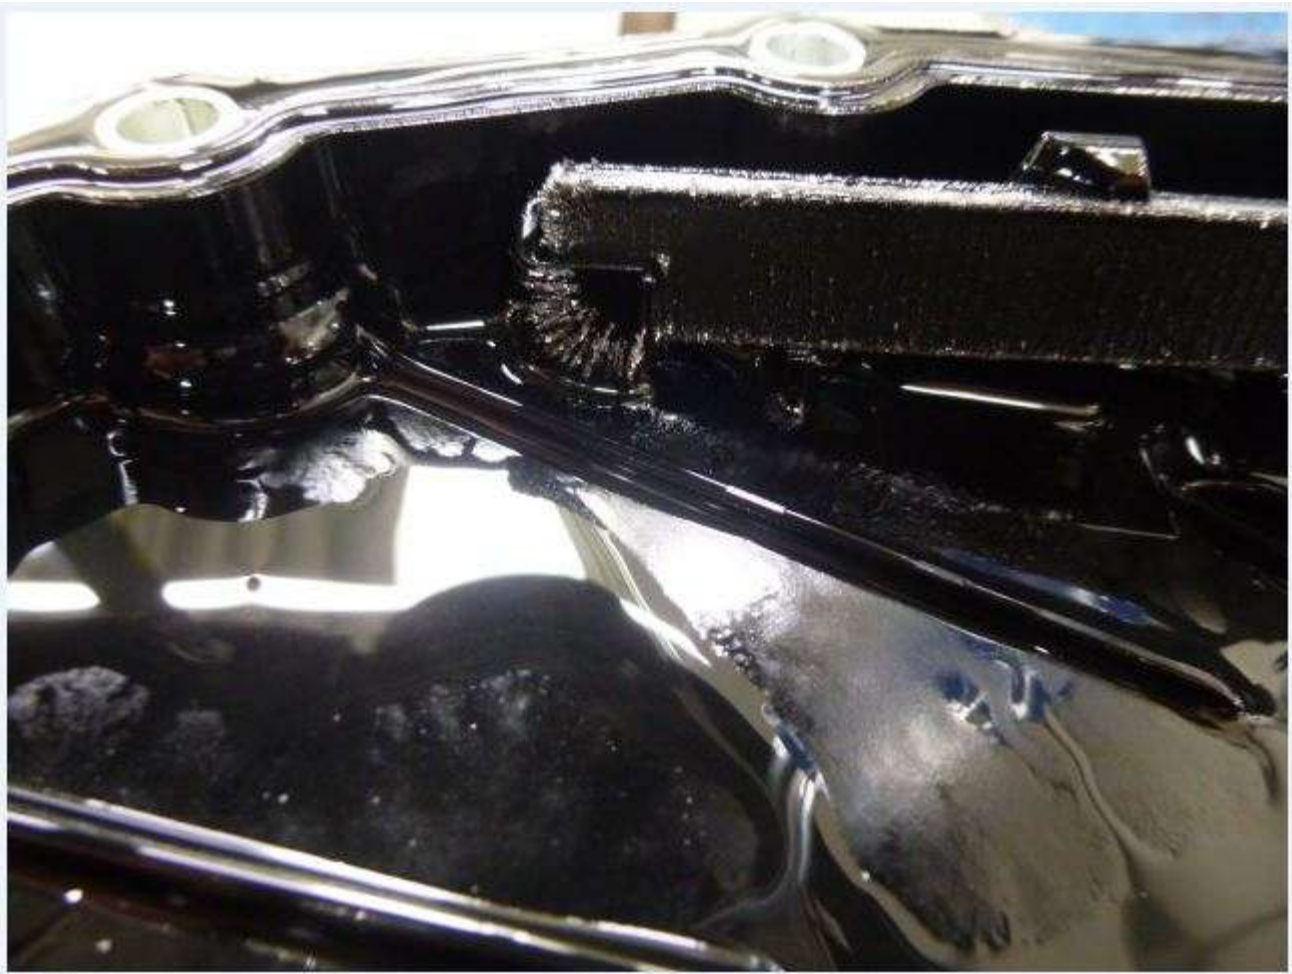
- **Abrasion visible on the permanent magnets of the oil pan (see figure 1).**

Figure 1. Abrasion is visible on the permanent magnets of the oil pan.

- After removing the filter, thoroughly **clean** the valve body in this area and **avoid** getting it dirty.
- Replace the permanent magnets in the gearbox oil pan.
- Also replace the ATF.

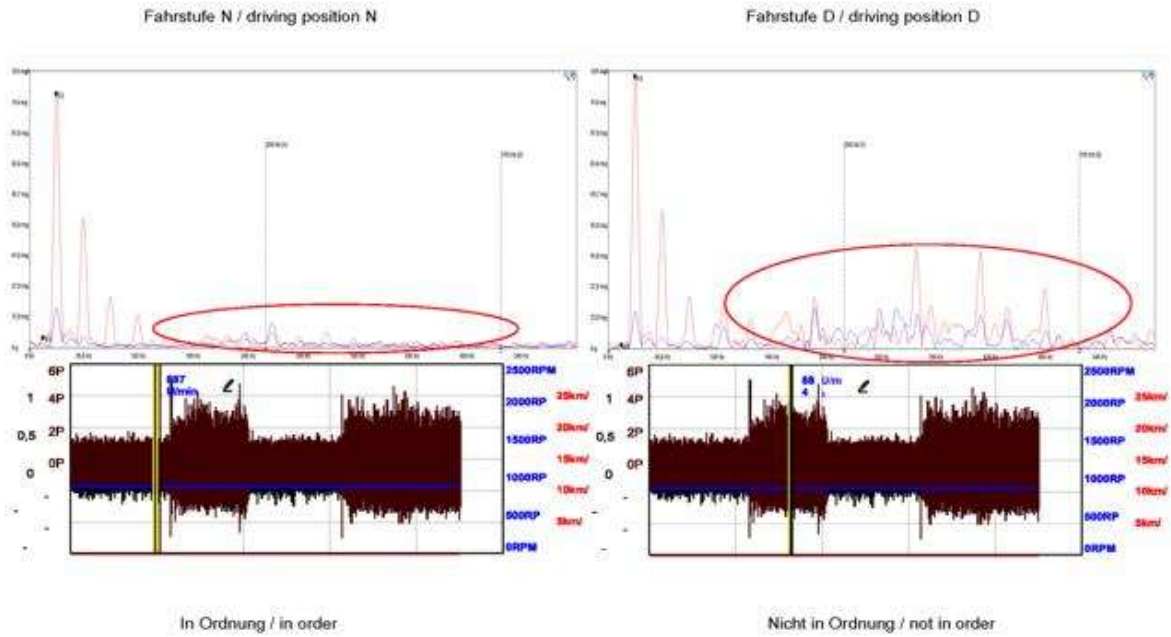
- Analysis of the measurement via acceleration sensor 1/channel A and acceleration sensor 2/channel B.
 - Frequency range of approx. 250-600Hz can be detected here.

Figure 6. Please note the visualization showing a measurement in the attachment (“measurement” and “measurement1”).

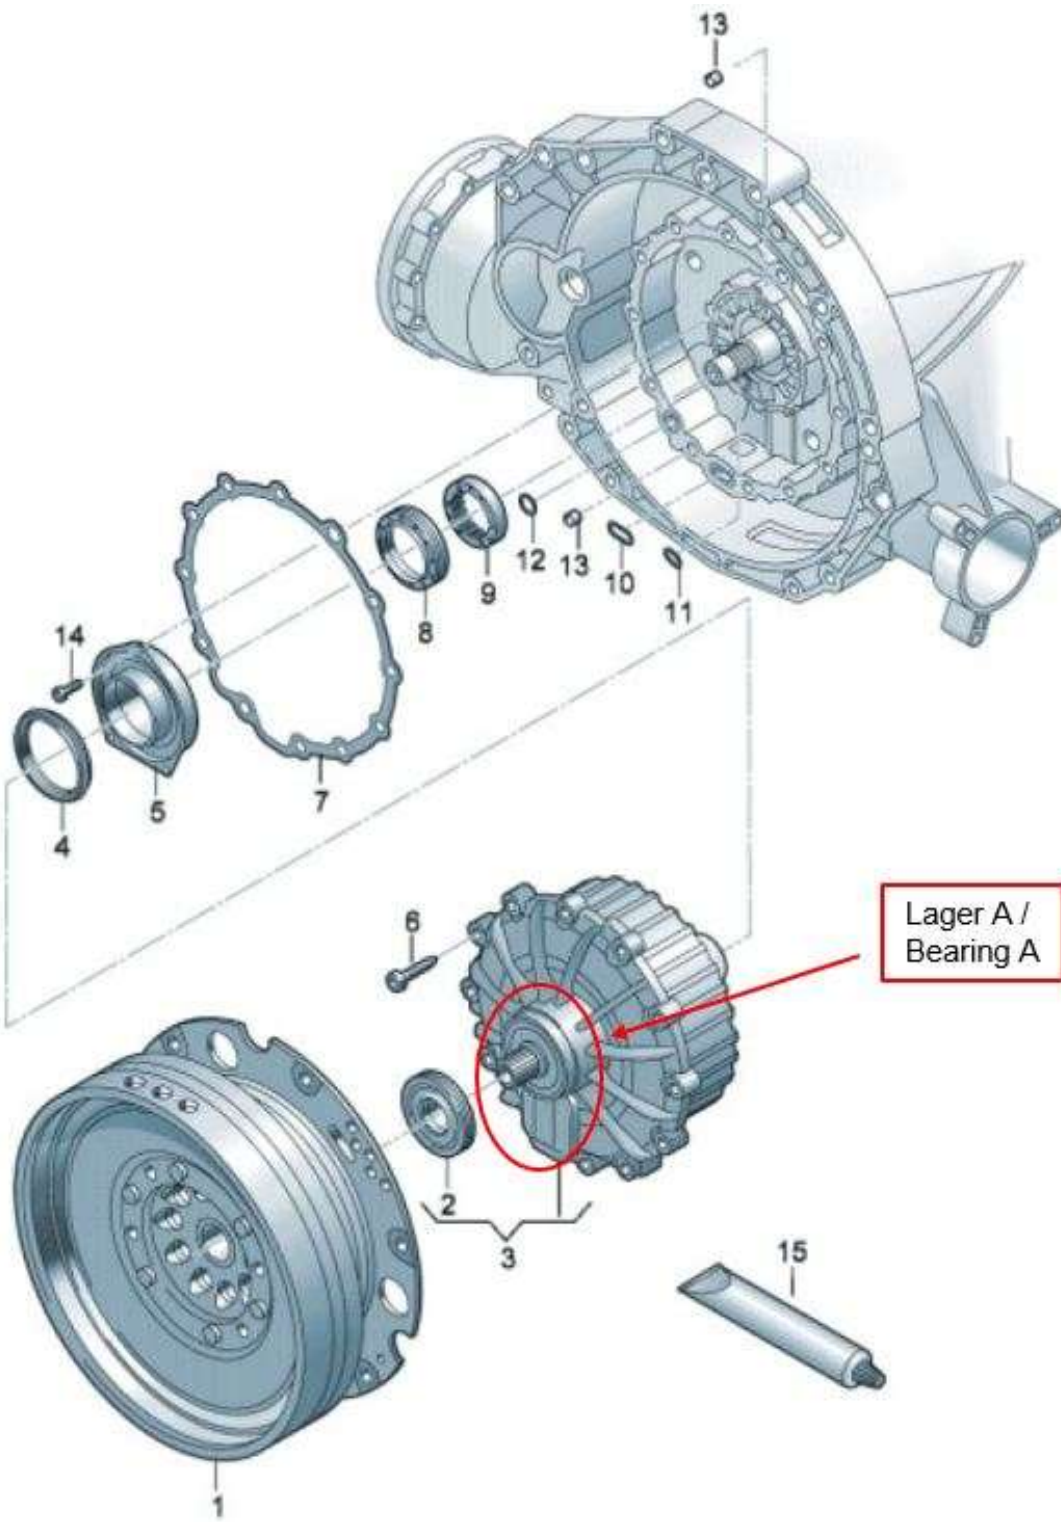
Bearing A (Figure 7) on dual clutch.

Figure 7. Bearing A on dual clutch.

- To do so, remove the oil seal on bearing A (figure 7 -> marked in red) of the dual clutch that was removed.

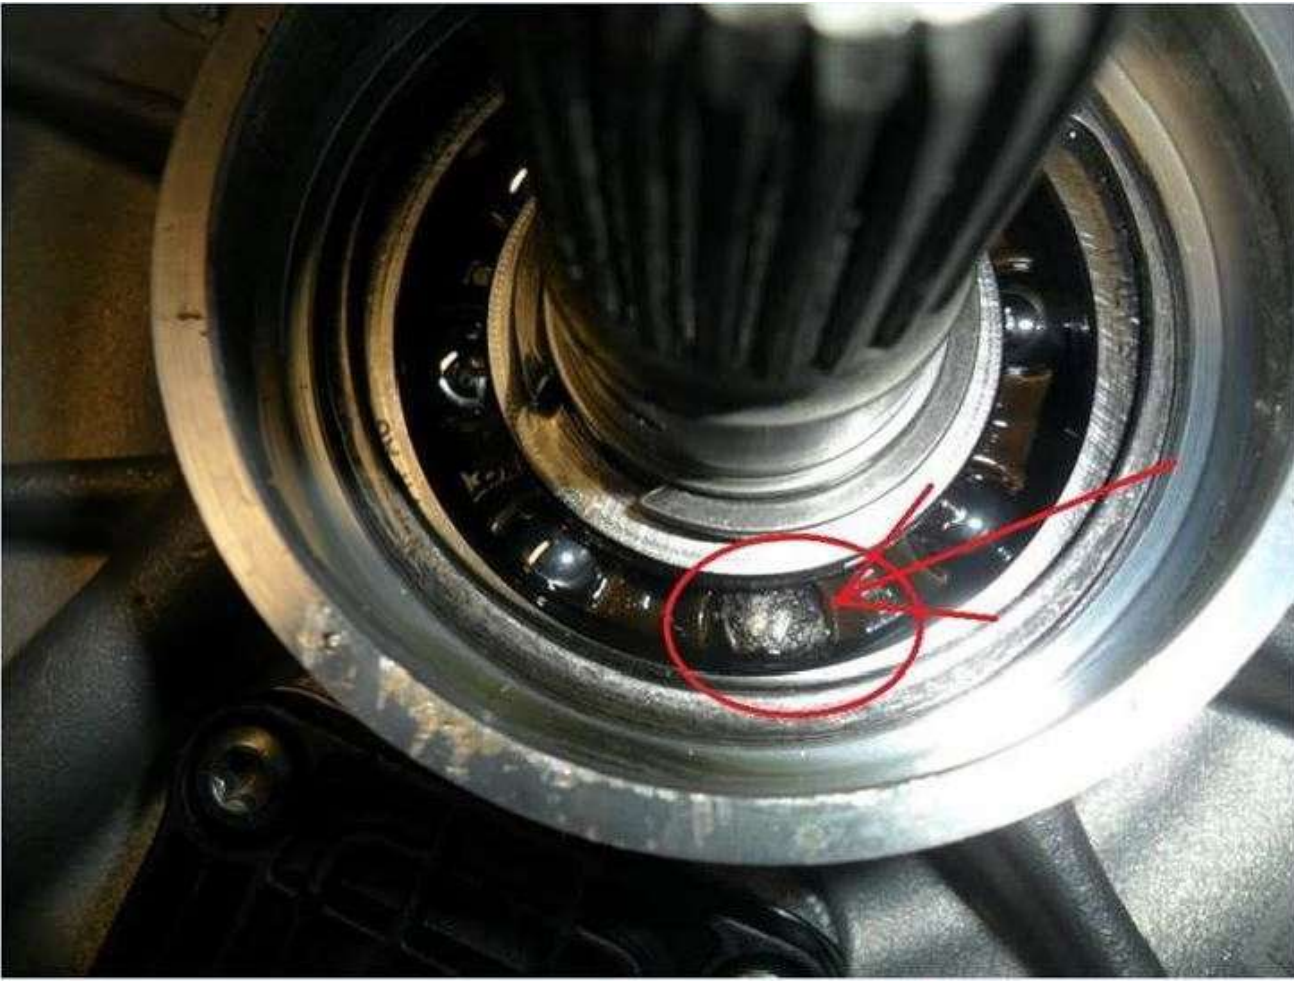
Figure 8. Bearing A circled, with red arrow.

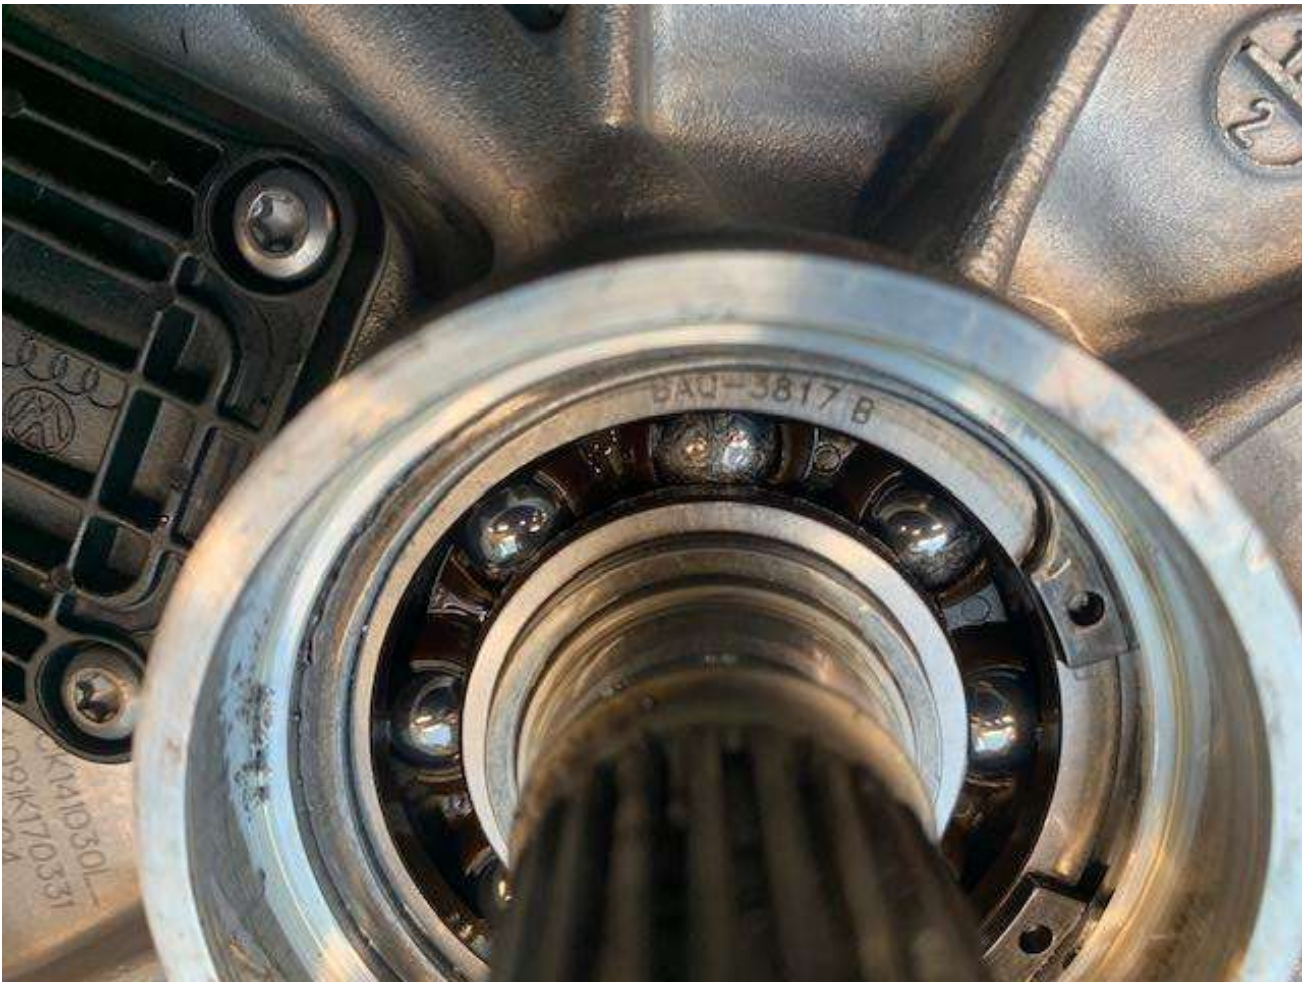
Figure 9. Bearing A and ball cage.

- Replace bearing A in cover for dual clutch if you find the following functional issue on bearing A:
- Wear can be seen on bearing A and ball cage is still in bearing A (see figure 9).

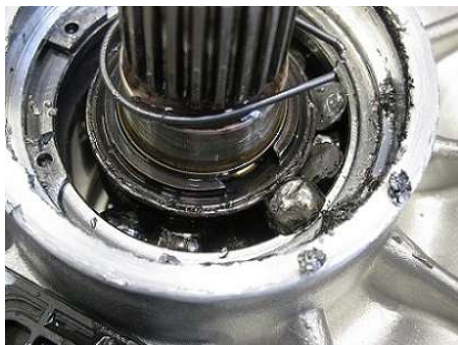
Figure 10. Damage is irreparable.

- Replace the entire dual clutch if you find the following functional issue in the installation space around bearing A:
 - Ball cage no longer in bearing A or irreparable damage to ball cage -> ball guidance no longer provided (see figures 10 and 11).

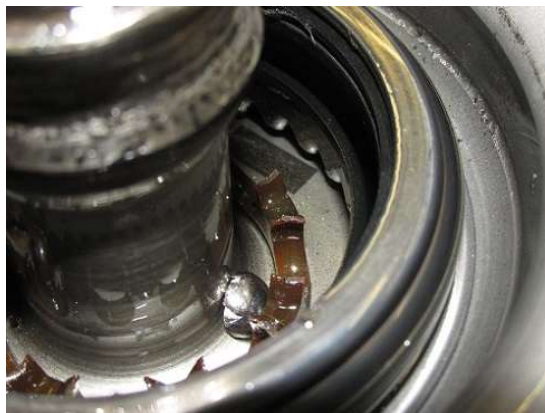
Figure 11. Damage is irreparable.
