Technical Service Bulletin

Transaction No.: **2076994/8**

27 Valeo 48V starter generator (BSG) DTC P0A1A00 P19F800 P0A1E00 U014600
U300100 P10F300 P056200 P056100 P065200 P069800

Release date: May 8, 2026

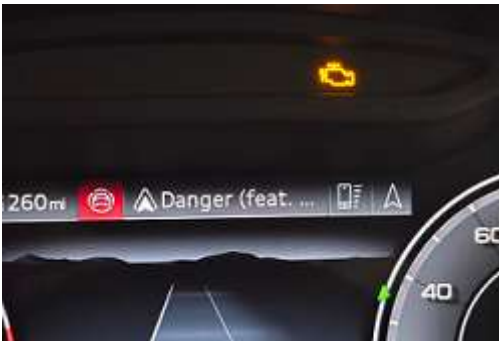
- The engine warning lamp (MIL) is on (Figure 1).

Figure 1. MIL is illuminated.
