Technical Service Bulletin

Transaction No.: **2077475/2**

37 Transmission: gearbox fault warning light on - event memory entry
P0174A00/P174E00

Release date: May 8, 2026

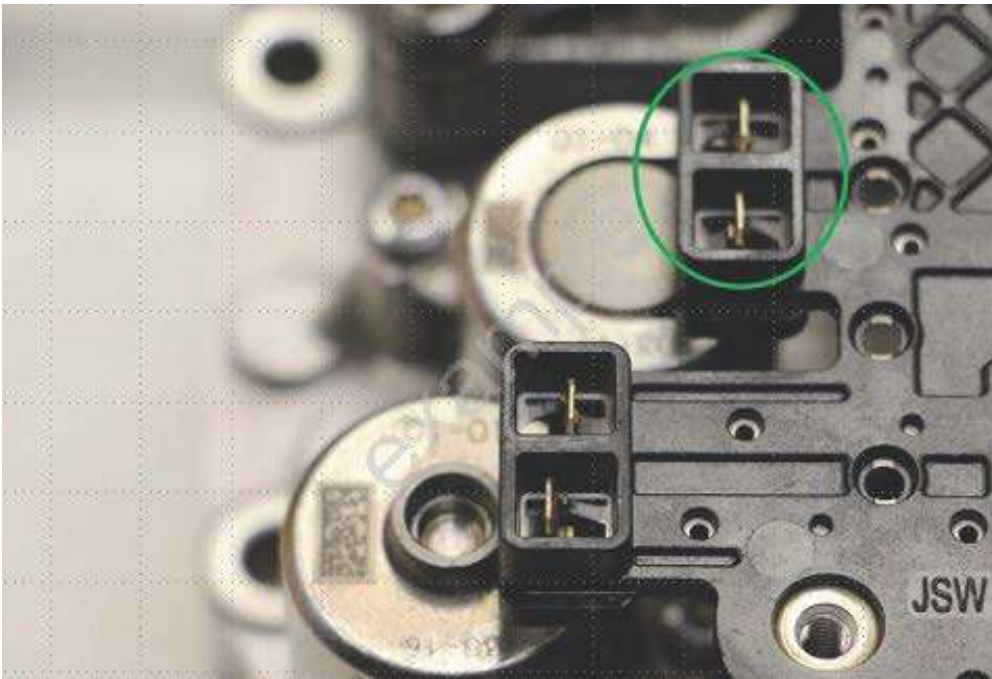
Figure 4. Contacts OK (green).

- Carefully detach the contact plate from the mechatronic unit towards the front, without levering it off.
- Fit new contact plate (see *Parts Information* for part number) on the mechatronic unit and carefully engage it audibly on the contacts (see figures 4 and 5).

- It is essential to ensure that all contacts are inserted in the intended/correct connector and do not get bent when fitting the contact plate to the mechatronic unit (refer to figures 4 and 5).

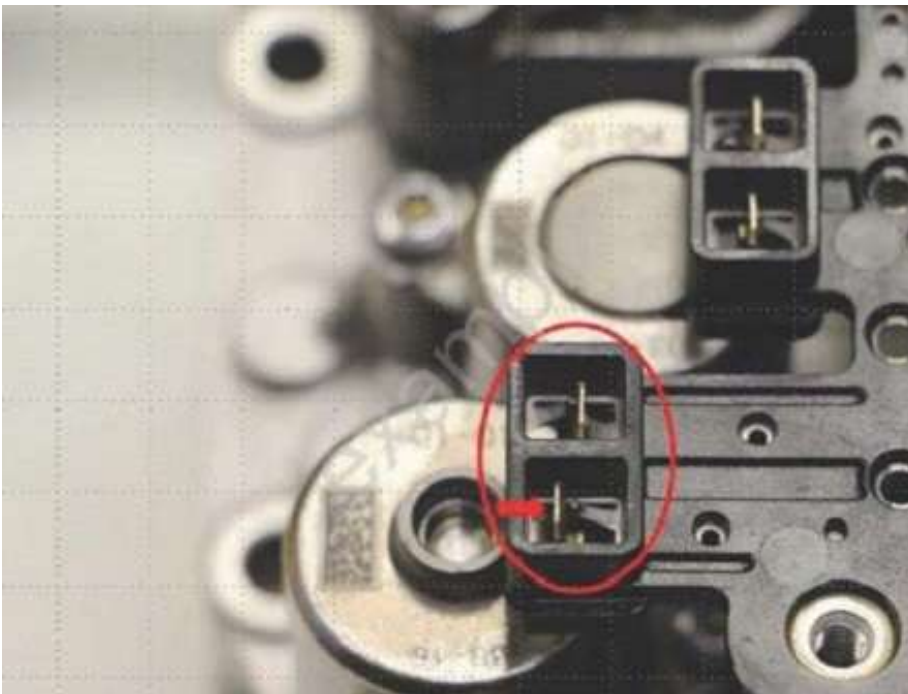
Bent contacts when fitting contact plate on the mechatronic unit.

Figure 5. Contacts not OK (red).
