Model(s)	Year(s)	VIN Range	Vehicle Specific Equipment
A5, S5 (FU), A6 Sportback e-tron, S6 Sportback e-tron, Q5, Q5 Sportback, SQ5, SQ5 Sportback (GU), Q6 e-tron, Q6 Sportback e-tron, SQ6 e-tron and SQ6 Sportback e-tron	2025	All	With PR Code GJ0 and FT4 GJ0 and FT5 GK1 GJ4 GJ5 GJ6 GJ7 GJ8 0019 – Data Bus OBD Interface Software: 85C907468AF 85F907468AF
A6	2026

REVISION HISTORY		
Revision	Date	Purpose
2	-	Revised header (Adjusted market visibility, models, PR Codes) Revised <i>Condition</i> (Updated model table) Revised <i>Service</i> (Updated instructions, included photo requirement)
1	02/19/2026	Initial publication

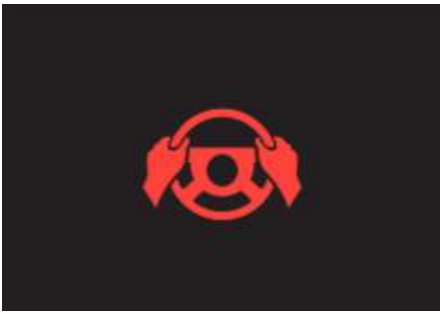
The customer complains that fault messages relating to the driver assist systems appear together with the take over steering prompt **only** shortly after starting the vehicle.

**Figure 1.** Take over steering warning light.

- Adaptive cruise assist: fault. You can continue driving
- Lane departure warning: fault. You can continue driving
- Active front assist / distance warning: fault. You can continue driving
- Traffic sign recognition: fault. You can continue driving
- Adaptive light: fault
- Main beam assist: fault
- Lane change assist: currently unavailable
- Proactive occupant protection: currently unavailable
- Driver assist systems currently restricted
- Emergency Assist: fault. You can continue driving (in combination with the red take over steering prompt (see Figure 1)).
