Condition

Model(s)	Year(s)	VIN Range	Vehicle Specific Equipment
A5, S5 (FU), A6 Sportback e-tron, S6 Sportback e-tron, Q5, Q5 Sportback, SQ5, SQ5 Sportback (GU), Q6 e-tron, Q6 Sportback e-tron, SQ6 e-tron and SQ6 Sportback e-tron	2025	All	With PR Code GJ0 and FT4 GJ0 and FT5 GK1 GJ4 GJ5 GJ6 GJ7 GJ8 0019 – Data Bus OBD Interface Software: 85C907468AF 85F907468AF
A6	2026

REVISION HISTORY		
Revision	Date	Purpose
3	-	Revised <i>Condition</i> (Updated photo requirement)
2	05/06/2026	Revised header (Adjusted market visibility, models, PR Codes) Revised <i>Condition</i> (Updated model table) Revised <i>Service</i> (Updated instructions, included photo requirement)
1	02/19/2026	Initial publication

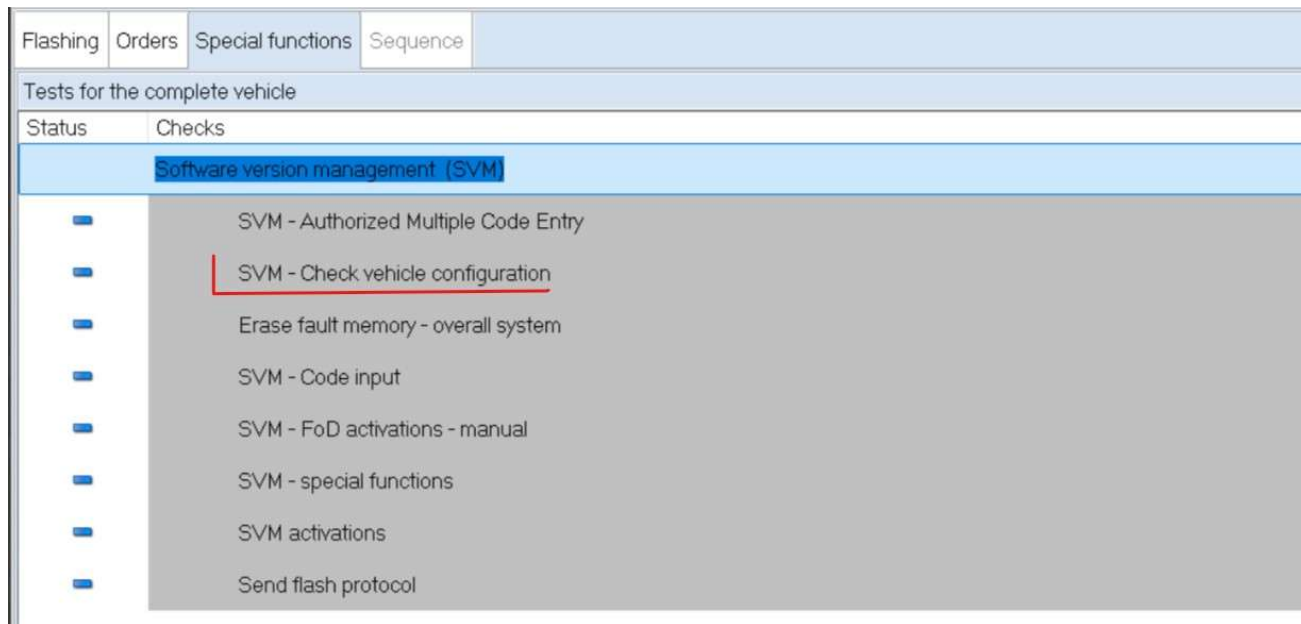
Figure 2: ODIS SVM Test Plan

1. Run the test program "**SVM – Check vehicle configuration**" in ODIS (Figure 2). This step is required to use the SVM-code in step 2.
2. Select the "Flash" function, select "SVM code input" and enter the code **EGDHCP5DA0019**.
3. Flashing will be performed. Due to a system restriction, the procedure will end with the error 8113. Ignore this error. If a different error code appears, proceed as specified in the error message.
4. Run the "**SVM – Check vehicle configuration**" test program in ODIS again.
5. Put the vehicle in bus sleep mode.
6. End the diagnostic session, and send the diagnostic log online.
