## TECHNICAL SERVICE BULLETIN

### Engine Misfire With An Illuminated MIL And DTC(s) P0301, P0302, P0303, And/Or P0304 Stored In The PCM

26-2210

26 May 2026

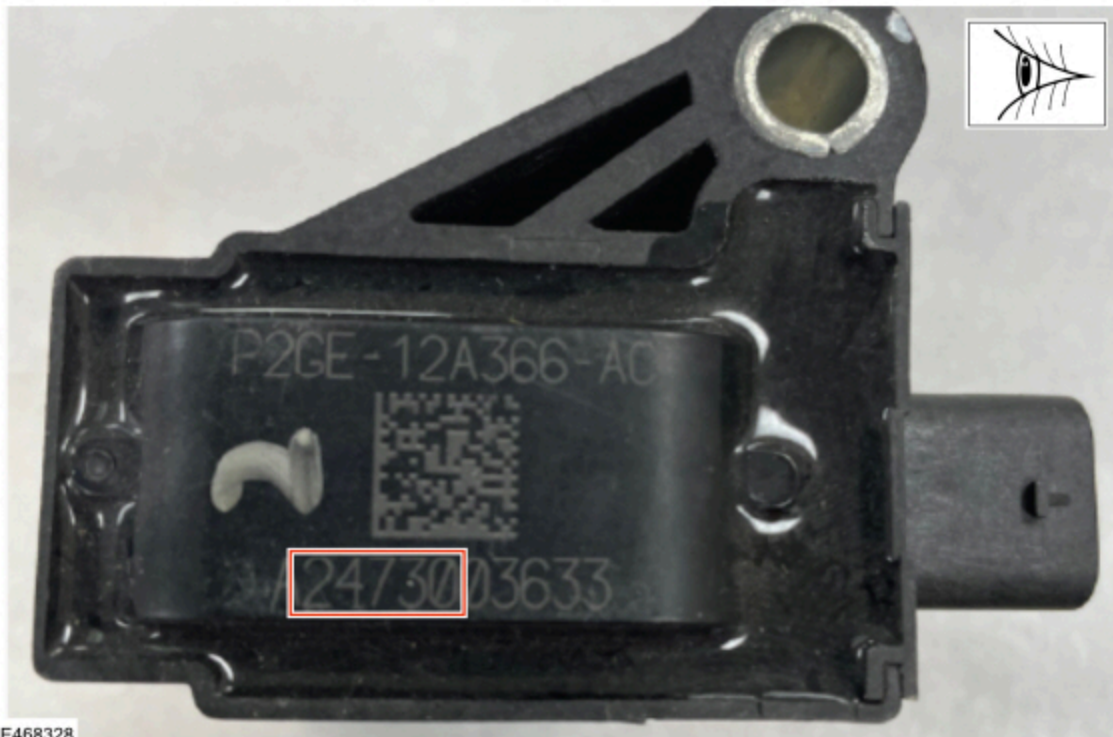
**NOTE: Each ignition coil has an 11-character alphanumeric manufacture code printed on top. The second through sixth characters of the manufacture code are the date code (Figure 1). The date code can be interpreted using the chart below.**

**NOTE: The date code in Figure 1 is 24730 = 30-Jul-2024**

1. Access the ignition coil for the cylinder setting the misfire DTC. Refer to the WSM, Section 303-07 > Removal and Installation > Ignition Coil-On-Plug. Perform only the steps necessary to view the date code located on the top of the suspect ignition coil.
2. Inspect the date code on the ignition coil for the cylinder setting the misfire DTC. Is the ignition coil build date on 01-Apr-2024 and through 31-Oct-2024?
  - (1). Yes - install a new ignition coil on the suspect cylinder. Refer to the WSM, Section 303-07 > Removal and Installation > Ignition Coil-On-Plug.
  - (2). No - this article does not apply. Continue with normal diagnostics outside of this article. Refer to the WSM, Section 303-07.
