J1- Measuring the Capacitance of High-Voltage Power Electronics

Models	Model Year	Model Type	VIN Range	Vehicle-Specific Equipment
Taycan	As of 2020 up to 2024	Y1A, Y1B, Y1C	N/A	Power Electronics

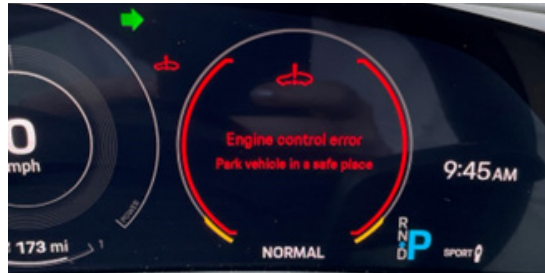
Customer complains of a red "Engine control error" in the instrument cluster (Figure 1). The workshop may find the following faults stored in the front and/or rear high-voltage power electronics CU and/or the DCDC Converter:

Figure 1
“Engine control error” in instrument cluster
