Complaint Regarding the Camera View (Real Top View) in the PCM Central Display (03/26)

Model line: **911 (992 II)**

Concerns: **Signal lines and plug contacts for the Real Top View cameras**

Situation: **The customer complains that the Real Top View in the central display fails sporadically, partially or completely.**

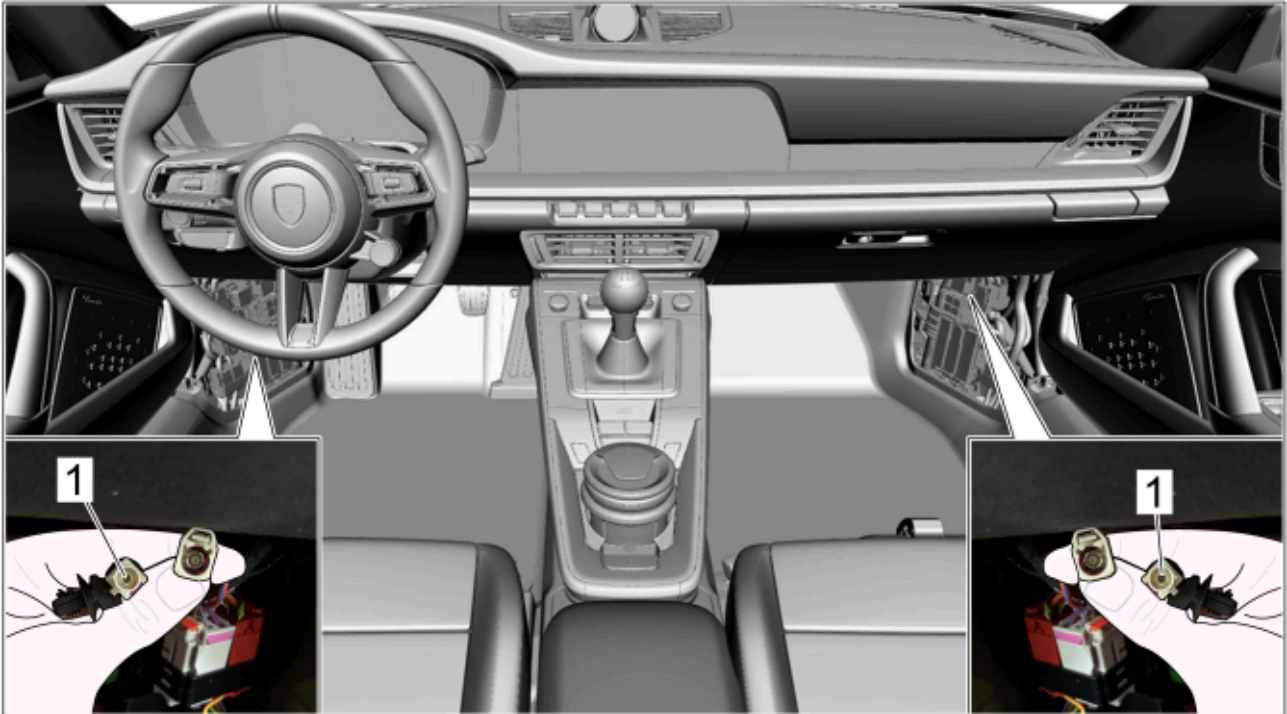
Assessment	Action
Resistance is 335 Ω or less.	<p>The resistance of the signal lines is OK.</p> <p>Connect electric plug connections until connector locks perceptibly.</p> <p>Install front side section and door trim panel \Rightarrow Workshop Manual '702419A1 Removing and installing front side section trim panel' \Rightarrow Workshop Manual '705919A3 Removing and installing the front door trim panel'</p> <p>Then connect earth strap for battery. \Rightarrow Workshop Manual '978509A1 Loosen and secure earth strap for battery'</p>

End of action.
The resistance value is greater than 335 Ω .	The resistance of the signal lines is not OK . Replace plug contact of a signal line in the passenger compartment. Continue with Step ⇒ 2.

Work Procedure: 1 Fasten the **measuring adapter** to the signal lines \Rightarrow Resistance measurement of the signal lines in the passenger compartment -1- in the passenger compartment on the left and right and perform a resistance measurement using the **P90999 - Porsche Tester 4**.

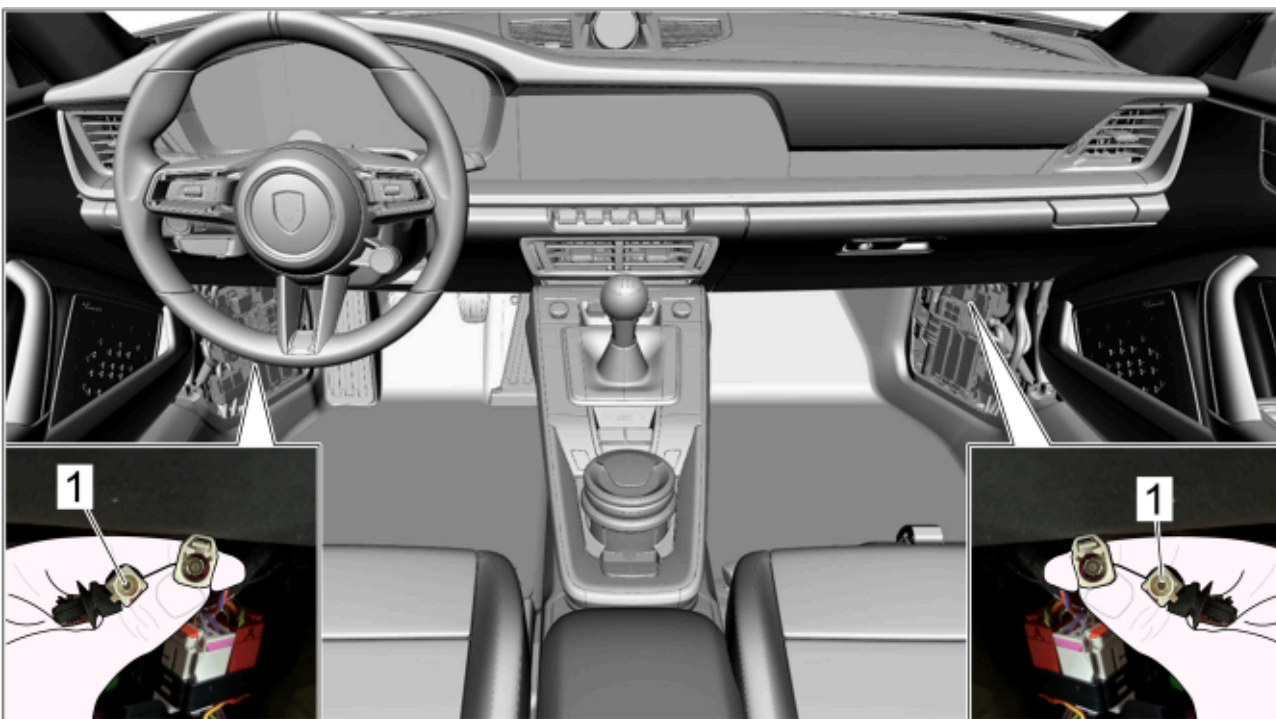
Resistance measurement of the signal lines in the passenger compartment

Assessment	Action
Resistance is 335 Ω or less.	<p>The resistance of the signal lines is OK.</p> <p>Connect electric plug connections until connector locks perceptibly.</p> <p>Install front side section and door trim panel ⇒ <i>Workshop Manual '702419A1 Removing and installing front side section trim panel'</i> ⇒ <i>Workshop Manual '705919A3 Removing and installing the front door trim panel'</i></p> <p>Then connect earth strap for battery. ⇒ <i>Workshop Manual '978509A1 Loosen and secure earth strap for battery'</i></p> <p>End of action.</p>
The resistance value is still greater than 335 Ω .	<p>The resistance of the signal lines is not OK.</p> <p>Replace plug contact of the signal line in the passenger compartment on the right.</p> <p>Repeat step ⇒ 2 on the right-hand side and then perform another resistance measurement.</p> <p>Install front side section and door trim panel ⇒ <i>Workshop Manual '702419A1 Removing and installing front side section trim panel'</i> ⇒ <i>Workshop Manual '705919A3 Removing and installing the front door trim panel'</i></p> <p>Then connect earth strap for battery. ⇒ <i>Workshop Manual '978509A1 Loosen and secure earth strap for battery'</i></p> <p>End of action.</p>

If the resistance reading is still too high after replacing **both plug contacts** in the passenger compartment, create a **Warranty PRMS ticket** with priority "B" and the title (brief description) "**TI 03/26 - Support**", attach the measurement results of the individual measurements and a brief description of the work performed. When submitting the ticket, ask to forward the ticket directly to the PRMS group "PAG_campaign_TI_SY_support". PAG then checks the issue and provides a repair recommendation.
