Location: Powertrain

Topic: McLaren Artura Cold Climate Engine Idling (CCV system and oil tank protection)

Condition: Permanent

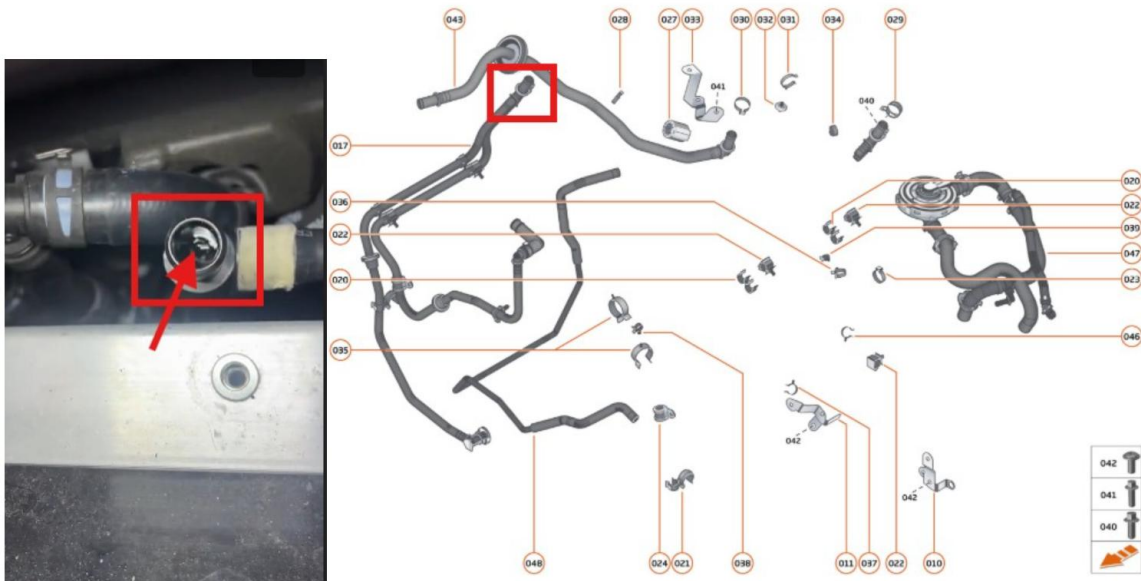
Cold climate static running combined with low oil and coolant temperatures, and a lack of utilisation of the engine full-load breather system, may lead to water vapour/condensate build up in the CCV system pipework, PCV and one-way valves through reduced evaporation rates.

Consequently, there is a risk of oil - water emulsification, or freezing of any trapped condensate leading to blocked or sticking valves.

Additionally, any build-up of condensate in system low points could also potentially cause system blockages, and a risk of hose, pipe or oil canister damage.

If testing or servicing requirements dictate that an extended cold idle is required; the following CCV system components should be monitored and inspected throughout and after the test:

- CCV Pipework and Hoses: Inspect hoses for visual damage or internal blockage; including checks for frozen sections, paying particular attention to system low points and directly above one-way-valves. Remove any blockages or replace any damaged parts as required
- PCV Valve: Remove and inspect the PCV valve and associated hoses, checking for condensation build up and signs of oil - water emulsification. Replace the PCV if evidence of emulsification found
- Oil Tank: Check and replace the oil tank if showing any signs of deformation, cracking or expansion
