G2.II Panamera - Exclusive Design Taillight Faulty

Models	Model Year	Model Type	VIN Range	Vehicle-Specific Equipment
Panamera	As of 2021 up to 2024	971	All	8VQ - Exclusive Design Taillight

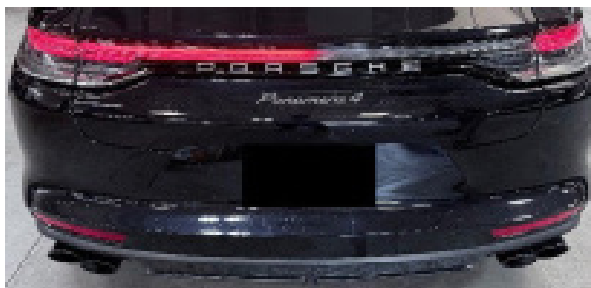
Figure 1

The customer states the taillights exhibit limited function in part (Figure 1) or in full (Figure 2), accompanied by an instrument cluster message pertaining to , "Tail light faulty".

The condition described above can occur if the vehicle is exposed to excessive ambient heat. For example, vehicles that are operated in warmer climates may be more susceptible to this condition.

1. Record the Pre-VAL
2. Replace the center taillight with the updated part number below

Old: 973.945.093.BC

New: **973.945.093.BD**

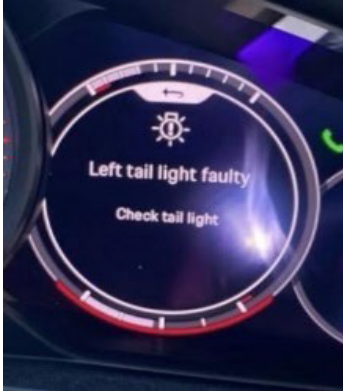
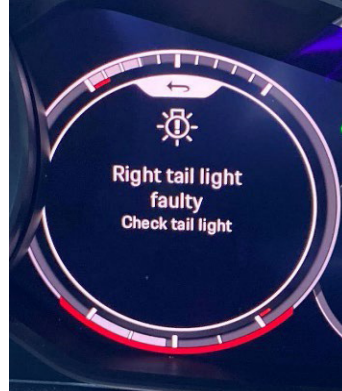
Vehicles exhibiting this condition typically display a message, "tail light faulty" as shown in Figure 3 or Figure 4. In cases where there are functionality issues in multiple tail lights, a "several rear lights faulty" display message may also be present (Figure 5).
