Macan Electric (XAB) – AC Charging at Home Not Possible after WSJO

Vehicles Affected

Model	Model Year	Model Type	Vehicle-Specific Equipment
Macan Electric (XAB)	2024-2026	All	N/A

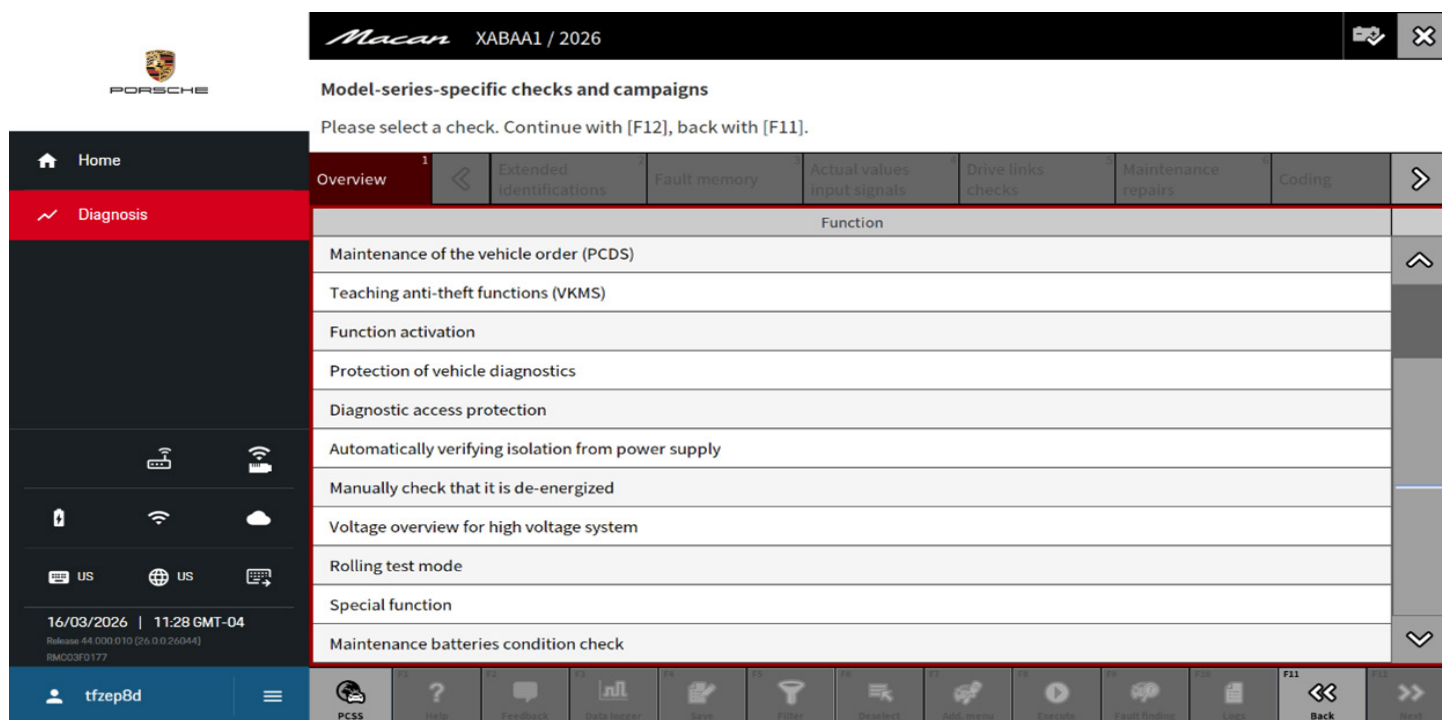
5. Use the Special Functions Tab of the Additional Menu [F7] to begin the programming procedure.
6. Read and follow the information and instructions on the PIWIS Tester during the guided programming sequence. A VAL will automatically be created after the programming is completed.

7. Verify the SW level is changed to 0346
8. Verify that the vehicle is still able to AC Charge at the workshop

Note: After following this procedure, an optional update will be available for the High-Voltage Central Box. This update must not be completed.
